Inspection Report

Property Address:
9876 Sloppy Construction
Plano TX 75074

PROPERTY INSPECTION REPORT

By: Kevin R. Weiss 7108 / Absolute Inspections, LLC 1/21/2016

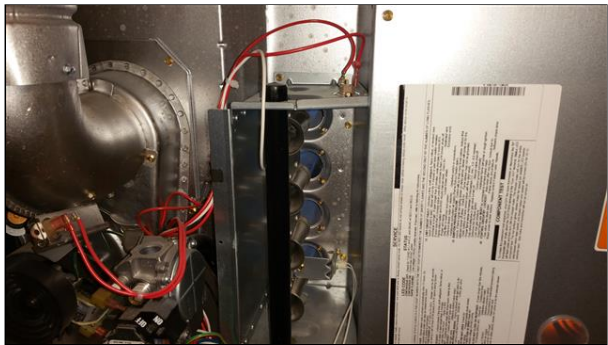
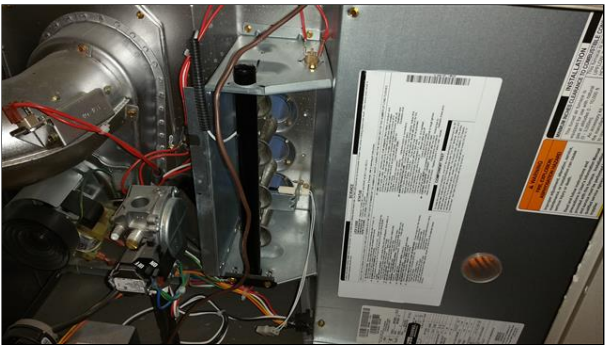
Type of Systems: Forced Air Furnace
Energy Sources: Natural Gas
Heat System Brand: CARRIER
Number of Heat Systems (excluding wood): Two

(3) The system(s) were operated using normal controls. The gas flame was a desirably blue color and no noticeable distortion of flames occurred when blower engaged.

Comments:
(1) We recommend that your heating equipment be serviced on an annual basis, before the start of the heating season. Annual service can help to keep the unit(s) running at peak efficiency, head off expensive repairs, and assure safety by checking for heat exchanger failures.
(2) Inspection of the integrity of the heat exchanger(s) is specifically excluded from this inspection. This part of the unit is not visible without major dismantling of the furnace, which is outside of the scope of the inspection.

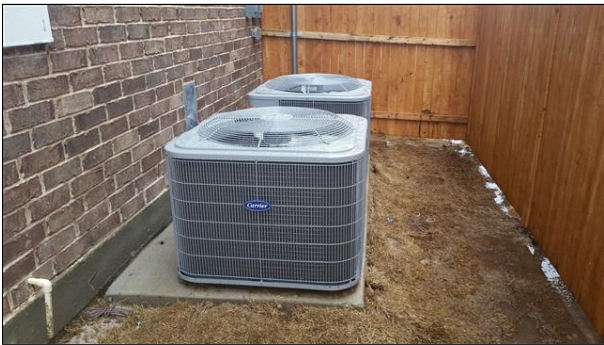
B. Item 1(Picture)

Type of Systems: Central Air Conditioning
Central Air Manufacturer: CARRIER

(1) We recommend that your cooling equipment be serviced on an annual basis, before the start of the summer season. Annual service can help to keep the unit(s) running at peak efficiency, head off expensive repairs and is recommended by manufacturers. You should speak to a licensed HVAC contractor about different service / tune up options.

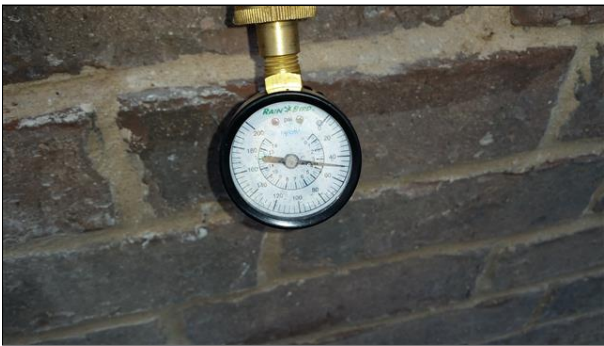
A. Item 1(Picture)

Location of water meter: Front of home near street
Location of main water supply valve: Observed in front flowerbed
Static water pressure reading: 60 psi
Comments:

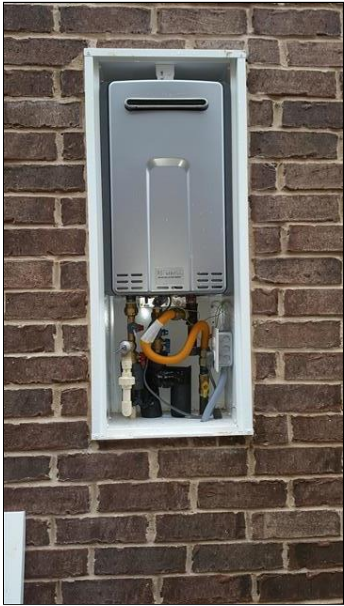
C. Item 1(Picture)

Energy Sources: Natural Gas
Capacity: Tankless
Water Heater Location:: Exterior
Comments:

(1) T&P valve was operated and appeared to function properly. If leakage is observed outside, at any time, it is an indication of a defective valve mechanism which needs replacement. This T&P valve is an important safety feature of water heater tanks and must be properly maintained. Most manufacturers

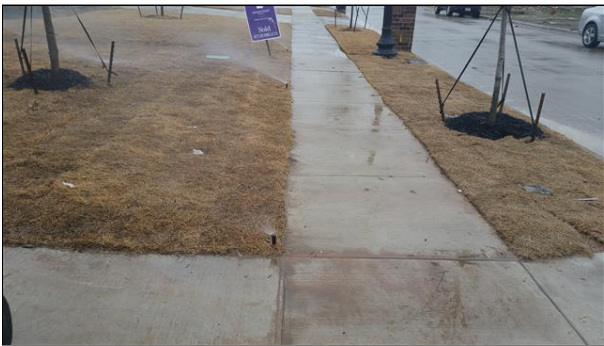
A. Item 1(Picture)

- (1) Rain / Freeze sensor observed to be present. Operation of the sensor was not tested.
- (2) This irrigation system is equipped with buried soaker type hoses controlled by the automatic control. It is difficult and sometimes impossible to determine if or how well these zones are working because the soaker hoses are buried and not visible. Inspections of these zones is limited and you should check them regularly for signs of leaks. Soaker zones are generally installed with inline filters present at the valve boxes. Different manufacturers have different maintenance requirements for these filters. You are advised to discuss these requirement and the locations of the filters with your builder or a licensed irrigation specialist.
