PRE-DRYWALL

1234 Main St. Colleyville Texas 76034

Buyer Name
07/20/2020 9:00AM

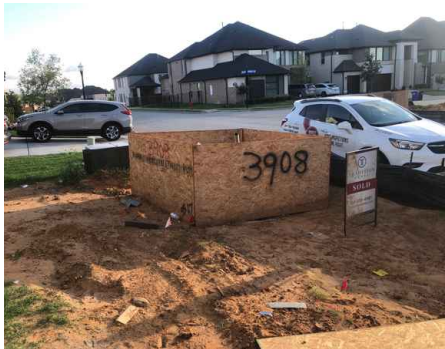
Trash Dumpster on Site: Job Site Dumpster

A Dumpster was present at the time of inspection.

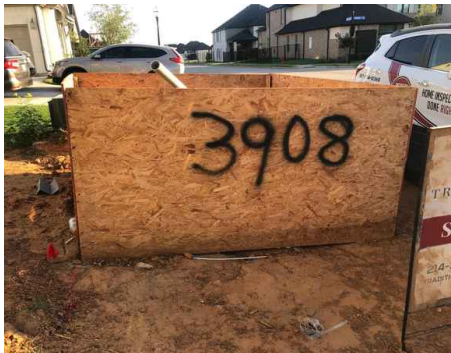
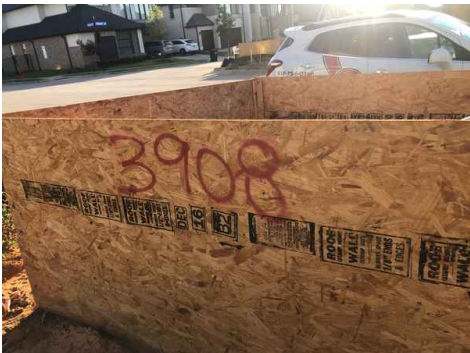
Address Posted: Job Site Address Posted

The Address and Lot # was visible at the time of inspection.

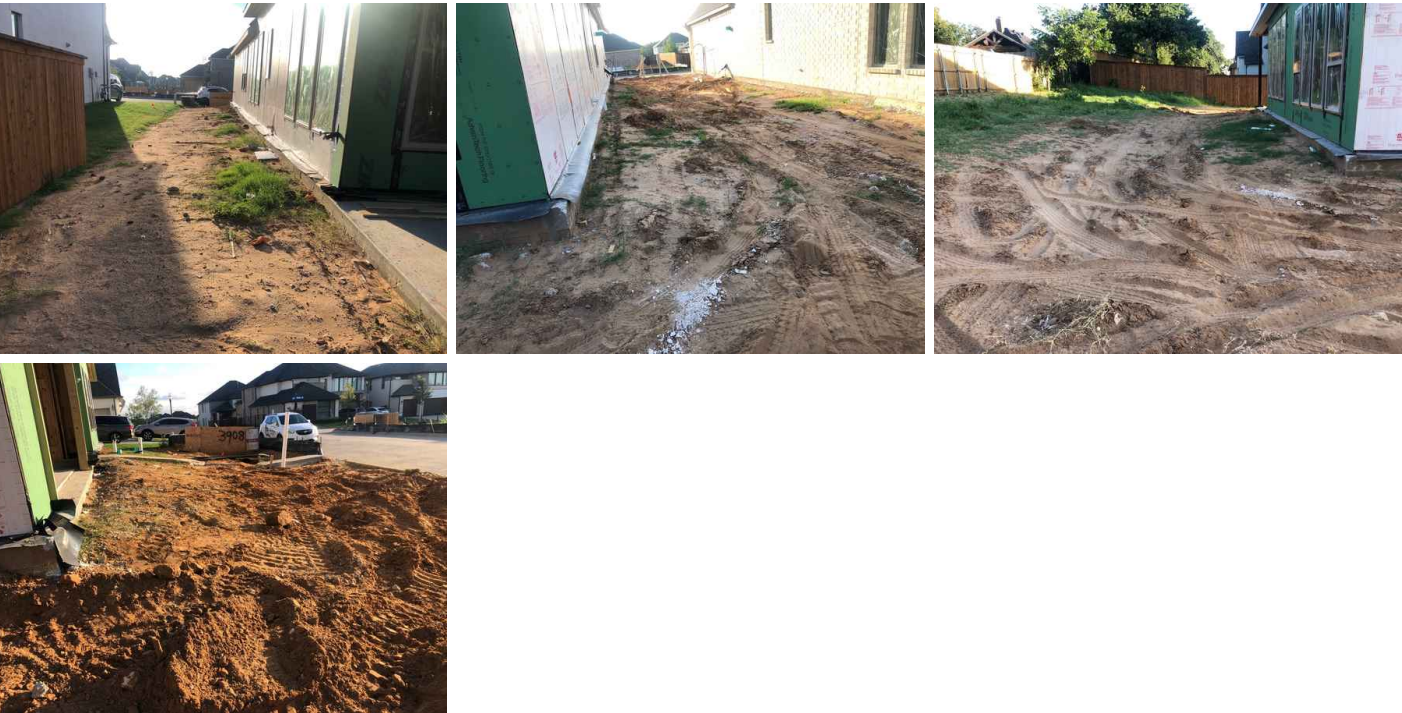
Slab: Elevations Good

The Elevations were ok at the time of inspection.

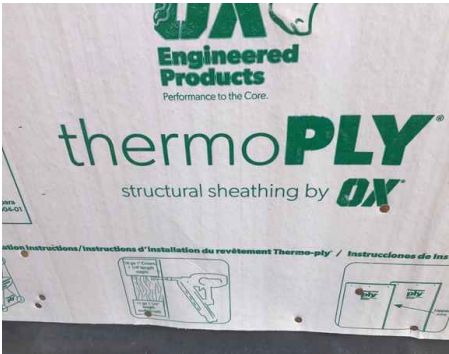
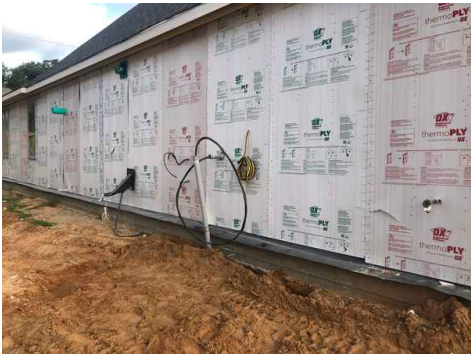
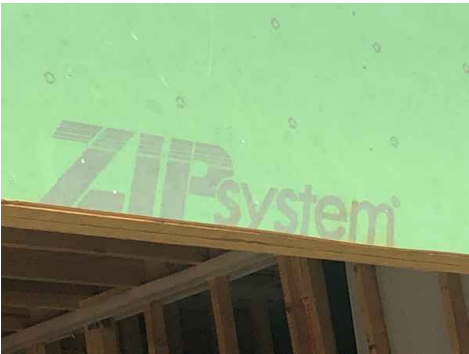
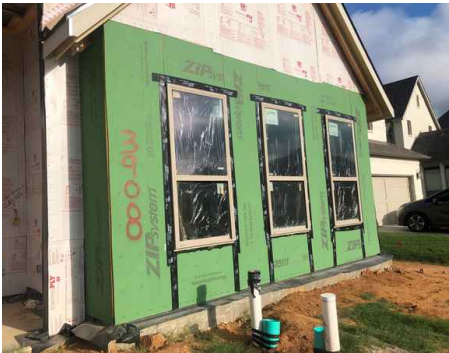
Wall Sheathing: Visual Inspection

Thermoply, Zip System

Only the visible areas were inspected at the time of inspection. No deficiencies noted to visible areas unless otherwise noted below.

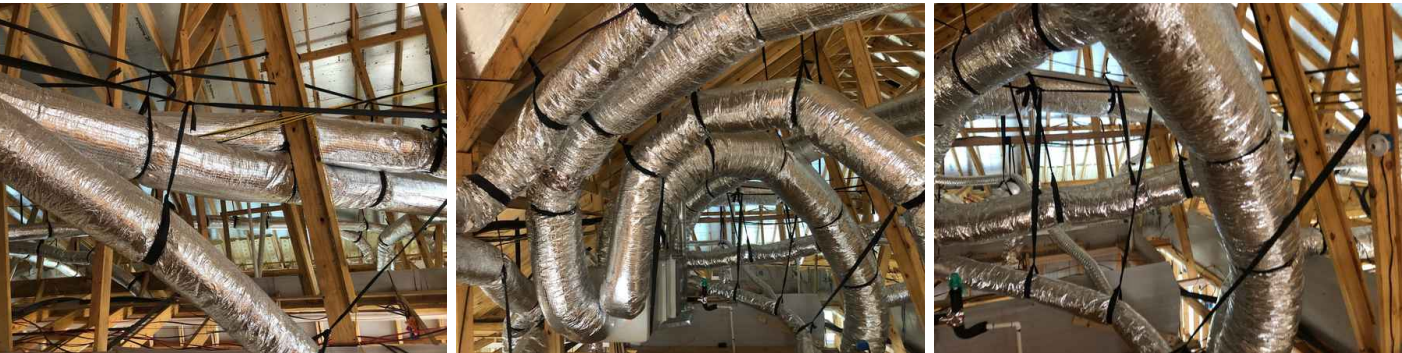
Ducting Properly Installed and Sealed: Visual Inspection

Only the visible areas were inspected at the time of inspection. No deficiencies noted to visible areas unless otherwise noted below.

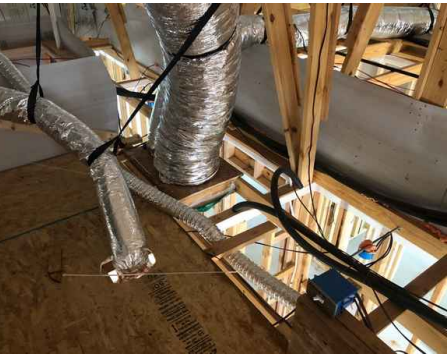
Return Air Duct Not Obstructed and Sealed: Visual Inspection

Only the visible areas were inspected at the time of inspection. No deficiencies noted to visible areas unless otherwise noted below.

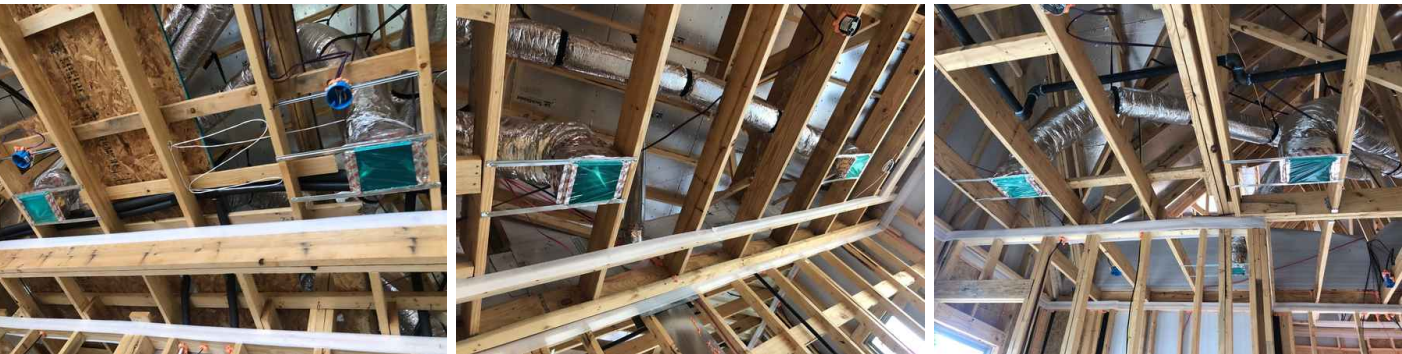
Presence of installed Heat/Cooling source in each room: Visual Inspection

Only the visible areas were inspected at the time of inspection. No deficiencies noted to visible areas unless otherwise noted below.

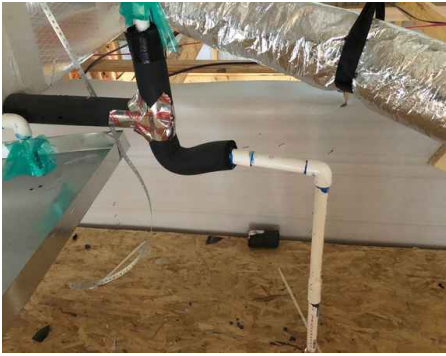
Condensate Drain Present: Visual Inspection

Only the visible areas were inspected at the time of inspection. No deficiencies noted to visible areas unless otherwise noted below.

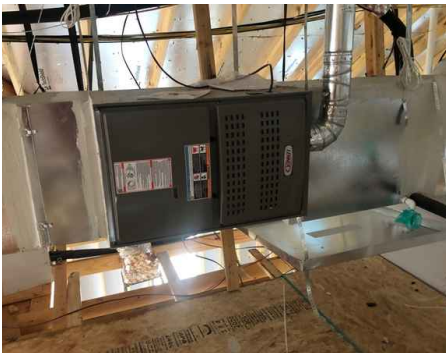
**Equipment Access Decking Installed(Attic Installation): Visual Inspection**

Only the visible areas were inspected at the time of inspection. No deficiencies noted to visible areas unless otherwise noted below.

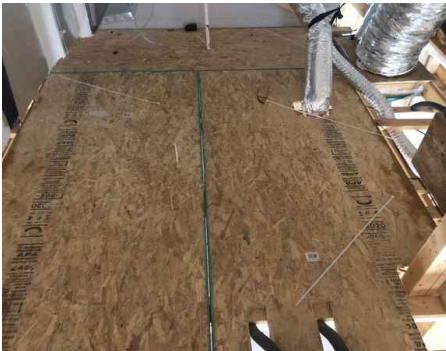
**Sufficient Workspace for Equipment(30 Inches): Visual Inspection**

Only the visible areas were inspected at the time of inspection. No deficiencies noted to visible areas unless otherwise noted below.

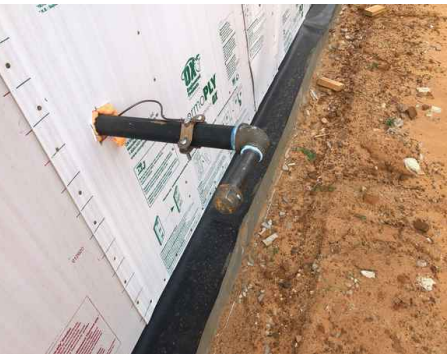
Gas Lines Installed & Stub Outs Secure: Visual Inspection

Only the visible areas were inspected at the time of inspection. No deficiencies noted to visible areas unless otherwise noted below.

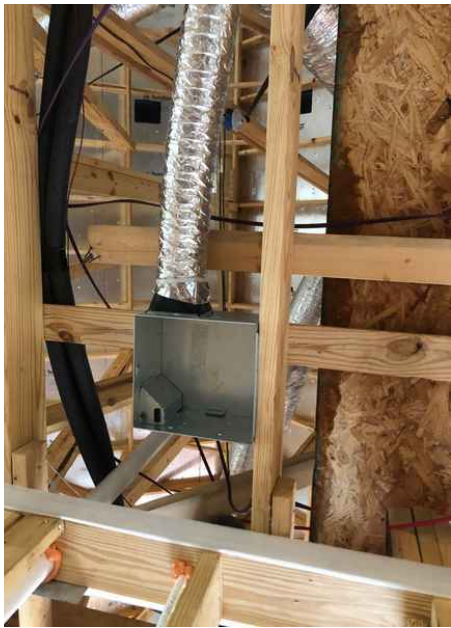
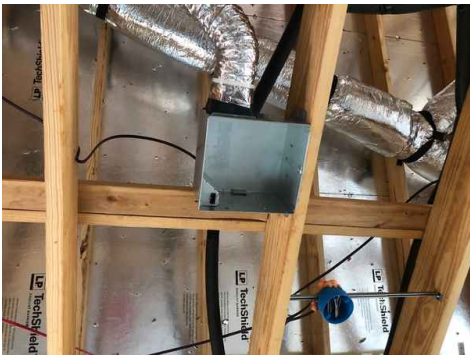
Bathroom Vents Installed and Properly Sealed & Terminated: Visual Inspection

Only the visible areas were inspected at the time of inspection. No deficiencies noted to visible areas unless otherwise noted below.

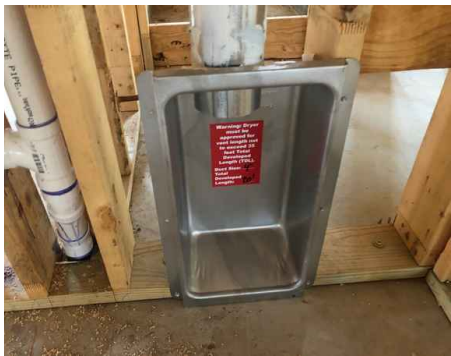
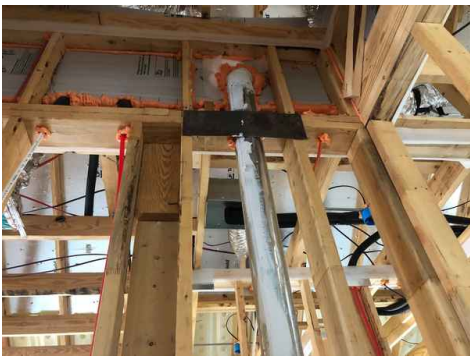
Dryer Vent Installed and Properly Sealed & Terminated: Visual Inspection

Only the visible areas were inspected at the time of inspection. No deficiencies noted to visible areas unless otherwise noted below.
