SDC HOME INSPECTIONS

INSPECTION REPORT

1234 Main St.
Bend OR 97702

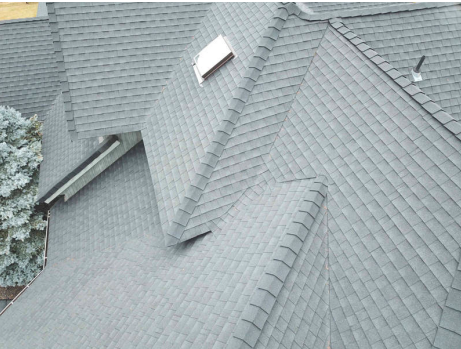
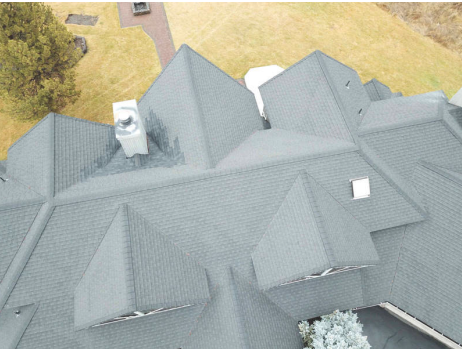
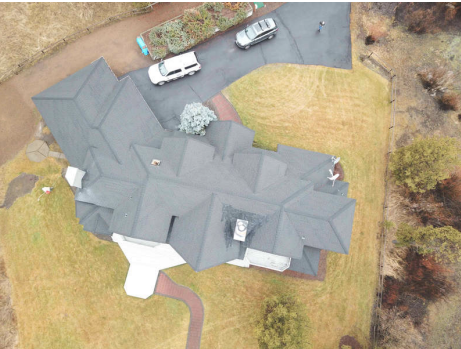
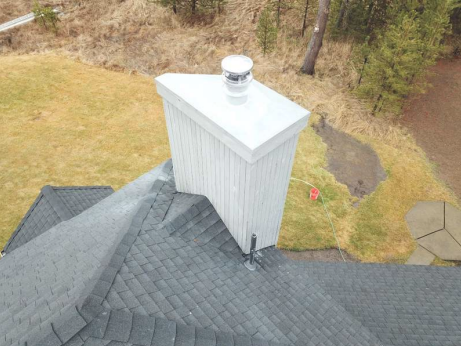
Inspected By Drone

The roof and its components were inspected with the aid of our drone. This was used because for whatever reason we deemed accessing the roof to be too dangerous.

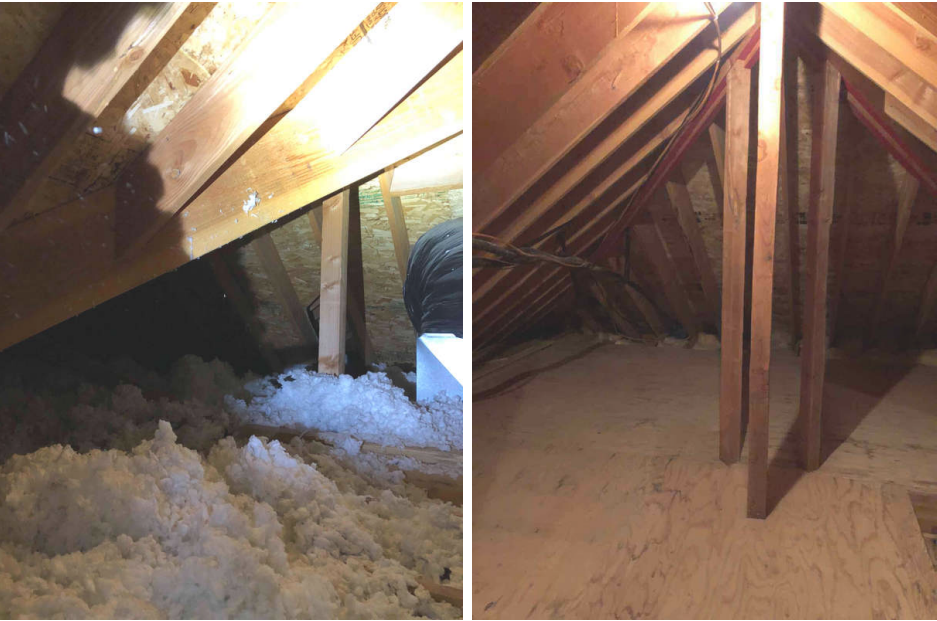
Access Location: Viewed From Within The attic was viewed from within the viewable and accessible areas.	Framing: Acceptable	Insulation: Type Blown fiberglass
Ventilation: Type Ridge Vent, Soffit Vents		
Vaulted Ceilings Some areas of the interior ceiling or vaulted and cannot be viewed because there is no access point which is common		
Access Location: Bedroom Multiple locations

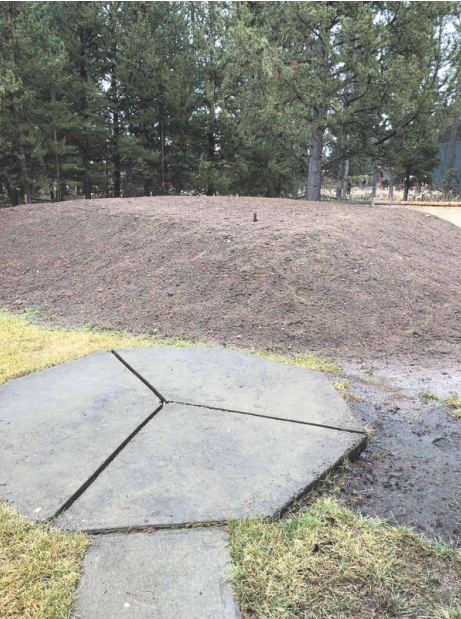
Waste System: Sand Filter

A sand filter is present for the waste system which goes beyond the scope of our inspection.

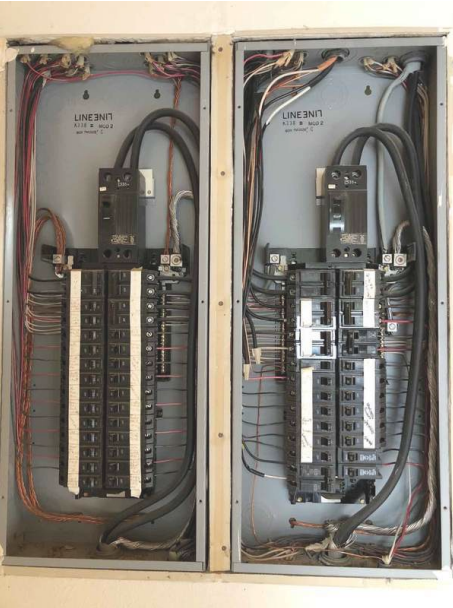
Breakers / Fuses: Main Disconnect Location

Main Panel, Garage

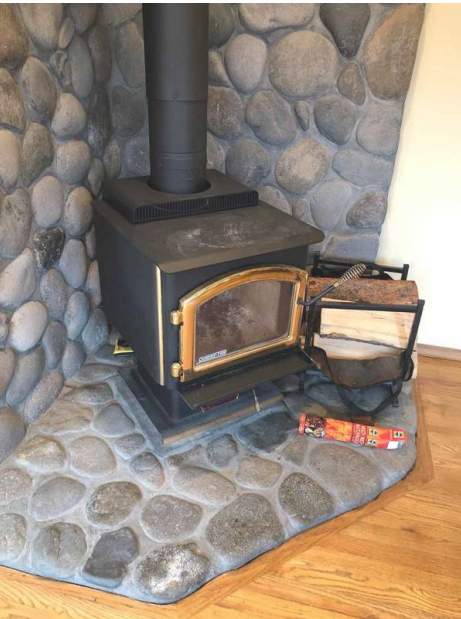
Wood Stove: DEQ EPA Approved

Acceptable and has a viewable DEQ or EPA label indicating it meets current clean air burning requirements.

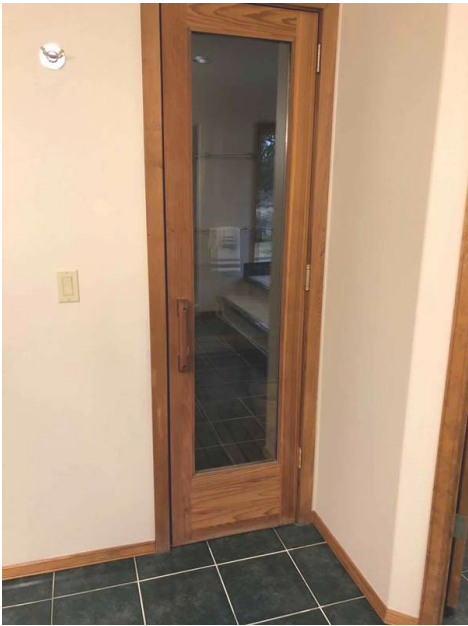
Dry Sauna
NOT INSPECTED
MASTER BATHROOM
Dry sauna's fall outside the scope of our inspection. Recommend the seller guarantees the sauna is functional or have it demonstrated.

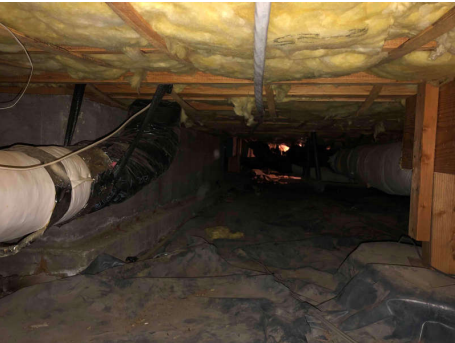
Method of Inspection Entered the crawlspace	Access Location: Location Master Closet	Interior Foundation Walls: Observation Acceptable where viewable.
