By Civil Aviation Administration of Yashiro Commission
And Fountaine Transportation Safety Board

Final Report of IZ-3524 Airbus A300B4 Inazuma Airlines Flight 8361 On May 7th, 2022

Published in June 2025

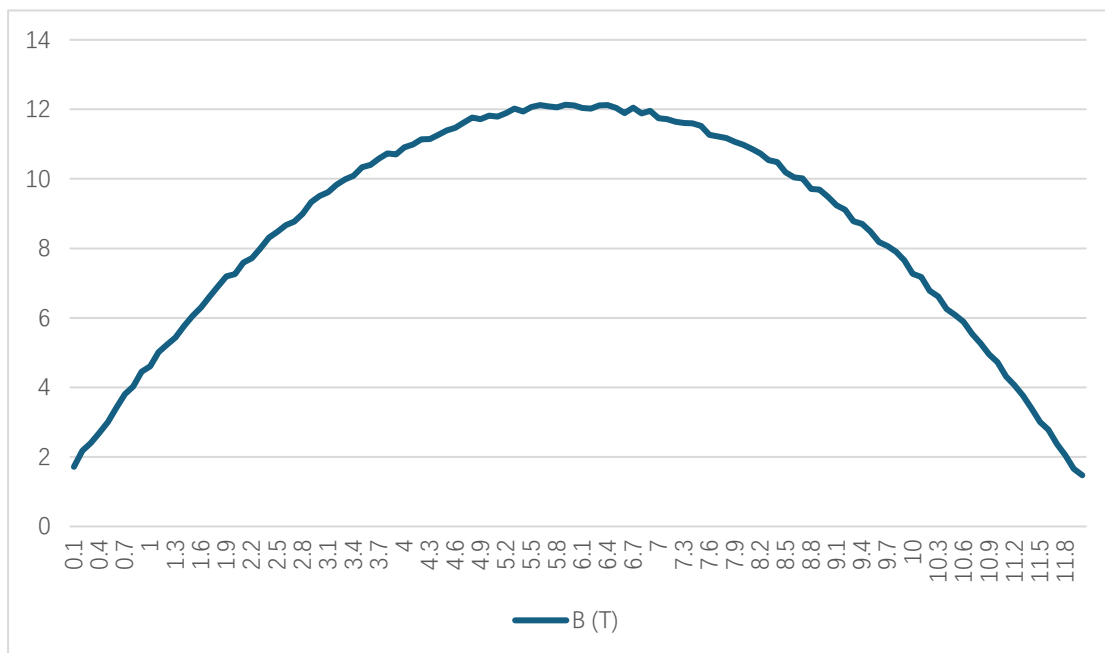
Diagram – Curve 1: 10 kV/m Electro and 10 mol Cyro

Investigators collected data of magnetic field that can be created by Electro-and-Cyro elemental superconducting system (inviting Ms. Lisa Minz and Mr. Kaeya Alberich). The result is given below (Cyro is input in 30 s and x-axis is time (s)).

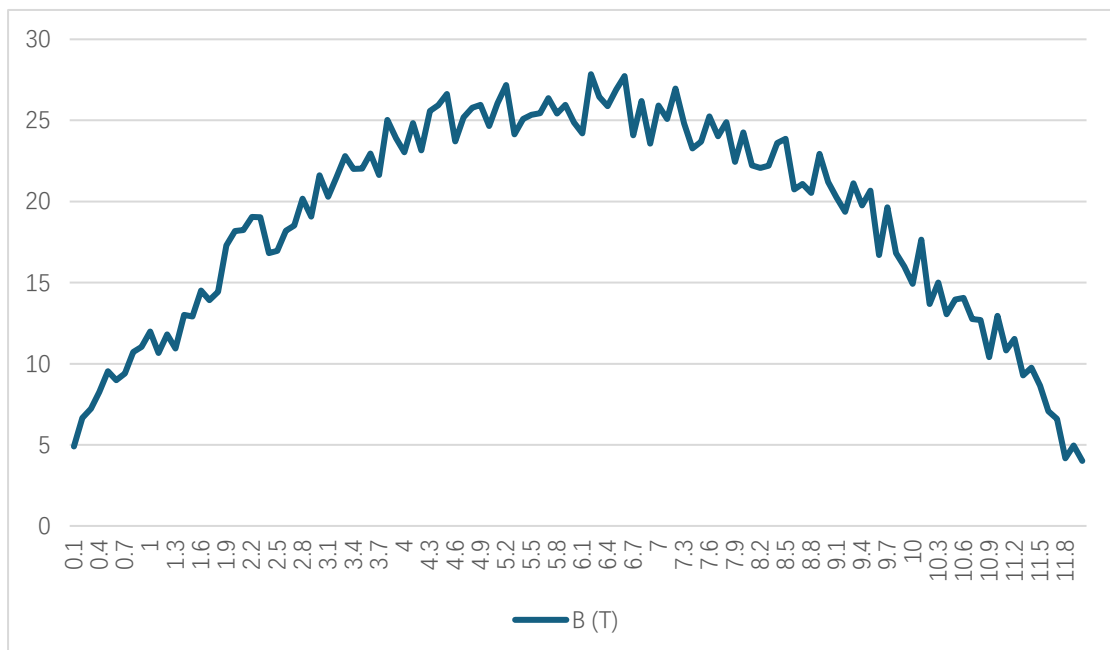
Diagram – Curve 4: 20 kV/m Electro and 20 mol Cyro

Investigators, after interviewing Ritteroder des Favonius members, determined that the actual environment the aircraft was in had much more powerful and unstable Cyro and Electro environment than the curve 4 displays, and according to the weather stations in Inazuma, the magnetic induction intensity should be multiplied by approximately 10.
