Presented by  
**Civil Aviation Administration of Mitakihara, and  
Regule Aire Transportation Safety Committee**

# Primary Report of Homura Akemi Properties' Aircraft MA-HMR (BAE 146)'s Accident over Mitakihara on December 15<sup>th</sup>, 2022

Released in November 2024

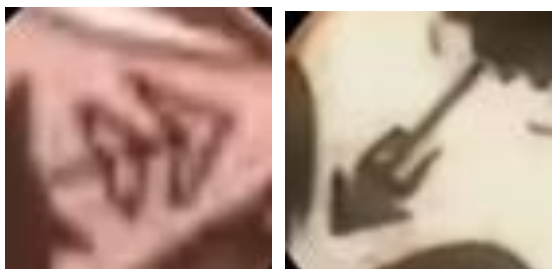
**Figure 4. Different tattoo between the actual pilot's head (left) and the registered (right)**

On November 8<sup>th</sup>, 2024, investigators received updated autopsy result from Mitakihara Police, reporting that the DNA sample collected from crash site and stored in RATSC's warehouse doesn't match DNA information of the pilot recorded in local database. Then, Mitakihara Police and autopsy technical team provided investigators more facts about differences between the actual pilot and the registered information about the inferred pilot:

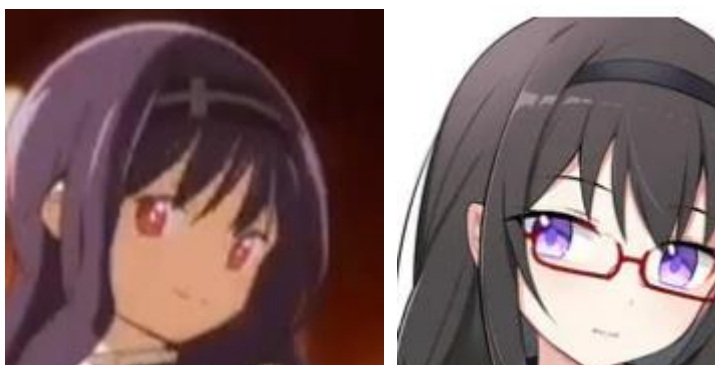
**Figure 5. Differences between the actual pilot's head (left) and the registered (right),**

Investigators, after improving resolution of airport camera record by using FFT and other video analyses techniques, also found differences:

In the figure above, differences including the color of hair and eyes (red for left and purple for right). However, since airport camera system also captured appearance of the pilot that was similar to the registration at the same time and same place, investigators are unsure if the difference was caused by an algorithm error.

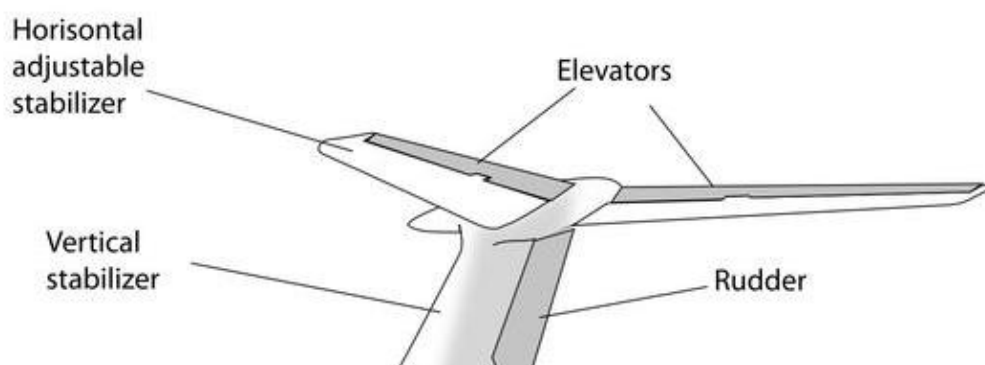
**Figure 11. Standard T-Shape Tail**

BAE 146 has T-shape tail design (stabilizer placed at the top of the tail, not the bottom). As a result, when it stalls, air passing through the tail immediately becomes turbulences (see following figures), which invalidates most of control input to the tail wing. It is for this reason that if the aircraft stalls, it's more likely to enter "deep stall"; when it enters "deep stall", or a state where the aircraft enters horizontal spin or long-lasting vertical spin (with airspeed sufficiently low), it becomes difficult for crew members to roll out, for which most pilots failed roll-out attempts in the *1.16.3 Flight Simulation* when an early roll-out fails because of the inefficiency of input caused by reduction of strength.
