# Corrosion growth of solar cells in modules after 15 years of operation

This paper is to study the deterioration of PV modules after 15 years of operation in Thailand. All 16 modules of a string were annually measured in the standard testing laboratory, then taken back to the same position of string since the 7th year after operation. The results and data analysis can be divided into 3 parts consisting of electrical performance evaluation, physical deterioration observation, and corrosion growth on cell ribbons. From the electrical results of performance at STC, it was found that power of modules were less than 80% of the nameplate value in the 15th year for 75% of total modules. The average degradation rates, based on nameplate, was 1.47%/year. The degradation rates of modules since the 10th year after operation were in the range of 2.5 to 3.0%. From the visual failures on the front and rear side of modules were appeared in all modules. During the 12th – 15th year, the corrosion area growth on cell ribbons, calculated by ImageJ program, was around 10–17%/3 years of ribbons area, especially for cells beside junction box. The colors of corrosion products were also observed in both

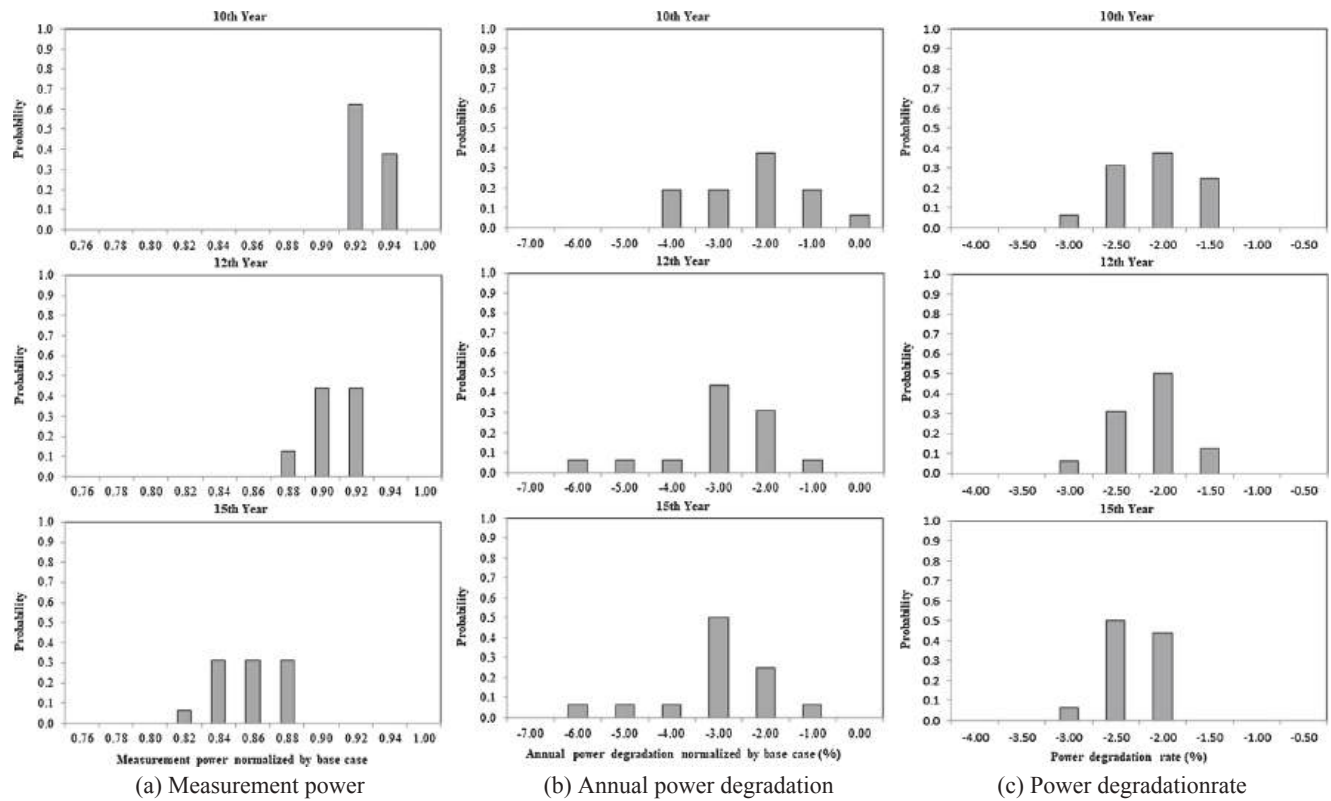
Fig. 5. Distribution of  $P_m$  on the 10th, 12th and 15th year normalized by  $P_m$  on the base case (the 7th year).

The annual degradation rates of electrical parameters can be calculated by Eq. (1). The evaluation is normally based on their nameplate values. In this paper, we calculated in comparison with both their nameplate values and their measured results in each year. In the period of measurement, 8 years, the 7th year to the 15th year), Pm of all modules decreased more than 10% from the base case. The annual power degradation results, based on the 7th year, were more than 2% per each year for over than 50% of total modules since the 10th year. In the 15th year, the annual power degradation results were more than 3% per year for 70% of total modules. The degradation rates of modules since the 10th year after operation were in the range of 2.5–3.0%. The distribution of population of modules can be found in Fig. 5(b) and (c).

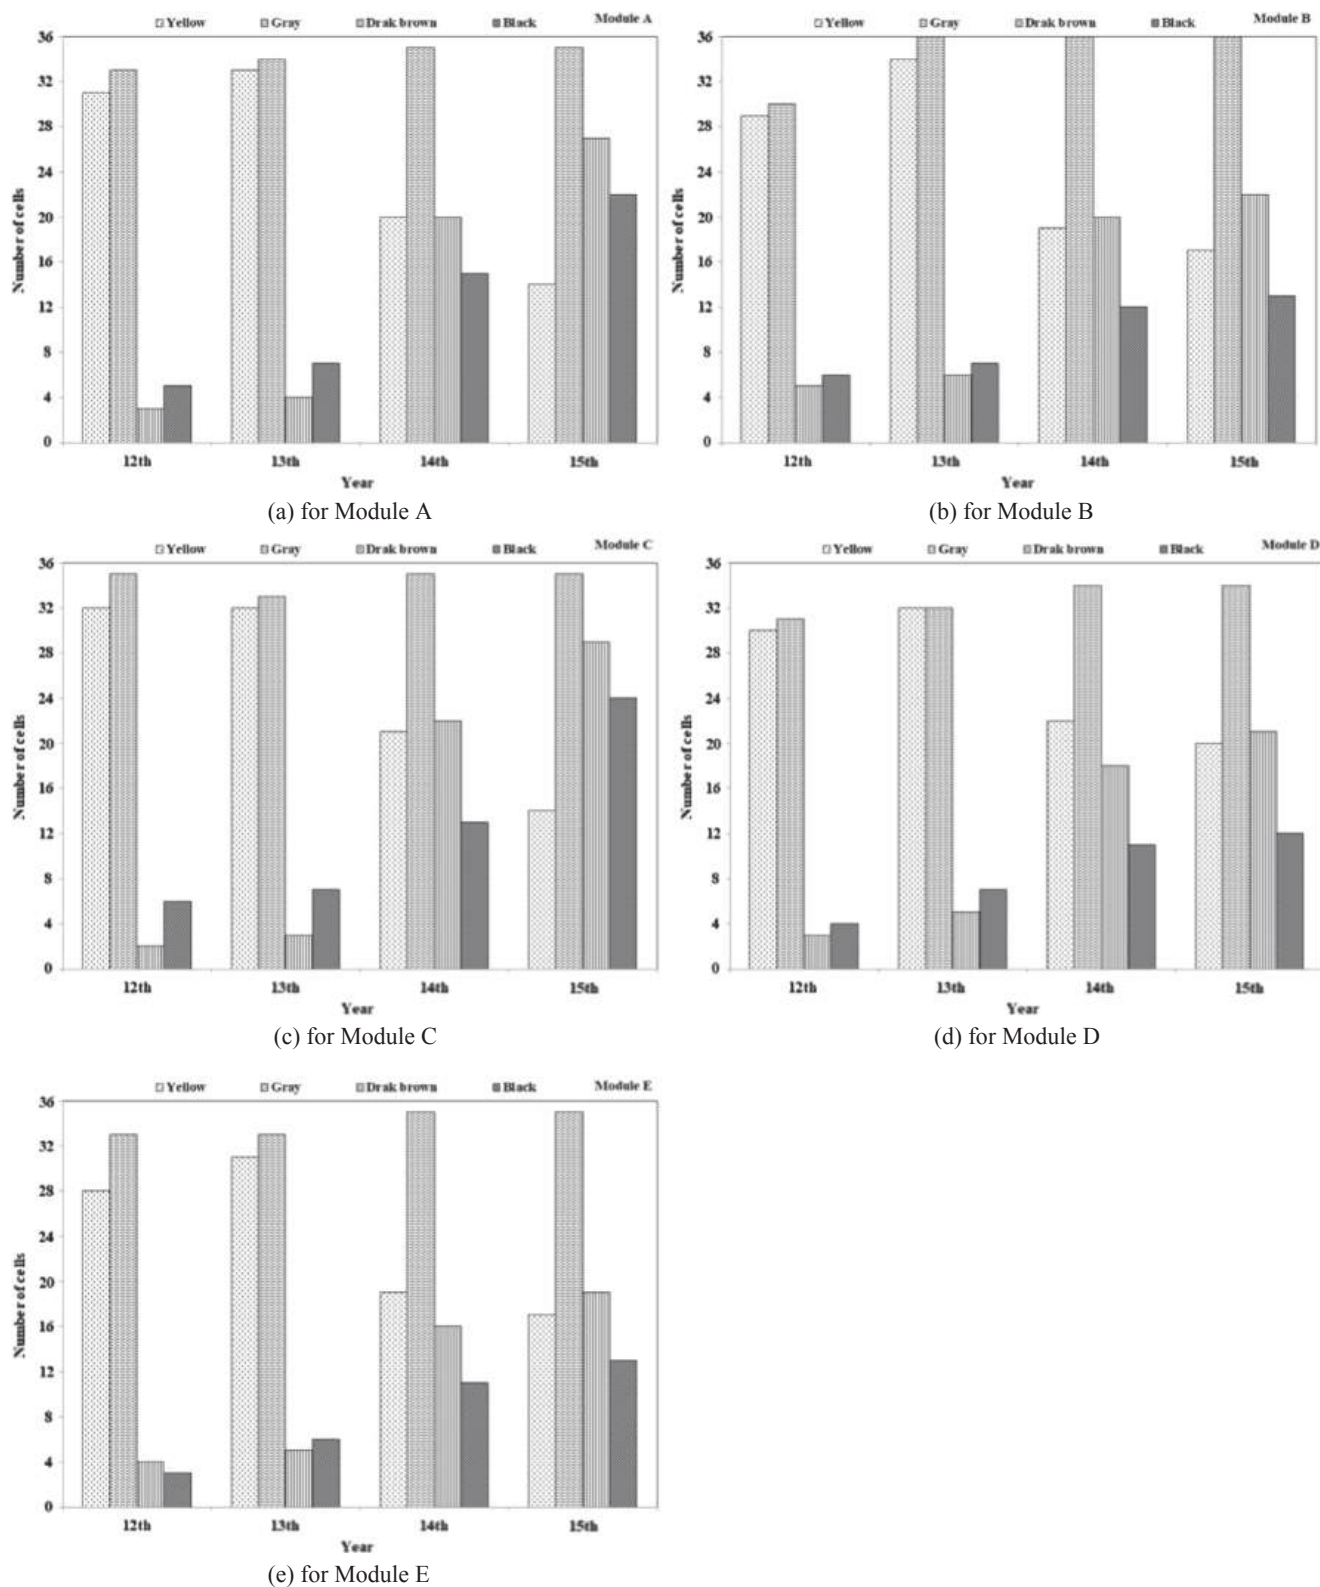
Fig. 13. Number of cells appearing each corrosion color on ribbon of each selected module.

Fig. 13 shows the number of cells counting each corrosion color in each selected module during the 12th–15th year after the PV system operation. Total number of cells in each module is 36 cells in series. Colors of corrosion found in this study consist of yellow, gray, dark brown and black. The number of cells with corrosion in black increased in the later years.

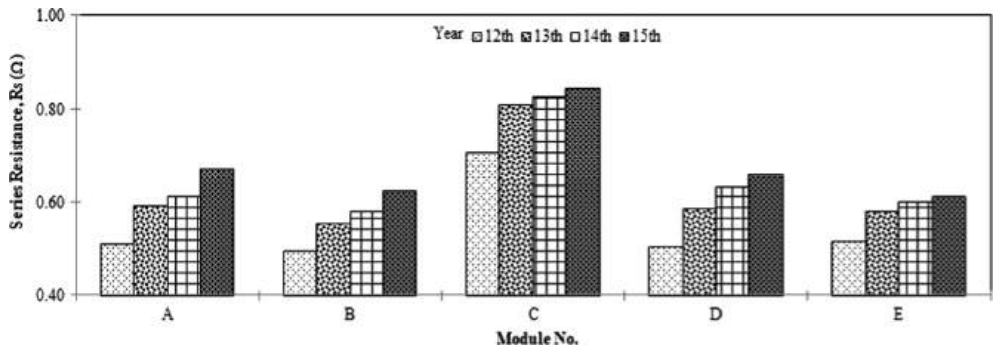
Fig. 16. Increasing series resistance of selected Modules during the 12th–15th year.

In Fig. 16, results of series resistance,  $R_s$ , of each selected module were plotted during the 12th–15th year. It cannot be summarized that the more the corrosion area, the higher the  $R_s$ . It means that the corrosion appearance on the cell ribbon may not be significant to the electrical resistance of the interconnection contacts.

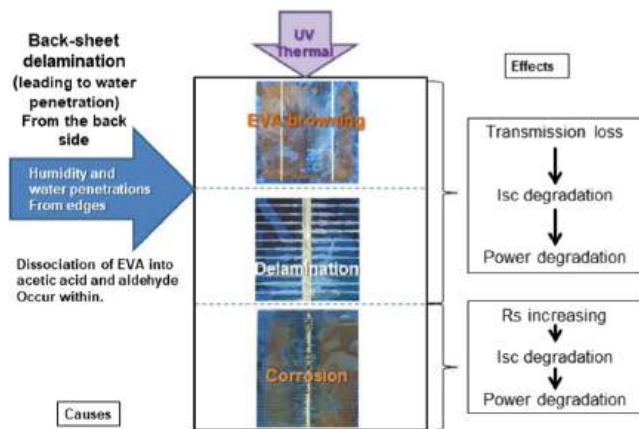
Fig. 17. Model of causes and effects of deterioration.

The analysis of PV module deterioration is based on the model of causes and effects as shown in Fig. 17. This investigation emphasizes on the metallic corrosion growth on cell. Fig. 17 describes the metallic corrosion on ribbons beginning with the delamination of Ethylene Vinyl Acetate (EVA) and moisture penetration ingress into a module. The encapsulant material, EVA, delamination can be occurred by UV and Thermal impacts under field exposure. The two main products of broken EVA chemical bond consist of acetic acid and aldehyde (Xiong et al., 2017). Then, acetic acid, which oxygen rich, becomes the electrolyte of the galvanic reaction of each dissimilar bimetal couple on solar cells in modules. There are four parts, in a general galvanic corrosion cell, consisting of anode, cathode, electrolyte and electrical connection between anode and cathode. At the time of this system installation, ribbons materials were generally used copper (Cu) coated with Tin-lead alloy (SnPb), and the surface of cell busbars were silver (Ag), and soldering metal were made of lead (Pb). So, the corrosion products may possible consist of  $PbO$ ,  $Pb(OH)_2$ ,  $SnO$  or  $Sn(OH)_2$ . The standard electrode potential at 25 °C of Ag, Cu, Pb and Sn are + 0.800, +0.520, −0.125 and −0.137, respectively (see Fig. 18).

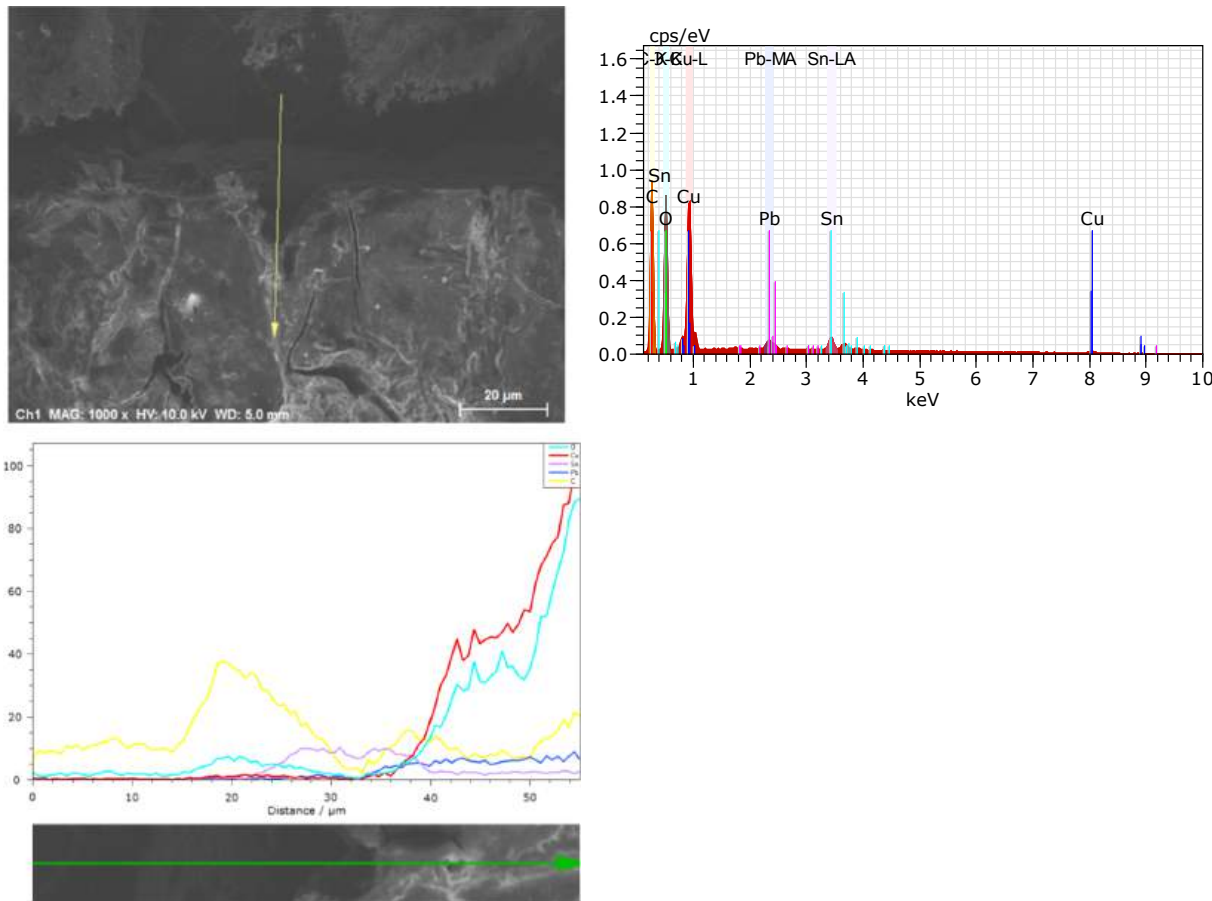
Fig. 21. SEM images and EDS line scanning of cross-section of ribbon.

The corrosion products and color of corrosion products can be justified by EDS and referred to ASTM D130 standard. From Figs. 20–24, the colors of corrosion products on ribbon surface consisted of yellow, dark-brown, light gray, and blue green (patina). Figs. 21 and 22 are to confirm Pb and Sn density decreasing and Cu remaining. Figs. 23 and 24 confirm the Sn and Pb corrosion product by SEM and EDS mapping.
