# Lightning Protection of a Golf Course Irrigation System

**Abstract**— The Moliets golf located is South West of France in a stormy area. This golf course uses electronic devices to monitor the water sprinklers and reduce water consumption. Buried decoders associated with the sprinklers receive orders from the central monitoring system. Since early 2012, 1262 decoders were installed but on 31st July 2016 445 decoders were destroyed by lightning surges. An expertise has been performed involving analysis on site and in laboratories regarding the surge withstand of the decoders and the failure mechanism. An analysis of the recommended surge mitigation measures proposed by the sprinkler's manufacturer for a few sprinklers (external SPDs and fuse as well as earthing system lower than 10 ohms) has also been performed. The provided SPDs were found too slow to satisfactorily protect the sensitive electronic devices. In addition, the SPDs were unable to provide satisfactory protection due to the distance between SPDs and many sprinklers (much more than 10 m) and also due to the voltage generated inside the loop. It was then decided to ask for the development of specific fast protections d

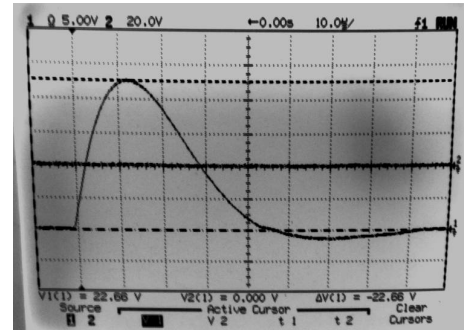
Fig. 9. Example of record of the impulse injected on the fast protection.

The behavior of the fast protections corresponds to that expected. Although the exact level of impulse withstand voltage of the different decoder ports is not known, the level of protection provided by the fast surge arresters is nevertheless sufficiently low and compatible with the need.

Furthermore, the tests with moderate current pulses (nominal discharge current) and even that with the highest current level, does not generate a variation of the insulation resistance between the different ports, and in particular across the terminals of the power line, suggesting that the decoders have not been damaged by the surge tests. At this stage, there is no degradation of the decoders consecutive to the current pulse injection lightning. The correct operation of the decoders after the application of current shocks can only be verified during on-site tests but at this stage no noticeable damage was found.

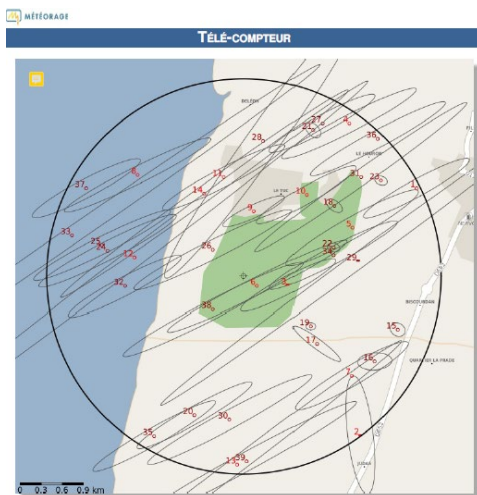
Lightning activity was measured by Météorage during the period from June 2018 to September 2018. For example, Fig. 10 shows the intra-clouds and lightning ground impacts: 39 were recorded on July 1st (3 impact to the ground and 36 intra-cloud strikes).

Fig. 10. Example of lightning activity on 01-07-2018.

Altogether there have been 23 lightning impact over a period of 3 months and a half in a circle of 2 km centered on the golf course (the intra cloud flashes have of course not been considered as well as the flashes to the sea). From this list 17 lightning impacts have been found as significant and the others were a bit too far to be considered. They occurred at a distance ranging from 11 m to 400 m from sprinklers systems. The lightning current ranges between 1.6 kA and 33.8 kA.
