2007 UPPER JOSEPH CREEK RESTORATION PROJECT
BPA Contract #33368
BPA Project #1992-026-01

Completion Report
February 2008

Abstract

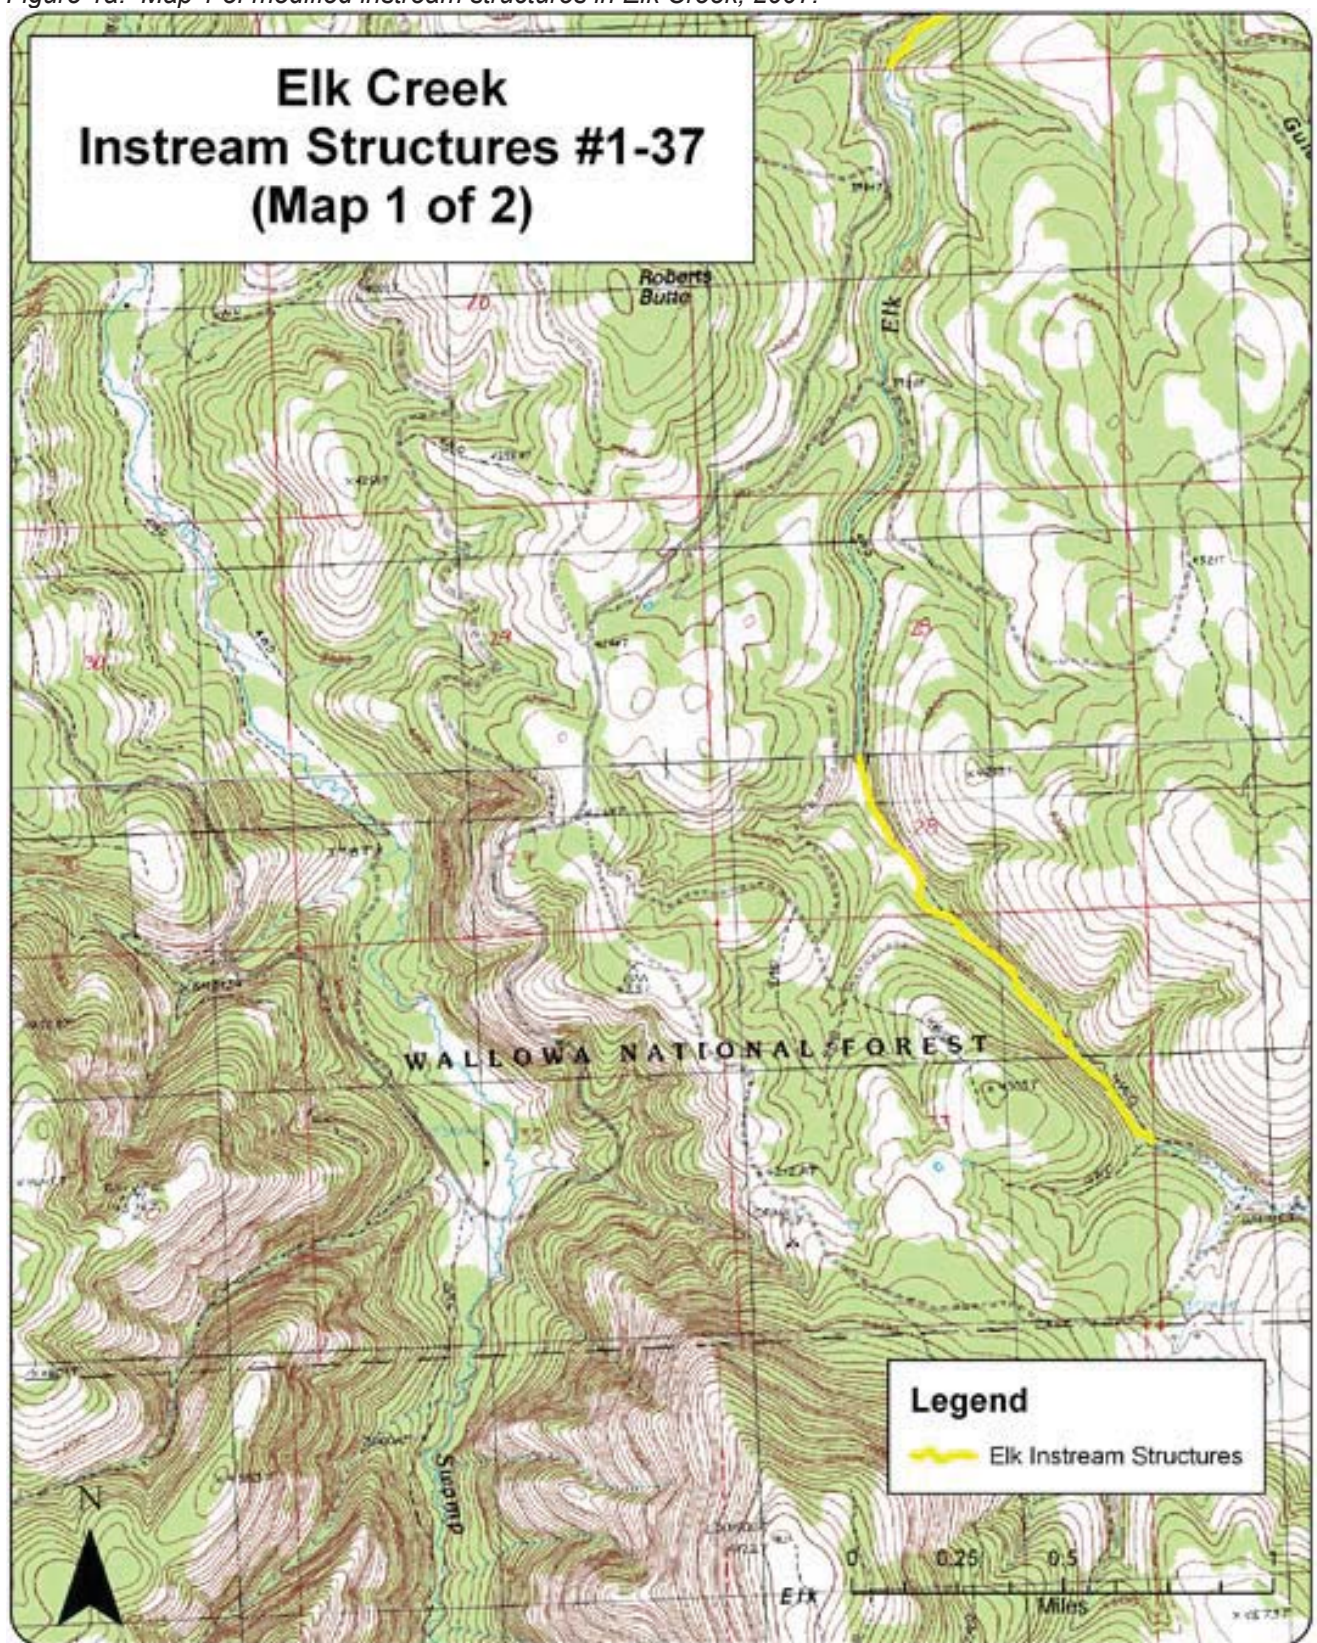
Figure 1a. Map 1 of modified instream structures in Elk Creek, 2007.

Instream Structure Modification One hundred forty-two instream structures were modified along 8.0 miles of Chesnimnus and Elk Creeks in August 2007. A small, thumb excavator was used to remove the geo-textile material and rusty wire from the streambed and reconfigure the structure logs from being buried in the banks to resting in the creek or angling into the stream from the bank. The channel was lightly graded 4-5 ft upstream to create a thalweg and provide a small transition riffle to prevent headcutting upstream of the former structure. Gabion baskets were opened and the rocks inside deposited in the overly-widened section of the creek just downstream of the former structure near one or both banks, depending on the channel morphology at each site. Empty baskets, wire mesh and geotextile material were removed from the site and disposed of by the contractor at the County landfill.

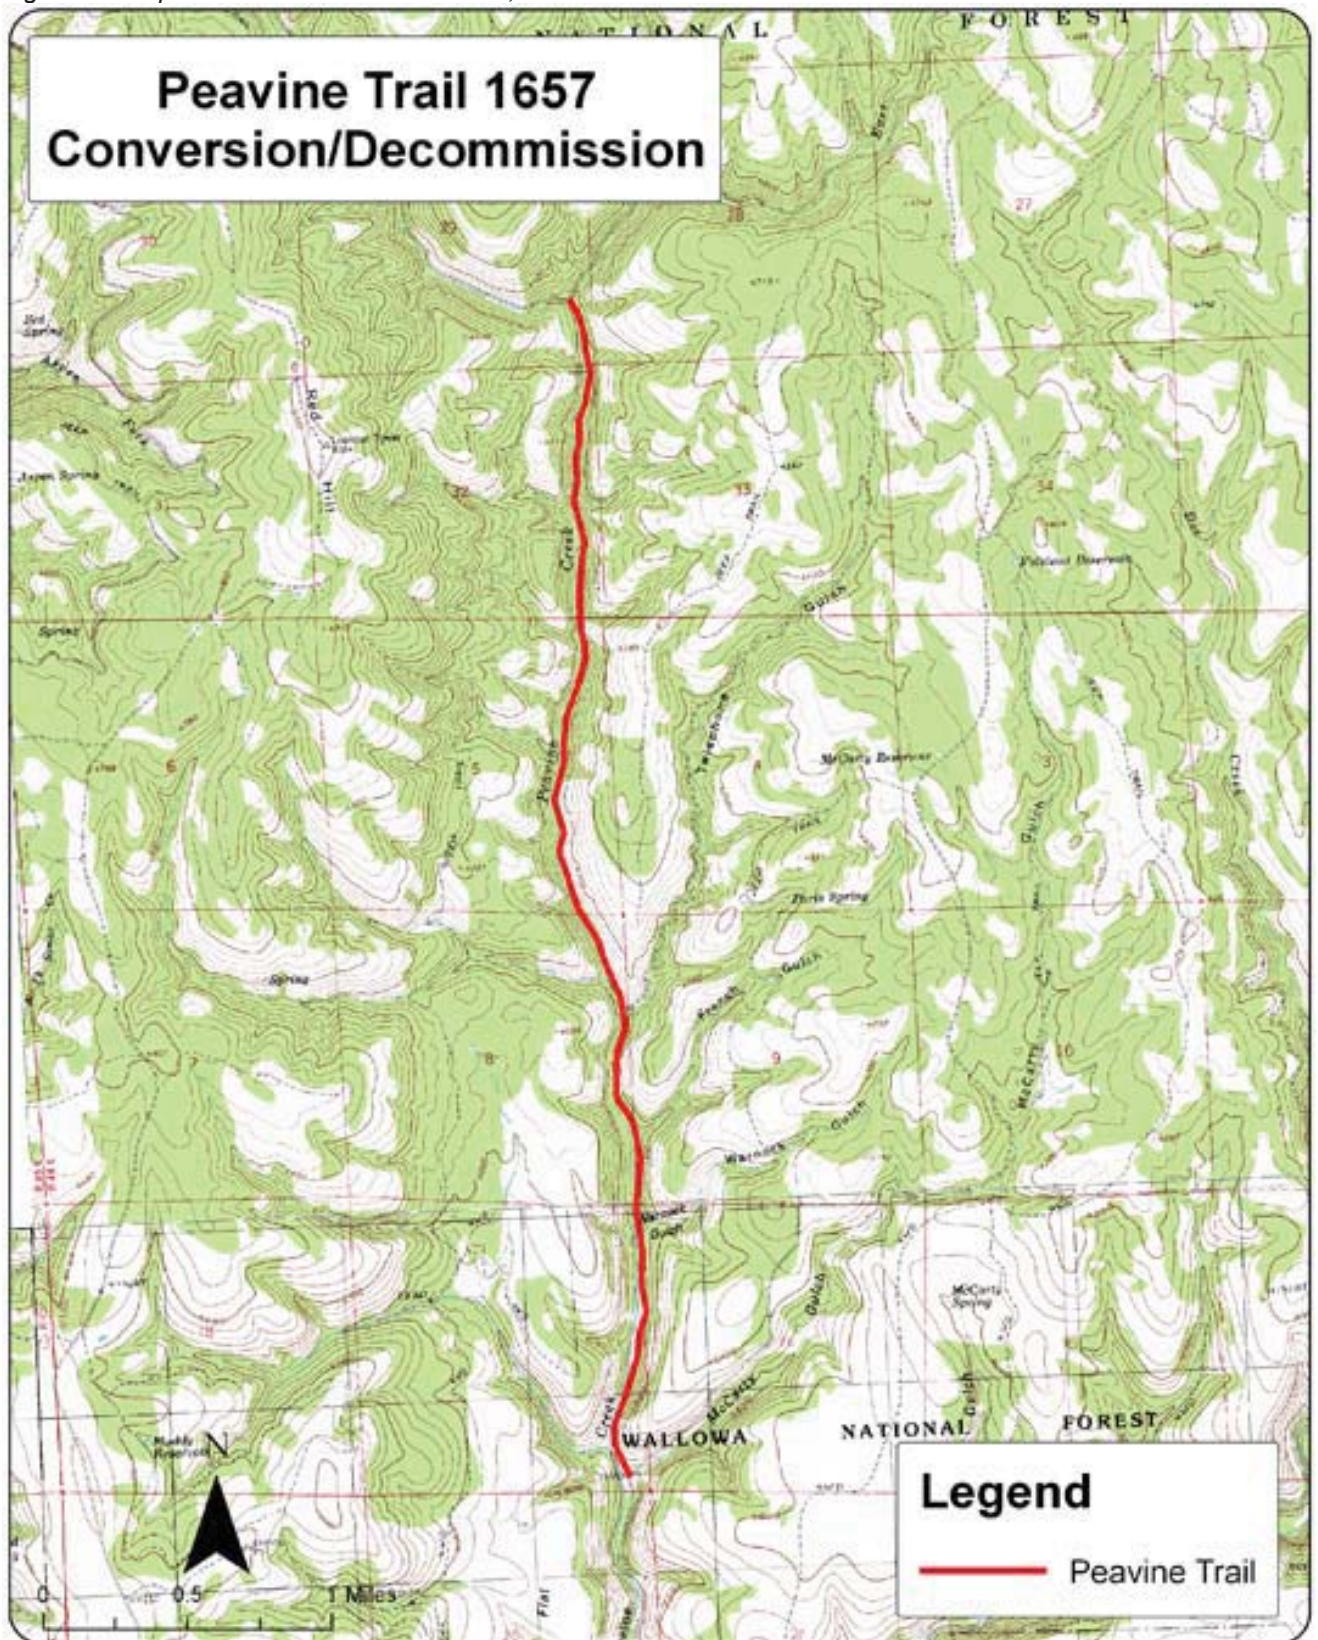
Figure 2. Map of Peavine Trail Conversion, 2007.

Peavine Trail This project took place along the entire length of the Peavine Trail, from the north-end trail bridge, 4.6 miles downstream to the 4670 road junction. Road fill along the entire 4.6 miles was pulled back from the creek, narrowing the trail to an average of 10 feet. Six culverts were replaced with rockbed fords. Nineteen cross-drains and smaller culverts were replaced with drain dips. The trail was outsloped at approximately 3%, eliminating the inside ditch. Exposed soil along the creek side of the trail was seeded with a native seed mixture and spread with chopped certified weed-free straw to reduce raindrop impact and erosion potential. All trees greater than 9" dbh on both sides of the trail were preserved, with the smaller, removed trees used as windrows along the base of the trail
