FY2006 Project Completion Report

Mahogany Creek Culvert Replacement Project

Contract #: 27255
BPA Project #: 1992-026-01

**Nez Perce Tribe Department of Fisheries Resource Management
- Watershed Division**

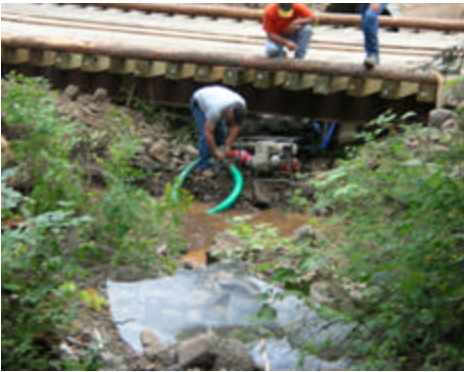
Specifically, the bypass road was created and removed, the fish salvage operation took place on August 29, 2006, the stream was dewatered, the old culvert was removed, the new channel was constructed and the new culvert was installed (see the series of photographs contained in Appendix B). The fish salvage operation was coordinated with all of the agencies listed in the Methods section of this document. There were sixty-two *Onchorhynchus mykiss* and twenty-four tailed frog tadpoles (*Ascaphus truei*) salvaged from the construction area. Of those, two of the tailed frog tadpoles and two of the *O. mykiss* were from above the old culvert. The rest were found downstream in an area approximately 100 feet long.

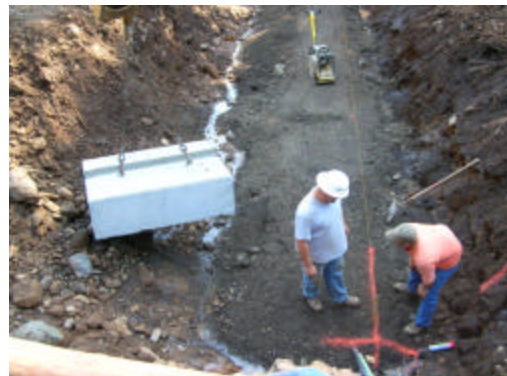
The channel was excavated to 0.5 feet below the bottom of the footings. Then at least 0.5 feet of fine gravel was placed and compacted as a surface for the culvert footings. This was done to provide a solid foundation for the culvert footings. The footings were then carefully positioned on the compacted fine gravel, which is shown in the photograph here. After they were all in place, they were re-aligned to ensure that the trough for the culvert was in exactly the right position.

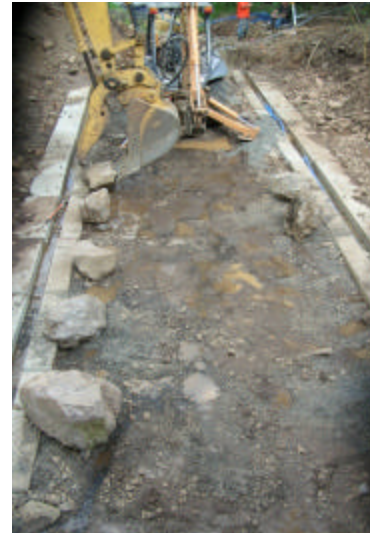
in the appropriate positions, which is shown in the picture on the left. The steps were approximately 6 feet long along the longitudinal stream axis. The critical

component of placing the rocks for the steps was to insure that they are not in a perfect line perpendicular to the flow, as well as maintaining the desired drop height at each step.

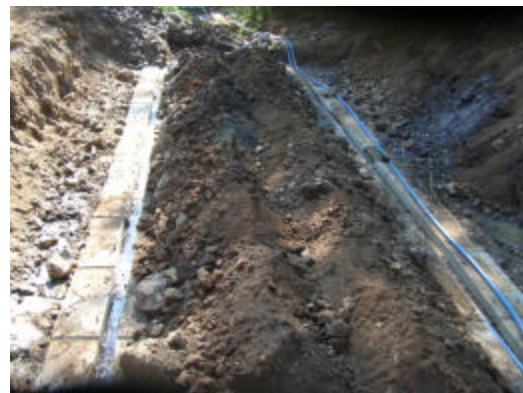
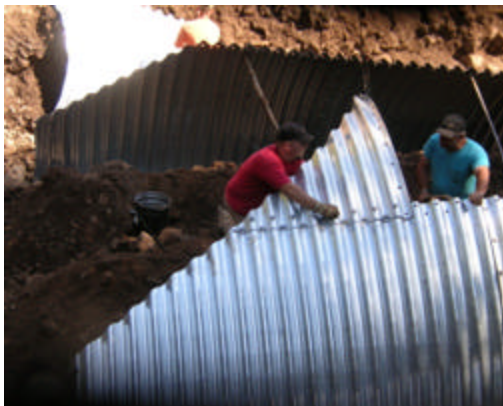
The top layer of natural channel simulation material was then mounded up in the section of stream between the culvert footings, which is shown in the adjacent picture to the right. The culvert was then bolted together and grouted in place (see also photograph below and series of photographs contained in Appendix B). The following day, the process of backfilling against the outside of the culvert was started. This was an iterative process of placing fill and compacting the material into place to create the

new road over the structure. At the same time this process was occurring, the mounded natural channel simulation material was placed against the inside wall of the culvert on either side. This step was done by hand to create the banks within the culvert and a bankfull floodplain within the structure. This was the phase of the project where the new stream channel cross section took shape. This layer was also washed and compacted into place to insure a good seal of the stream bed.

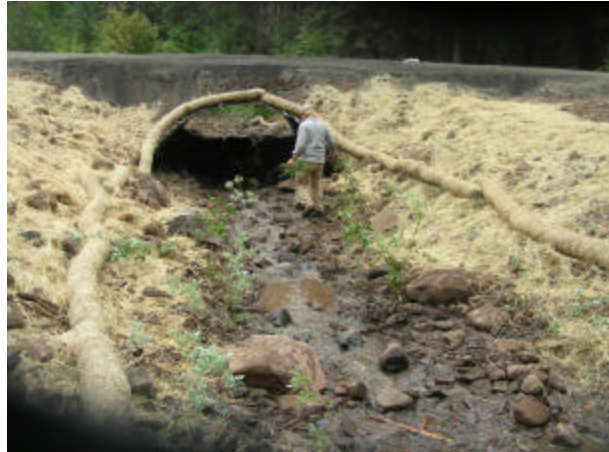
Immediately following the completion of the construction of this project, seventy-five willow plantings that were salvaged from on site were planted along the newly constructed section of the channel, which is shown in the picture on the right. These are the only shrub or tree plantings that will occur this fall. The hydro-mulching and grass seeding of all disturbed areas will occur after October 15, 2006. These portions are also the responsibility of the contractor. A native grass seed mixture that is suitable to this site will be obtained from the Forest Service.

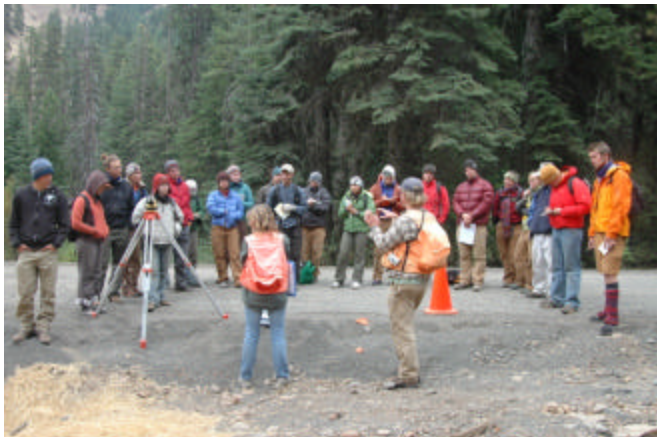
The project effectiveness monitoring was already started in the form of an “As Built” survey. This survey consisted of taking a longitudinal profile, cross sections, Wolman Pebble counts and numerous photographs. The survey was extended for 290 feet through the construction site and including a significant portion of undisturbed stream above and below the construction area. This will be used to monitor changes over time. The intent is to capture at least one relatively major high flow event (at least a five year event) within the monitoring period of this structure. This will ultimately yield the most useful information about the stability of the structure over time.
