Service experience with
2020-compliant fuels

SL2022-726/KNB
July 2022

Owners and operators of MAN B&W
two-stroke marine combustion engines.
Type: All MAN B&W engines.

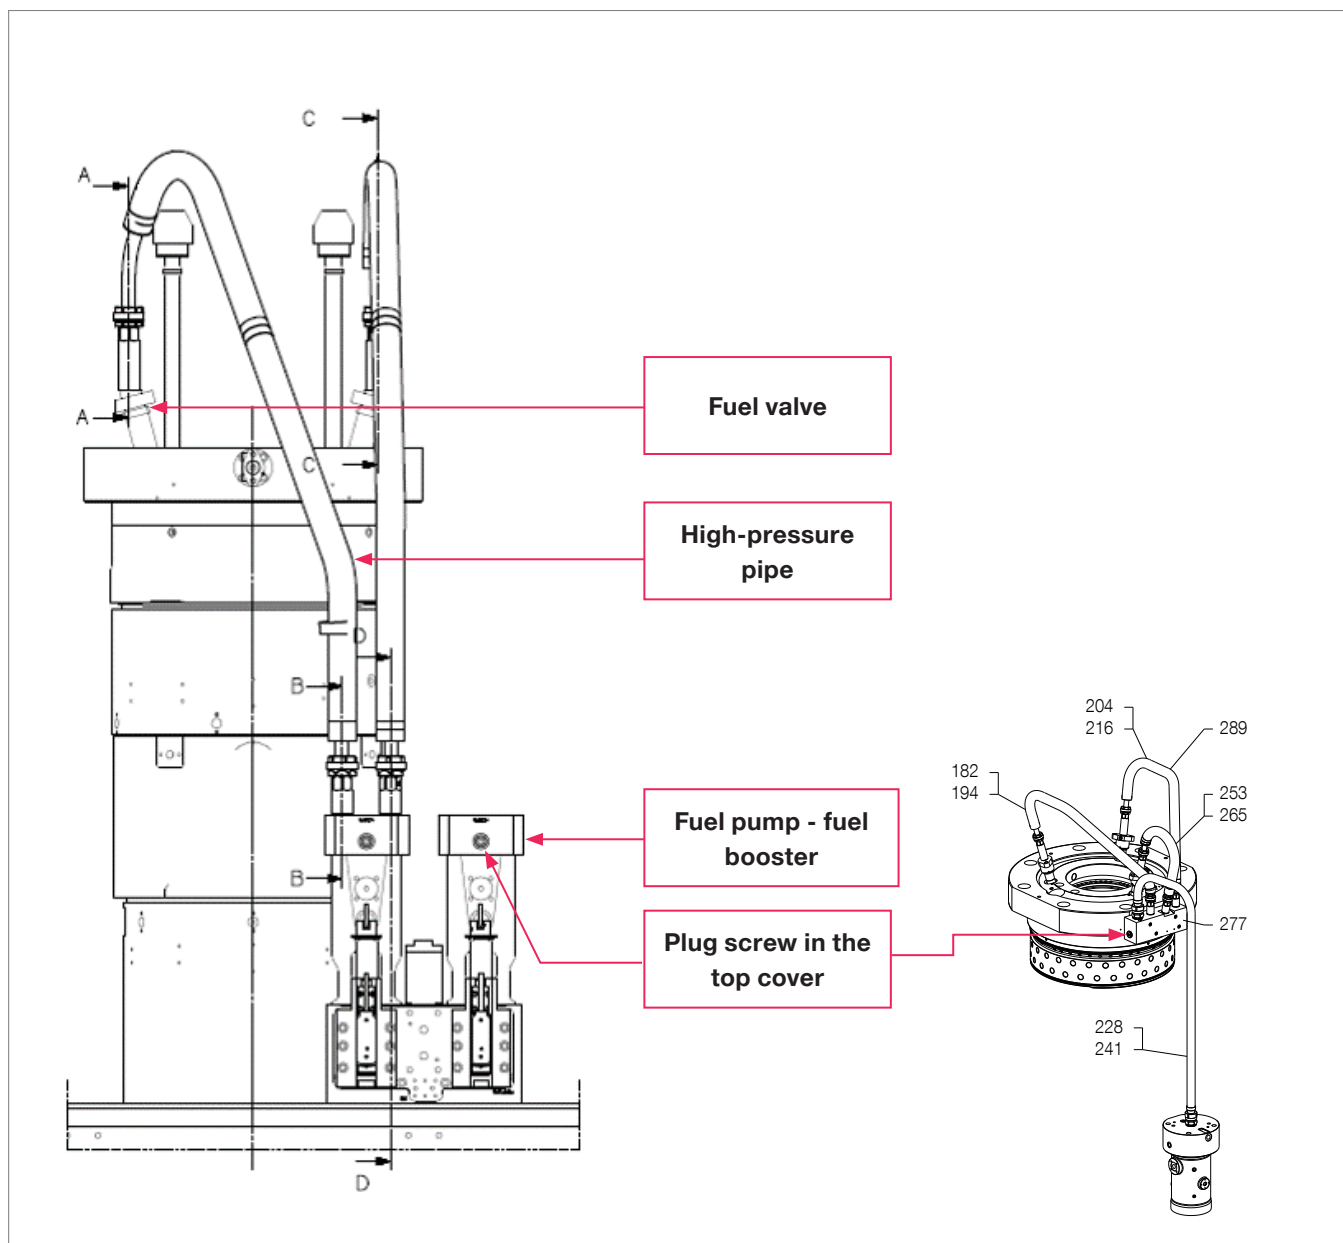
Cavitation damage has not been reported for the fuel pump or fuel booster, see Fig. 4.

Fig. 4: Fuel injection equipment

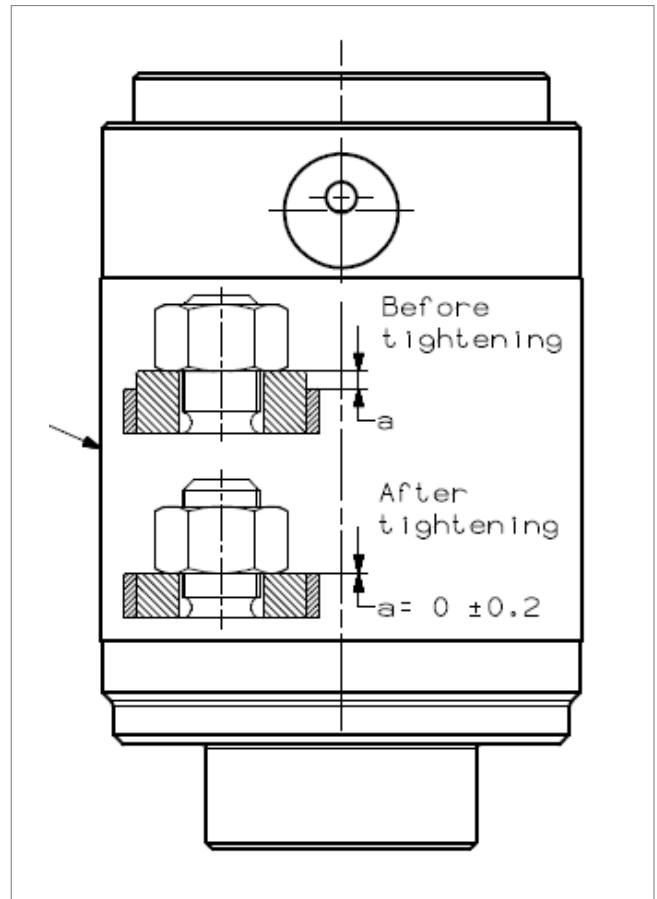
Fig. 18: Spring housing

The spring housing is a wear part that secures the correct tightening force in the engine. If it is not up to acceptable standard, this may have a huge impact on the operation of the fuel valve and the lifetime of internal components.
