Diving Department		Project No.:	5/894	Activity No.:	002:001
Underwater Inspection Report		Date:	22-08-23	Prepared By:	DANNI
Location/Vessel:	801 / GLOBE PEGASUS		Page 1 of 29

**MV "GLOBE PEGASUS"**

**UWILD**

**22-08-2023**

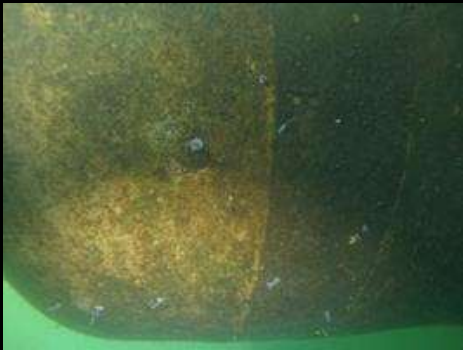
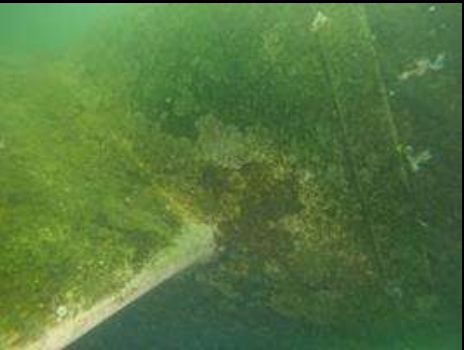
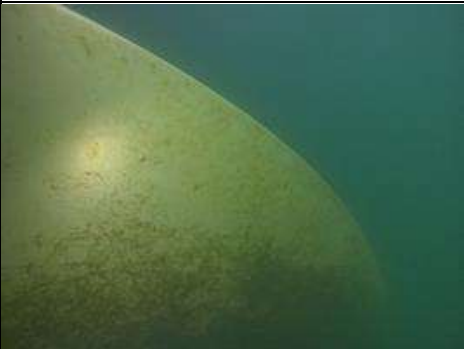
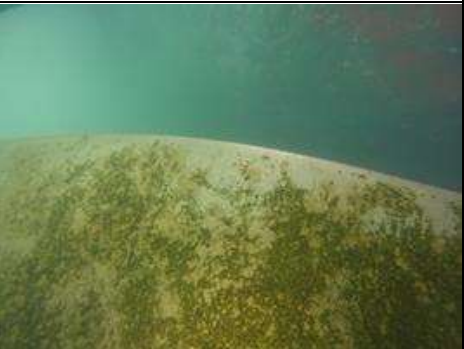
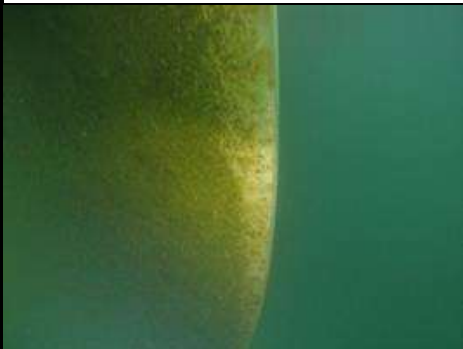
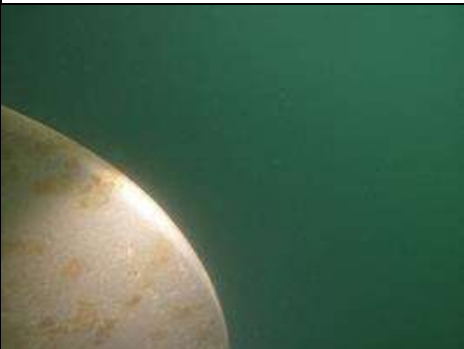
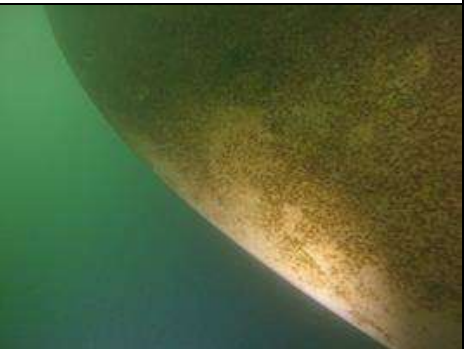
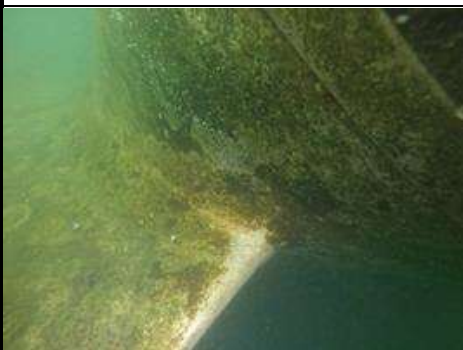
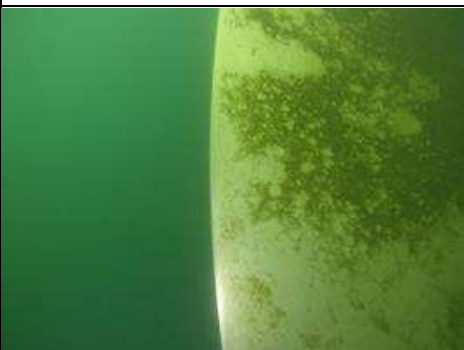
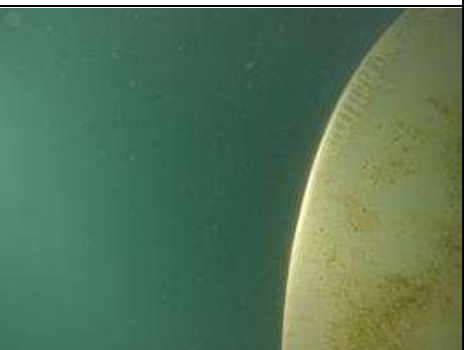
7.1 Propeller photos

✓ Fishing net was found in rope guard around stern seal.

<div>✓ All entanglements were removed.</div> <div>✓ No oil leaks detected.</div>

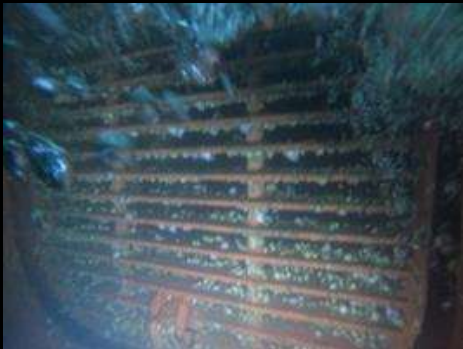
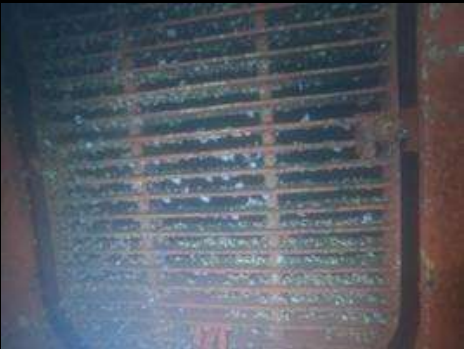
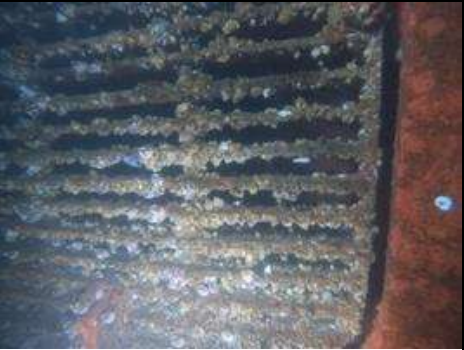
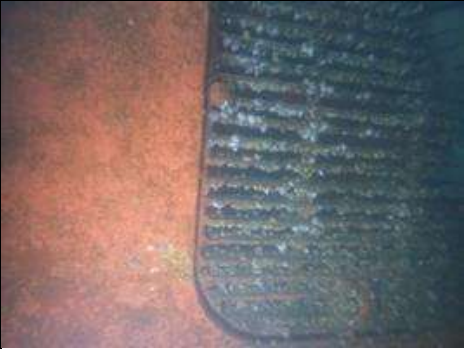
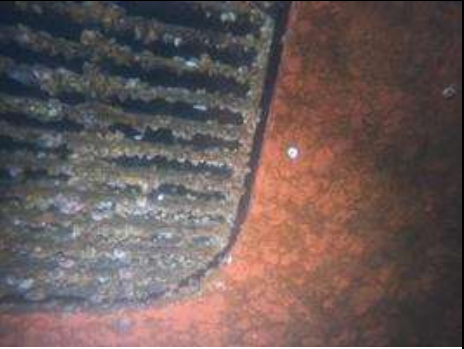
9.4 Sea chest grids photos

Number of:				Number of: 4				Number of:			
Port		Stbd		Port	2	Stbd	2	Port		Stbd	
Paint Detachment /Mechanical Damage:	<input type="checkbox"/> No Detachment Observed			<input checked="" type="checkbox"/> Detachment Observed			<input checked="" type="checkbox"/> Light		<input type="checkbox"/> Med		<input type="checkbox"/> Severe

<input type="checkbox"/> Localised			<input checked="" type="checkbox"/> Scattered			<input type="checkbox"/> Whole Area				
	<input type="checkbox"/> Paint Scraping Damage			<input type="checkbox"/> Bare Metal Exposed Where Paint Miss			<input type="checkbox"/> Blistering				
	<input type="checkbox"/> Cracking			<input type="checkbox"/> Crazing			<input type="checkbox"/> Low Film Thickness				
	<input checked="" type="checkbox"/> Only Undercoat Exposed			<input type="checkbox"/> Peeling			<input type="checkbox"/> Refer to Diagram
