DIVING REPORT

Vessel:	GLOBE PEGASUS
IMO No:	9403188
Flag:	MARSHALL ISLANDS
Work Scope:	BILGE KEEL, RUDDER, FLAT BOTTOM, SEA CHEST CLEANING & PROPELLER POLISHING
Performed Date:	July 21 – July 22, 2022
Location:	Thieng Lieng Anchorage, Viet Nam

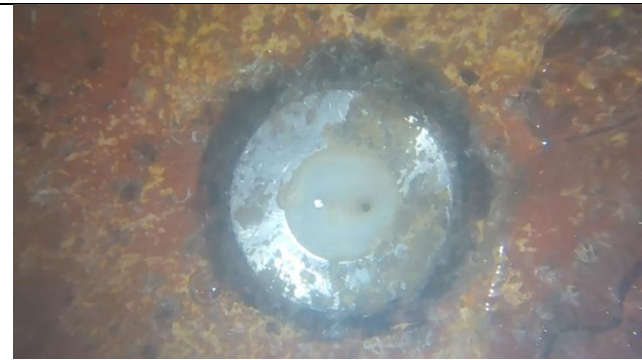
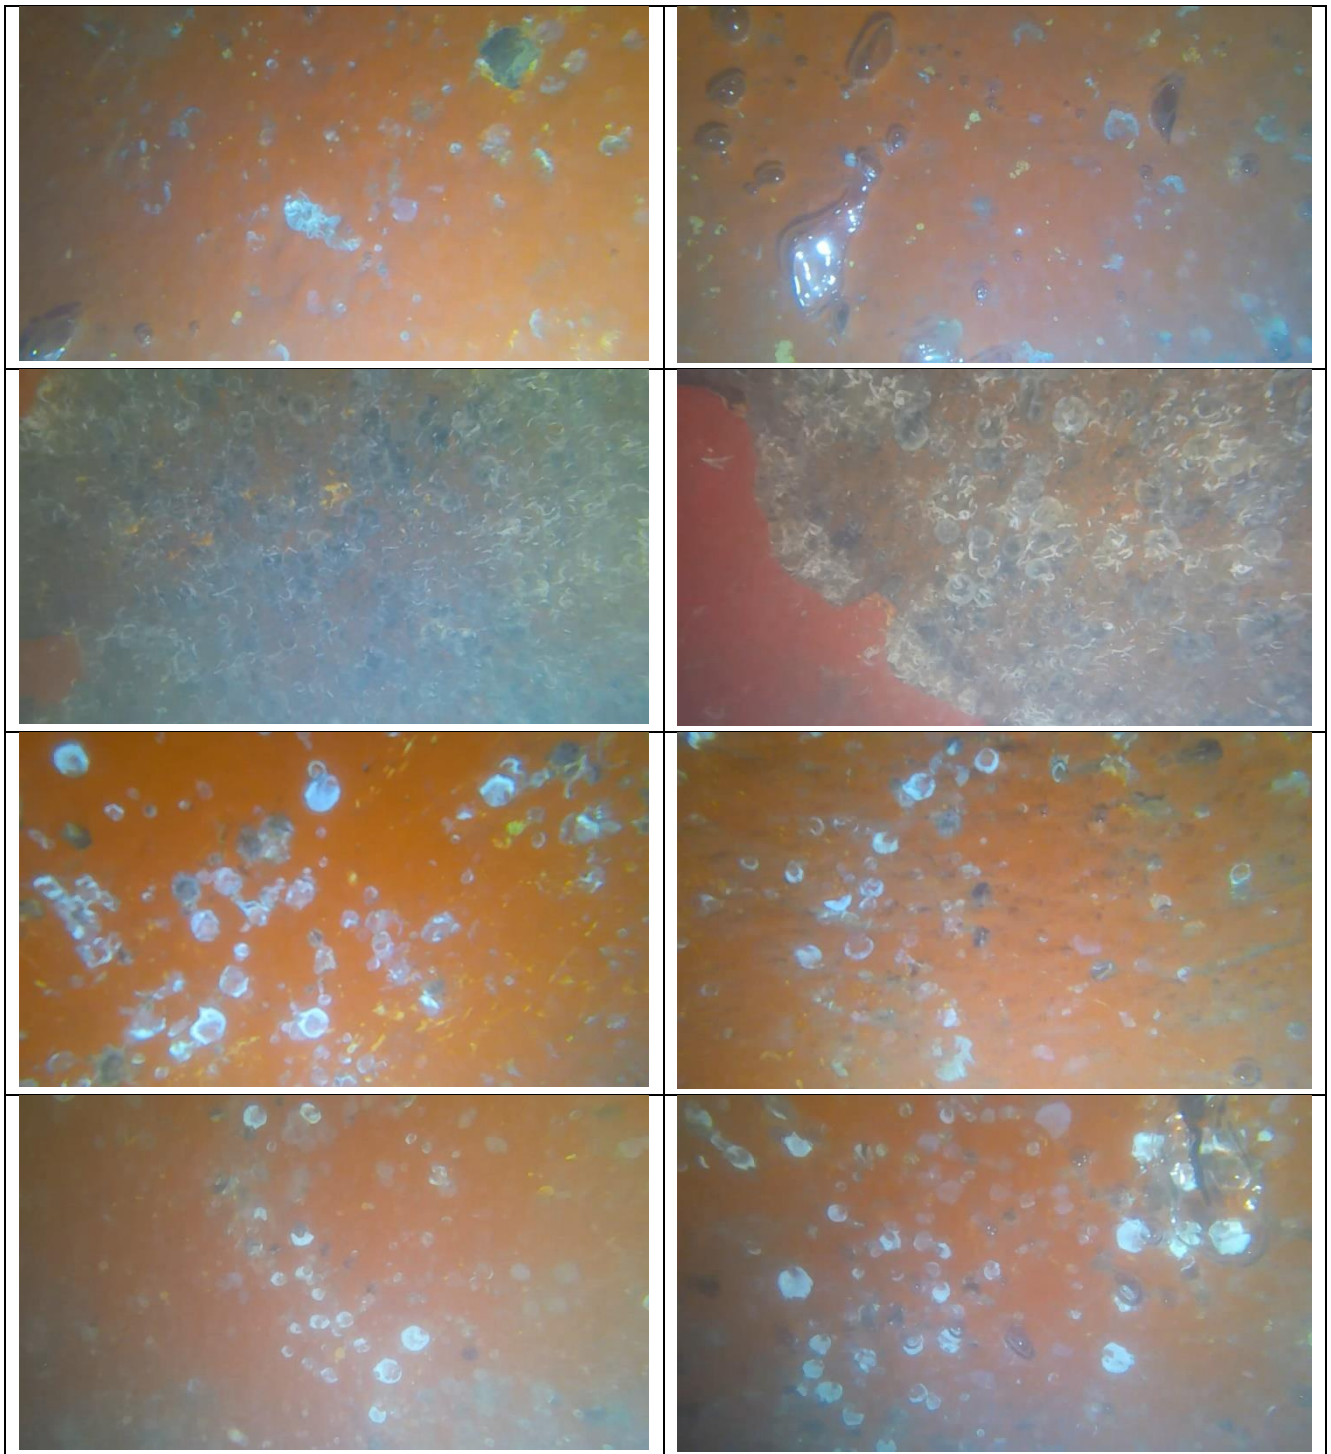
After Cleaning

Hull Flat Bottom	
General Condition	<input type="checkbox"/> Good <input checked="" type="checkbox"/> Normal <input type="checkbox"/> Poor
Mechanical Damage	No
Plate Indentation	No
Weld Seams	In normal condition
Coating	In normal condition
Fouling	Cover 15% Barnacles & Tubeworm
Before Cleaning

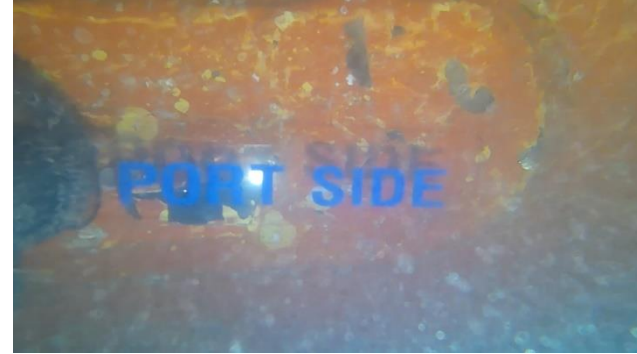
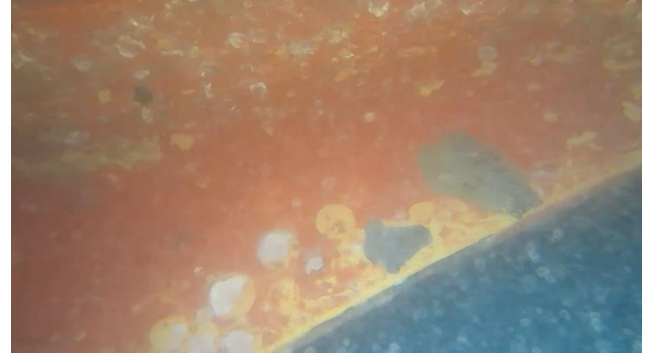
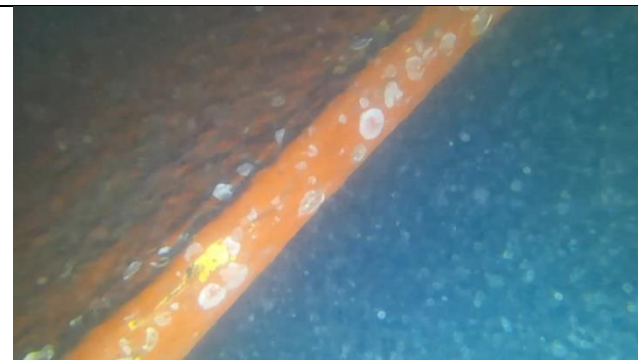
After Cleaning

General Condition	<input type="checkbox"/> Good	<input checked="" type="checkbox"/> Normal	<input type="checkbox"/> Poor
Mechanical Damage	No		
Weld Seams	In good condition		
Coating	In normal condition		
Fouling	Cover 30% Barnacles & Tubeworm		
Before Cleaning

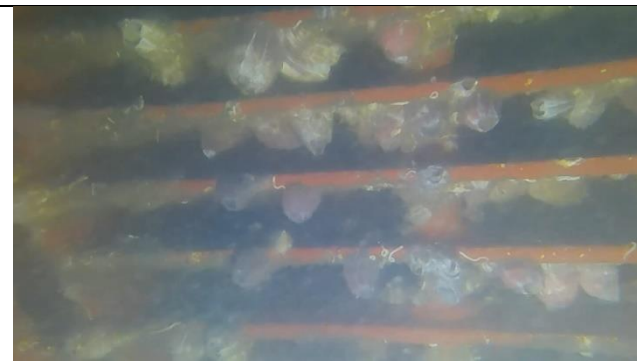
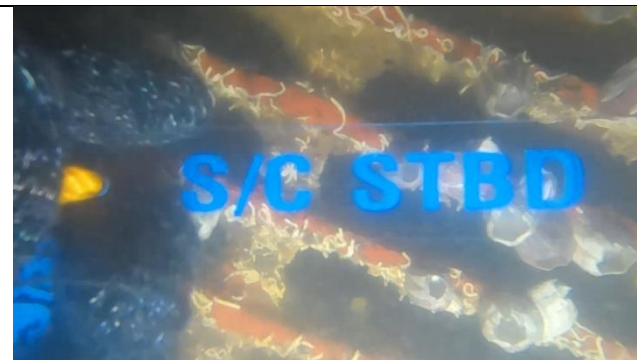
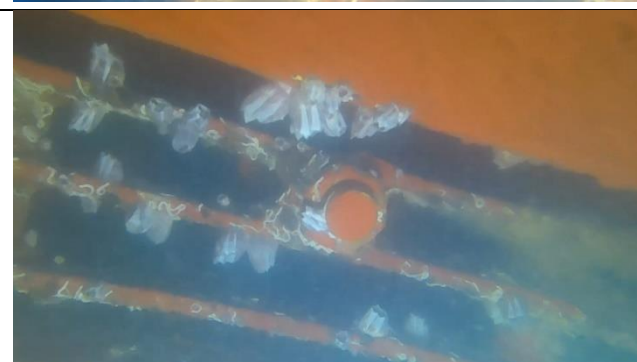
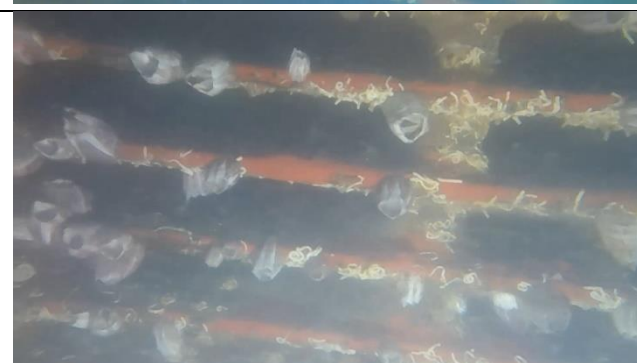
Before Cleaning

Grating Condition	<input type="checkbox"/> Good	<input checked="" type="checkbox"/> Normal	<input type="checkbox"/> Poor
Mechanical Damage	No		
Securing Type	Bolted		
Bolts Condition	Intact		
Fouling in Grating	Cover 80% Barnacles Sea Chest – Port side & 50% Barnacles Sea Chest – Starboard side

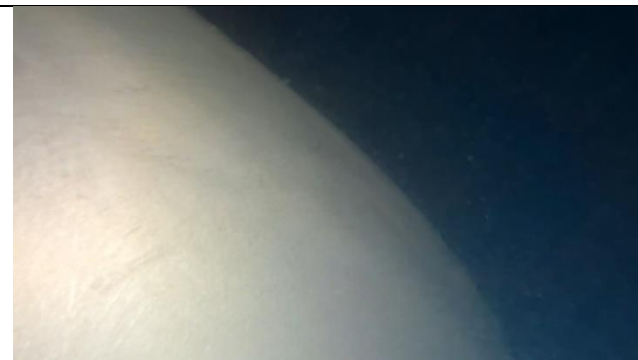
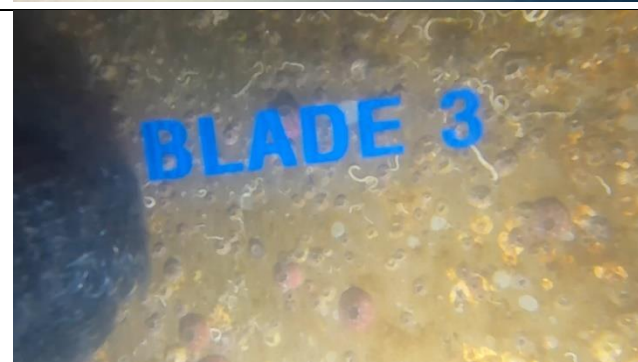
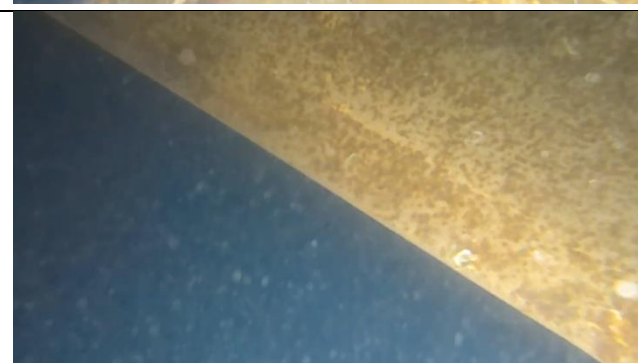
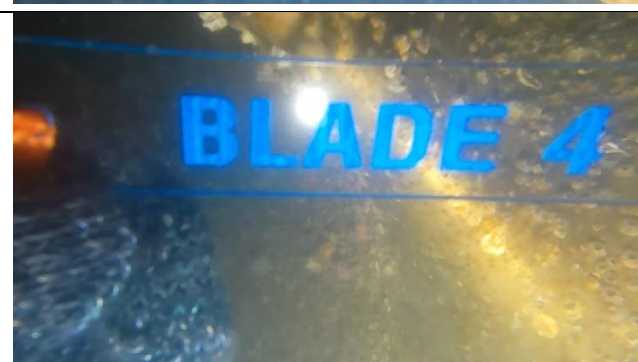
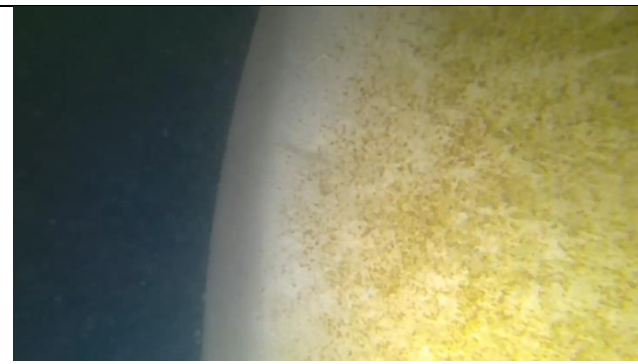
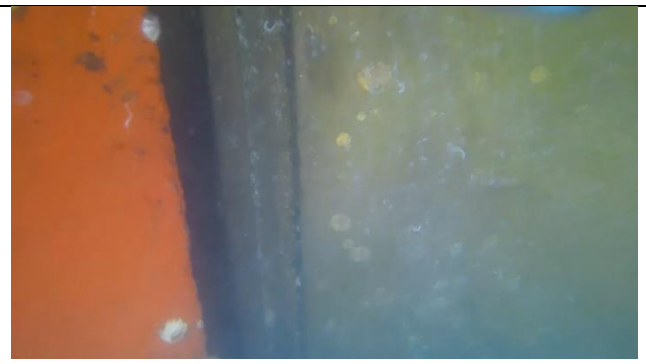
Before Cleaning

Location	<input checked="" type="checkbox"/> Center Line	<input type="checkbox"/> Twin Propellers	
Blades	<input type="checkbox"/> Good	<input checked="" type="checkbox"/> Normal	<input type="checkbox"/> Defective
Rope Guard Cover	Plate condition: In normal condition		
	Securing Type: Welded		
	Oil Leaking: No		
	Rope/ Cable/ Net: No		
	Rope cutter: Intact		
Boss Cone	In normal condition		
Fouling	Cover 10% Barnacles & Tubeworm

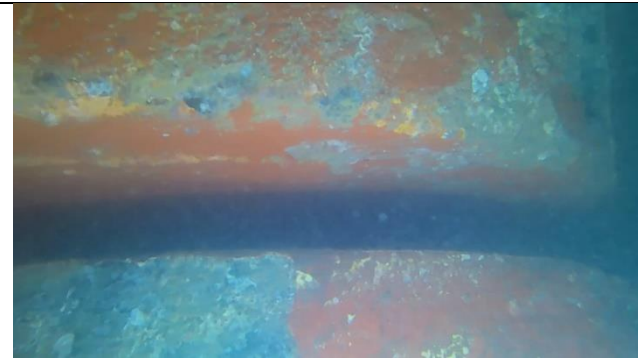
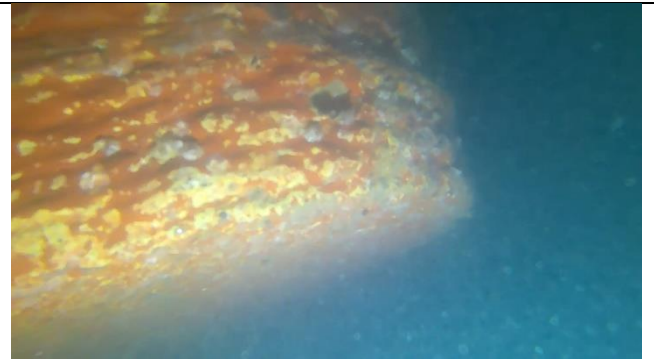
After Cleaning

General Condition	<input type="checkbox"/> Good <input checked="" type="checkbox"/> Normal <input type="checkbox"/> Poor
Mechanical Damage	No
Plate Indentation	No
Weld Seams	In normal condition
Bottom Rudder	In normal condition
Corner Plates	In normal condition
Coating	In normal condition
Fouling	10% Barnacles
<i>Before Cleaning</i>
