INCIDENT ANOMALY REPORT

REPORT DATE: 19th October 2021.
TYPE OF ANOMALY: Material Incident.
COMPANY/VESSEL : Tranship / TS Luxento.
VESSEL ACTIVITY : Hose Handling - Offloading.
INCIDENT DATE/TIME : 15th October 2021/ 16:10LT.
INCIDENT LOCATION : FPSO Espirito Santo.

This document is the investigation report of the incident on what the communication, internet and navigation antennas of LH TS Luxento was damaged after making contact with the hawser recovery cable, near the stern of FPSO ES.

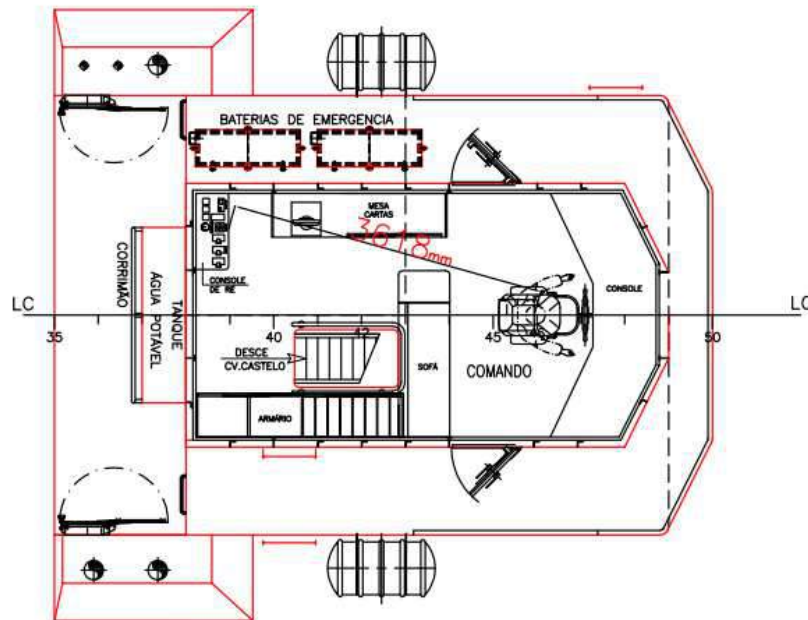
Step 02 – Following the instructions of Wladimir Alencar – Assistant Mooring Master to take photos in other point along the hose that was further after the tug. There is a Able seaman watching the distance. While he tug chief officer moved from the bow command to the stern command, due to the sea current the hose was pushed to starboard and TS Luxento commencing to move to starboard side

in the direction of the hawser. The distance from the bow to stern command is approximately 3.6 meters (Bridge arrangement below).

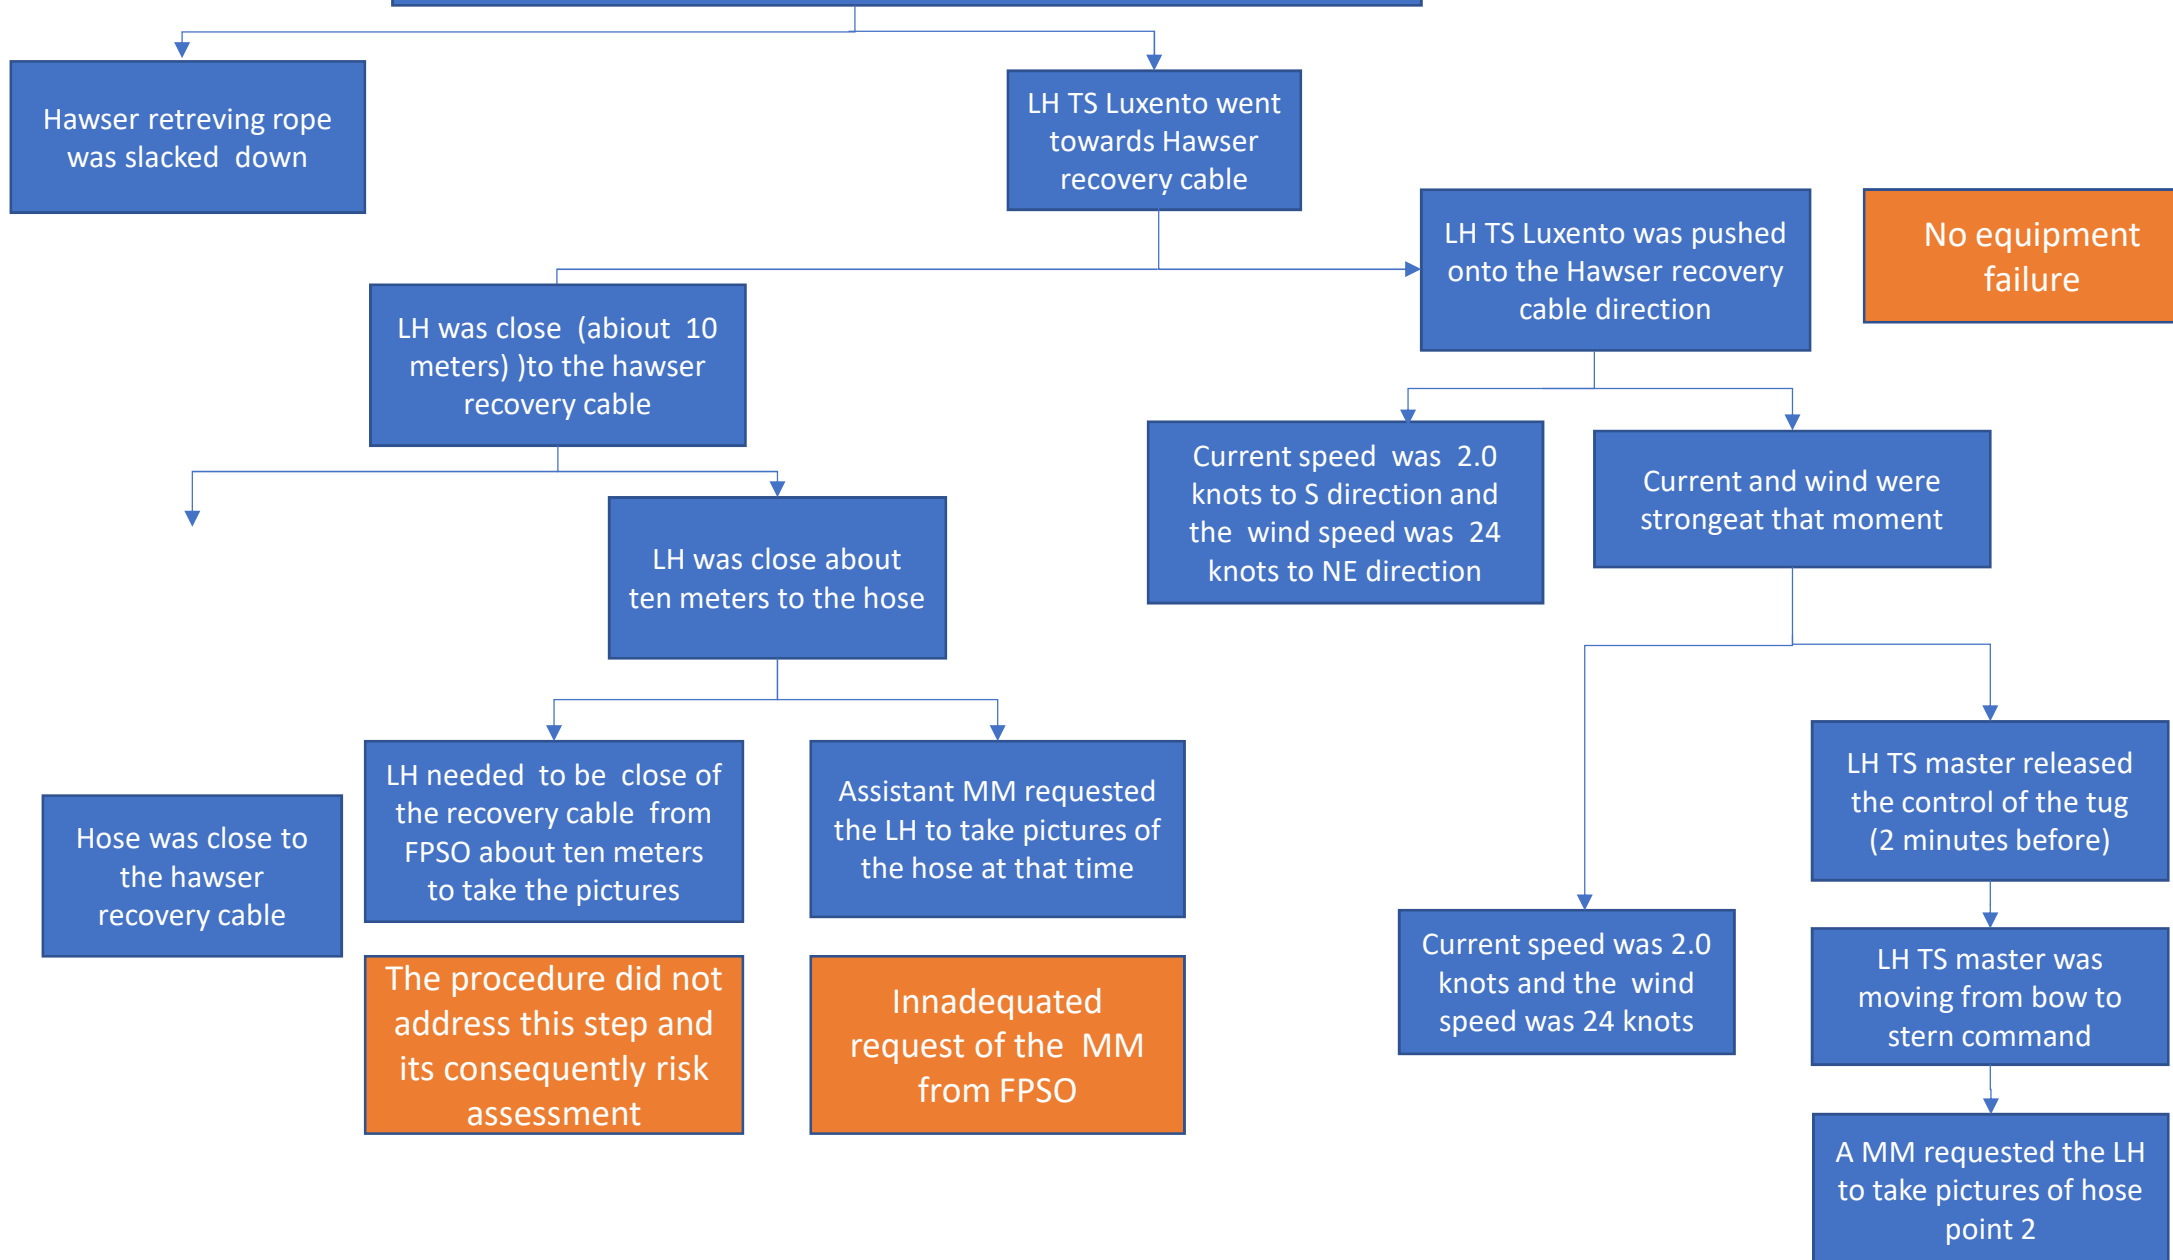
TS LUXENTO COMMUNICATION ANTENNAS CONTACT WITH THE FPSO ES HAWSER RECOVERY CABLE

TS Luxento operates too close to FPSO ES Hawser Recovery cable

Inadequate TS Luxento hose approach on the OTT proximities to take picture requested from the mooring master assistant

Ts Luxento were close too much from the FPSO ES recovery cable (about ten meters) to take the pictures)

The offloading procedure did not address this step to take picture from the hose and its consequently risk assessment

Failure on risk perception

Hawser retrieving rope was slacked down, lower than communication and navigation Ts Luxento antennas

The procedure did not address this step and its consequently risk assessment establishing the safe distance to perform the hose inspection

Failure on the procedure management

Contact between Ts Luxento communication and navigation antennas and the Hawser recovery cable due the tugboat failure equipment

Verified Ts Luxento check-list ensuring the good conditions of the tug's systems e equipments

Discarded possibility

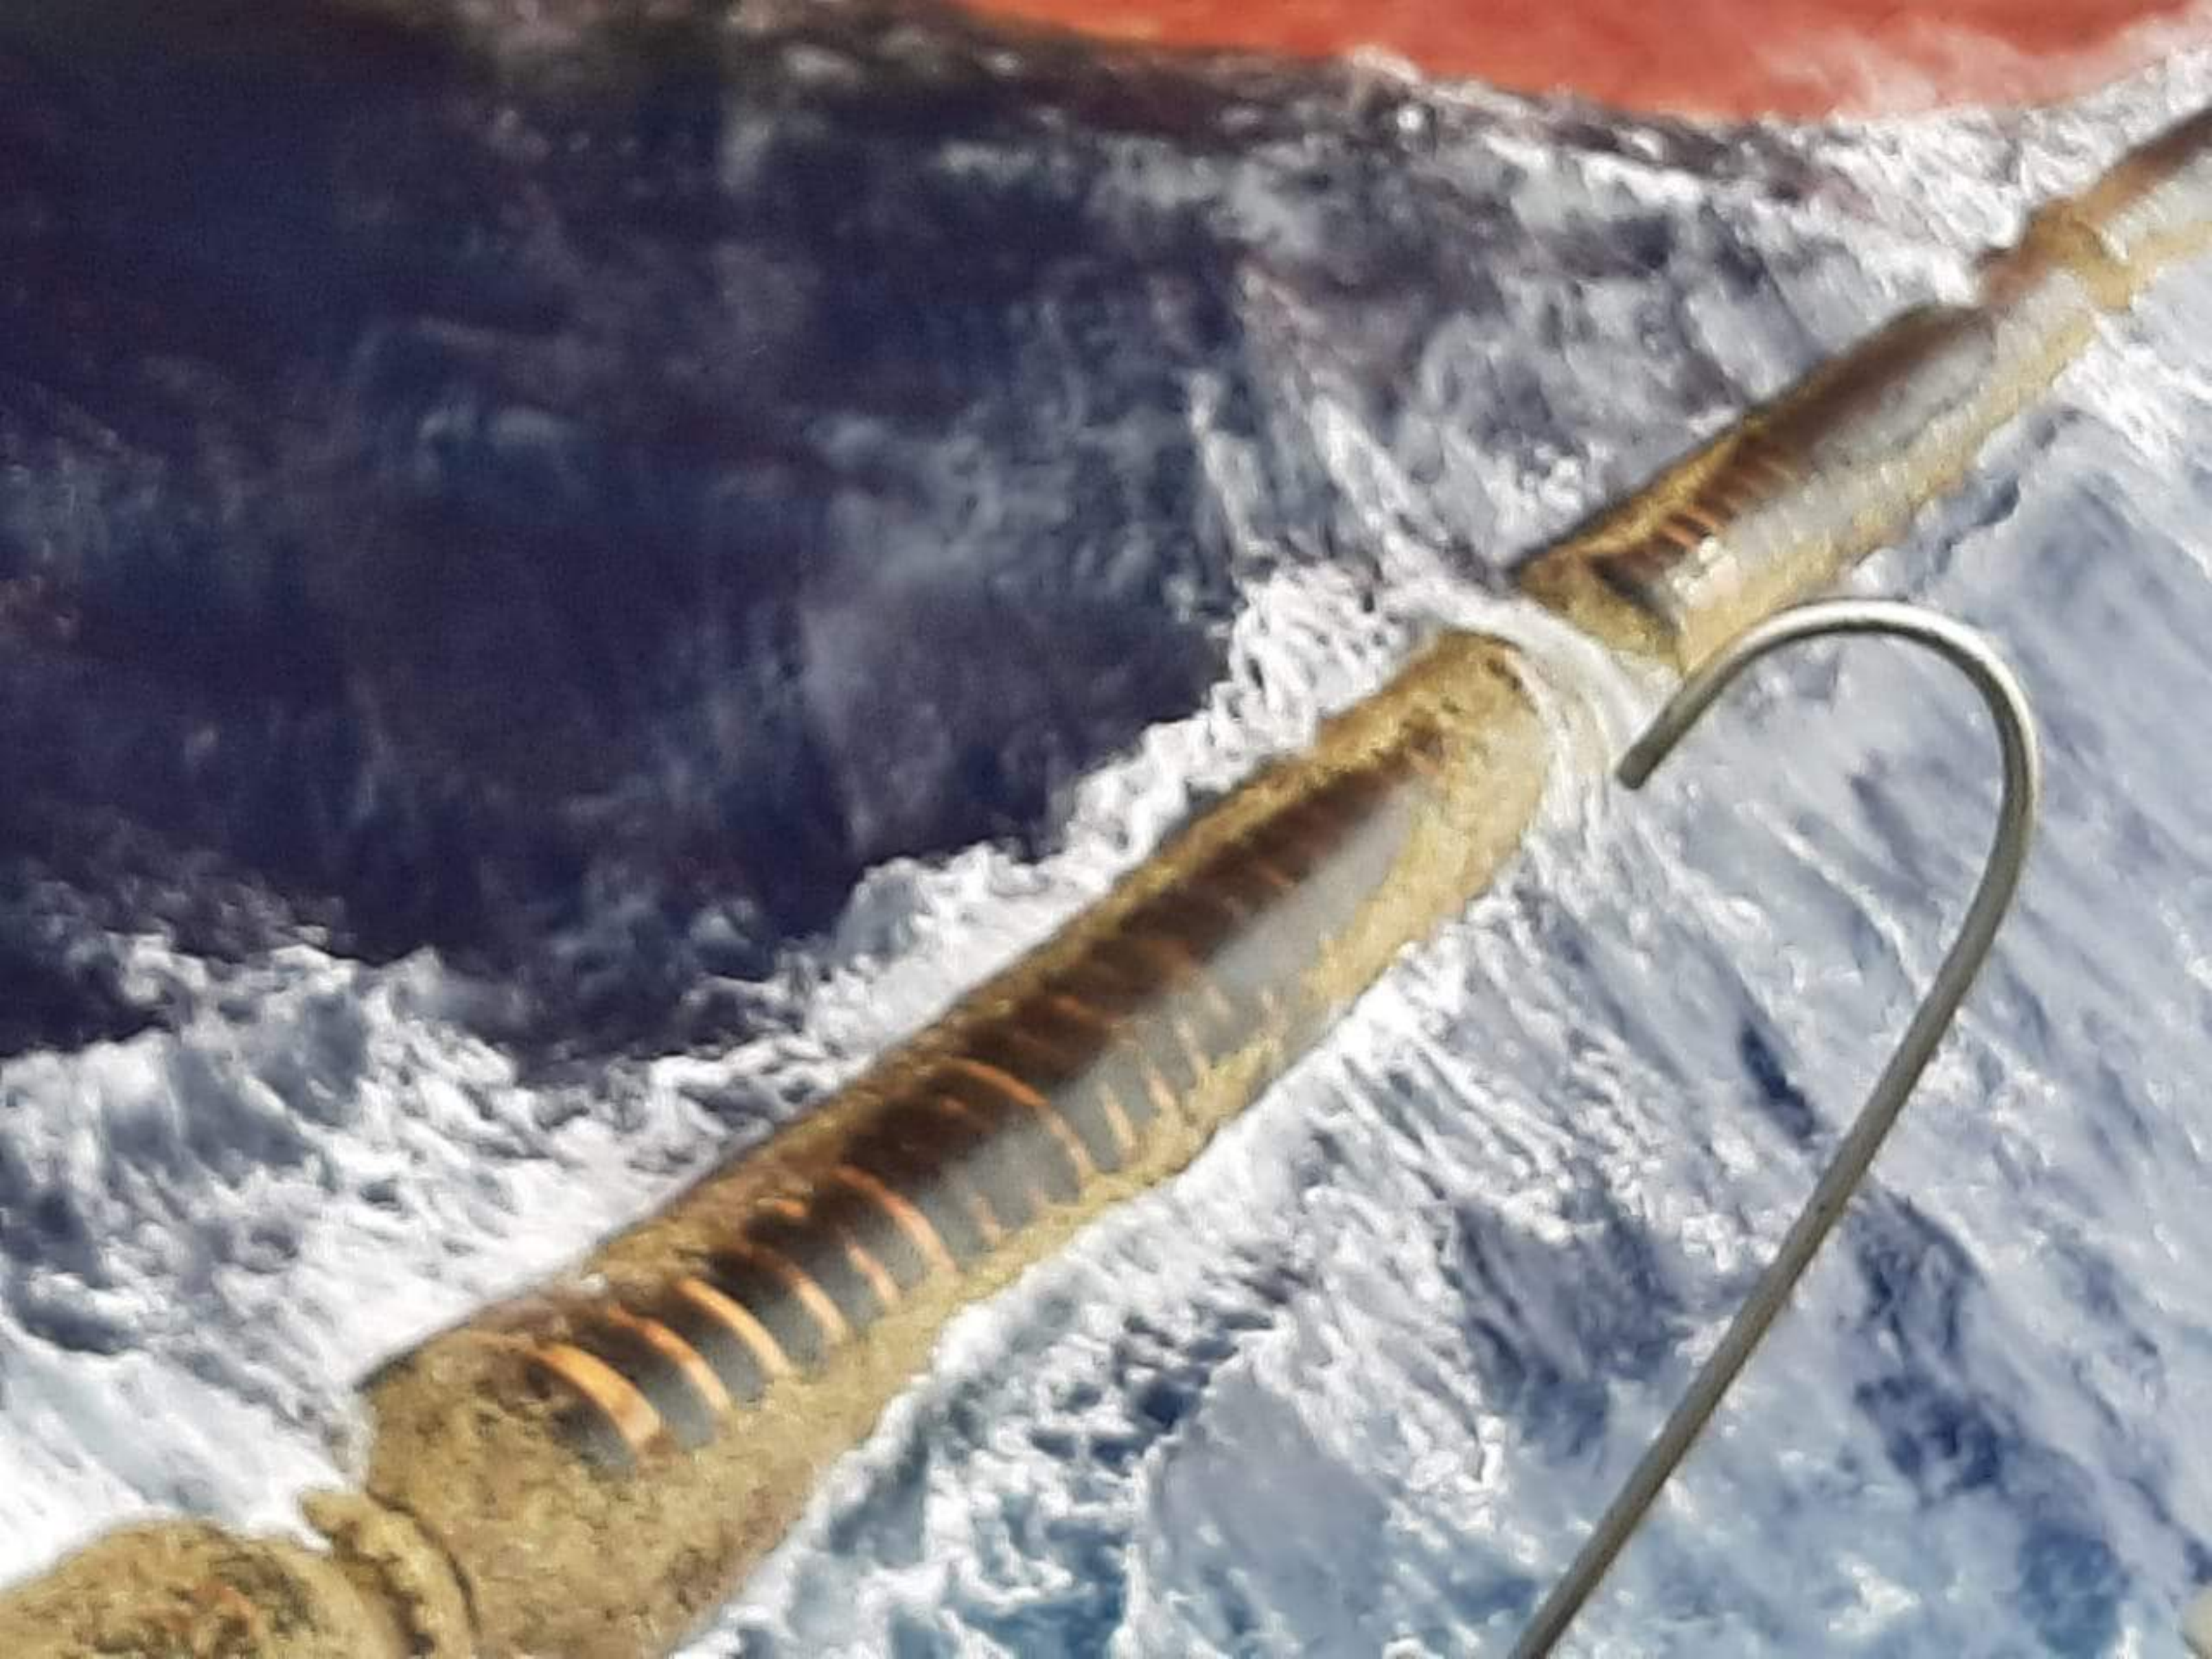
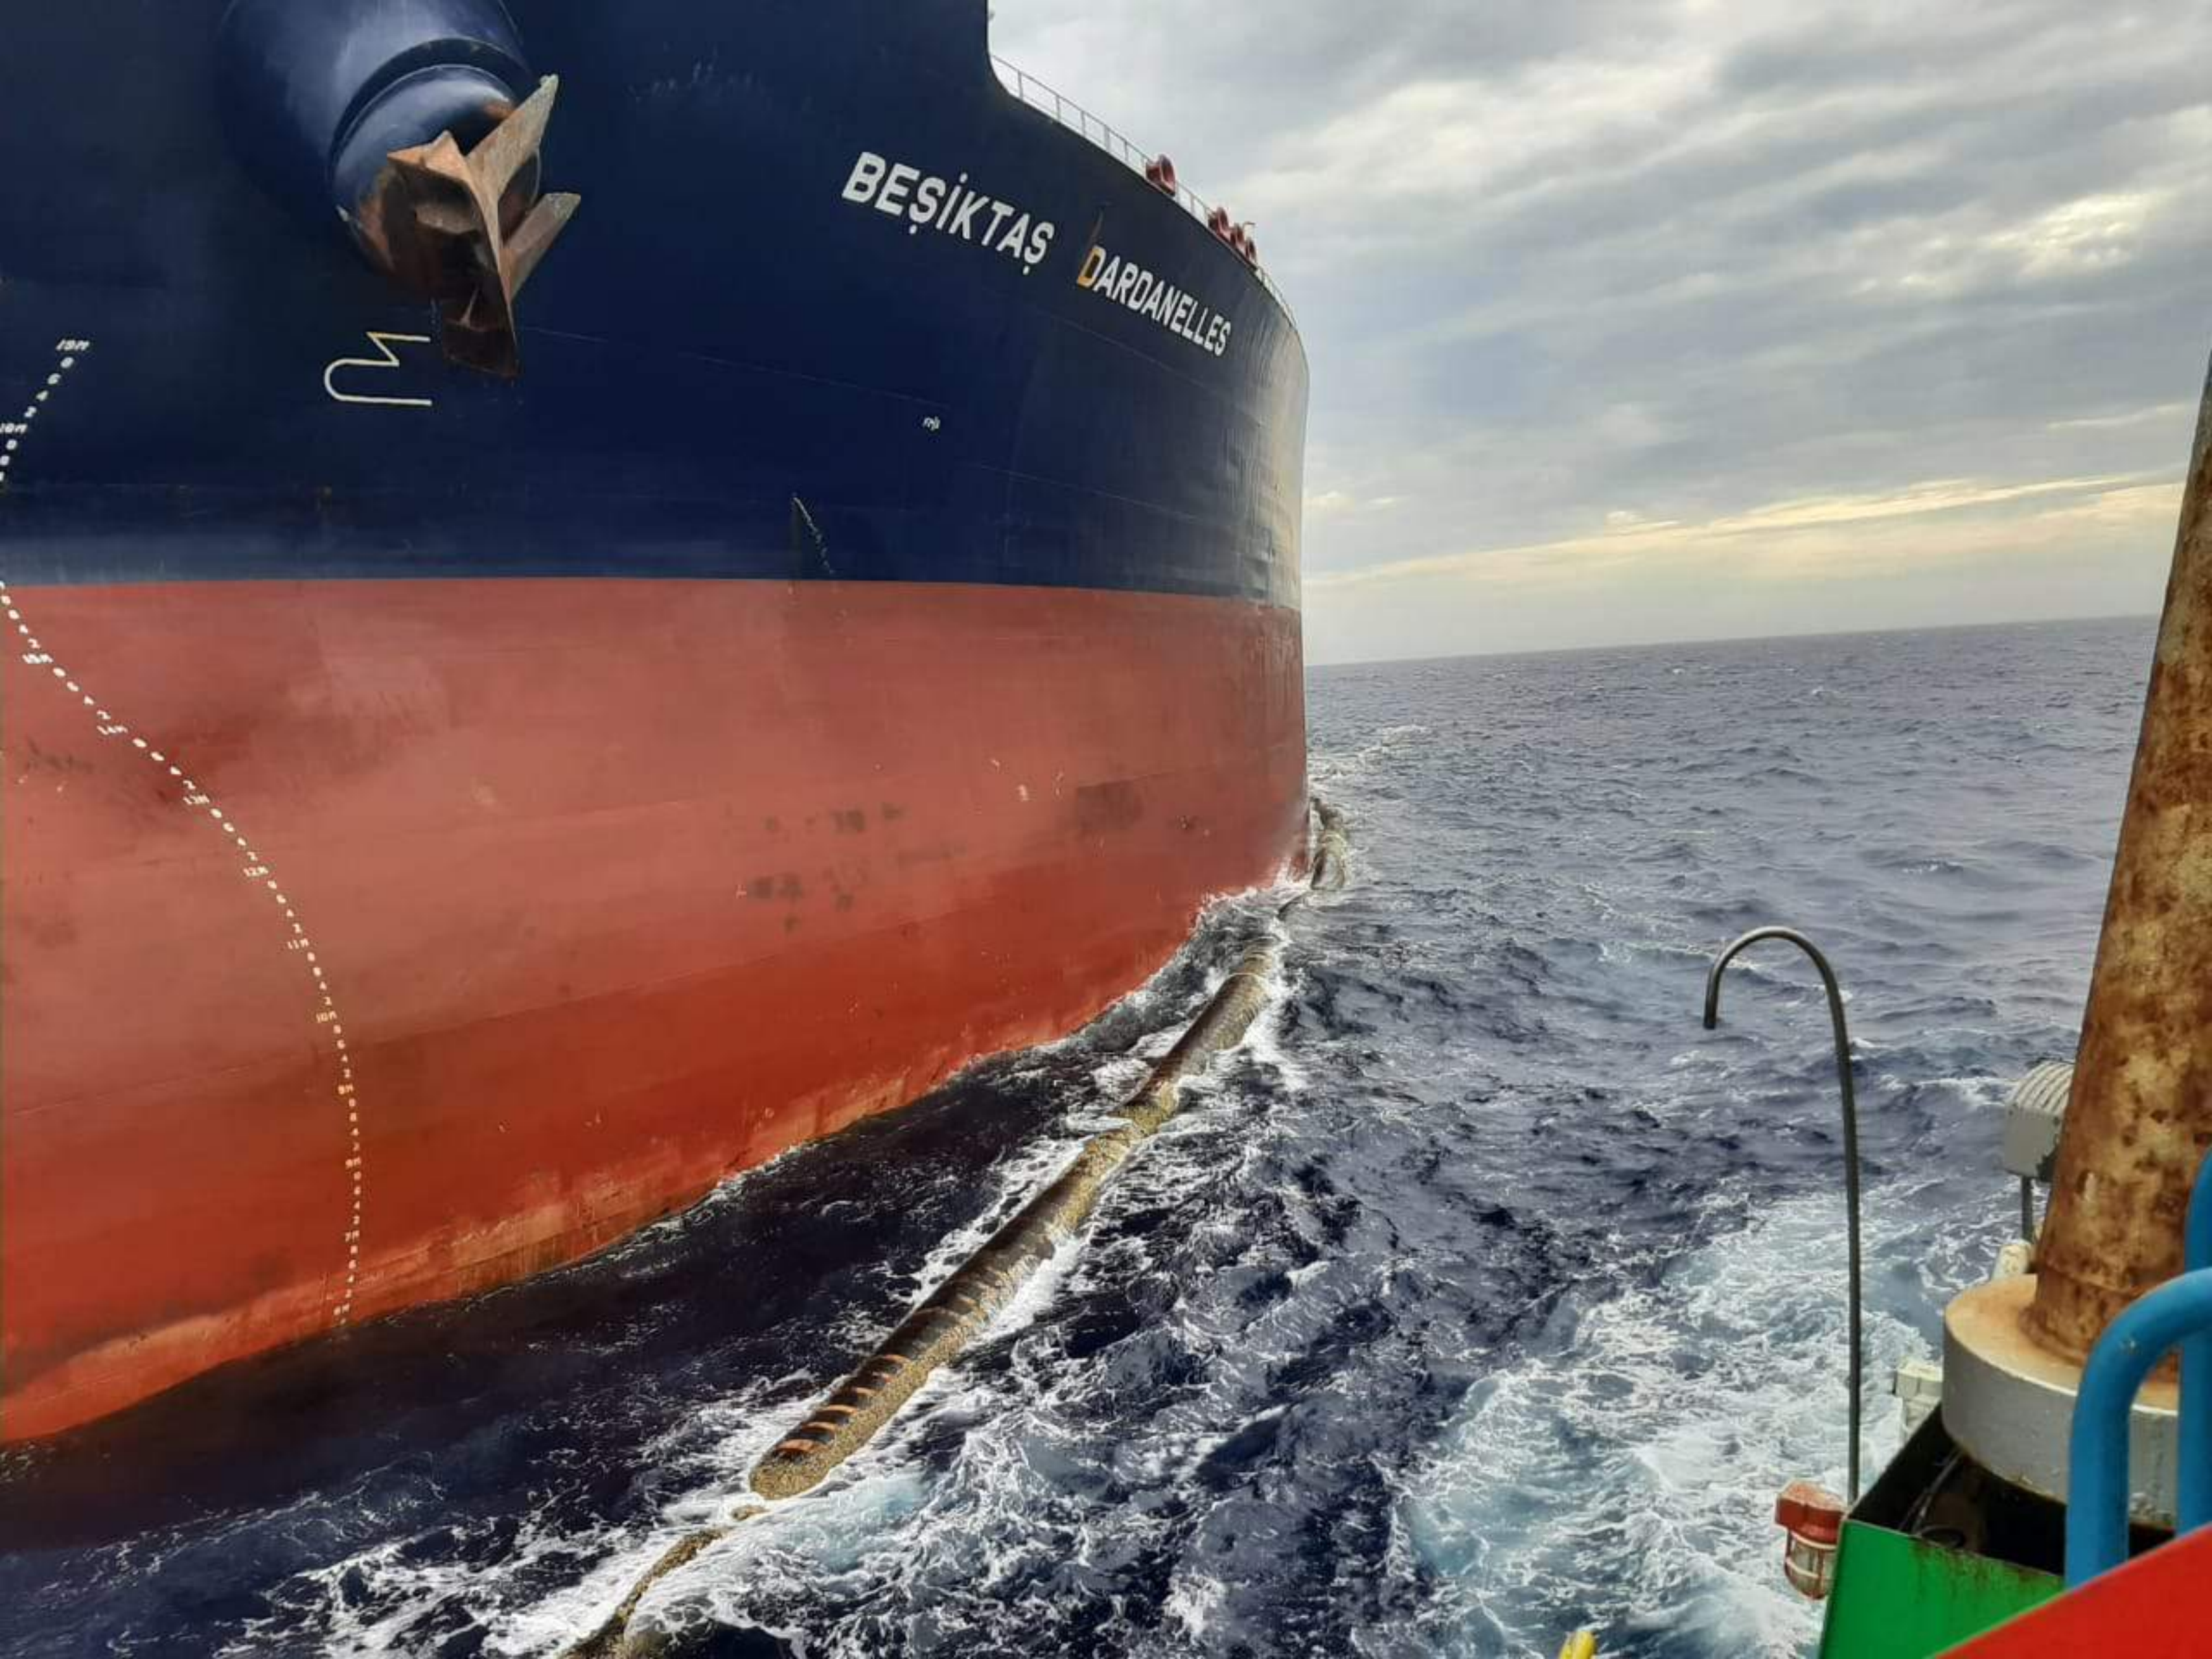
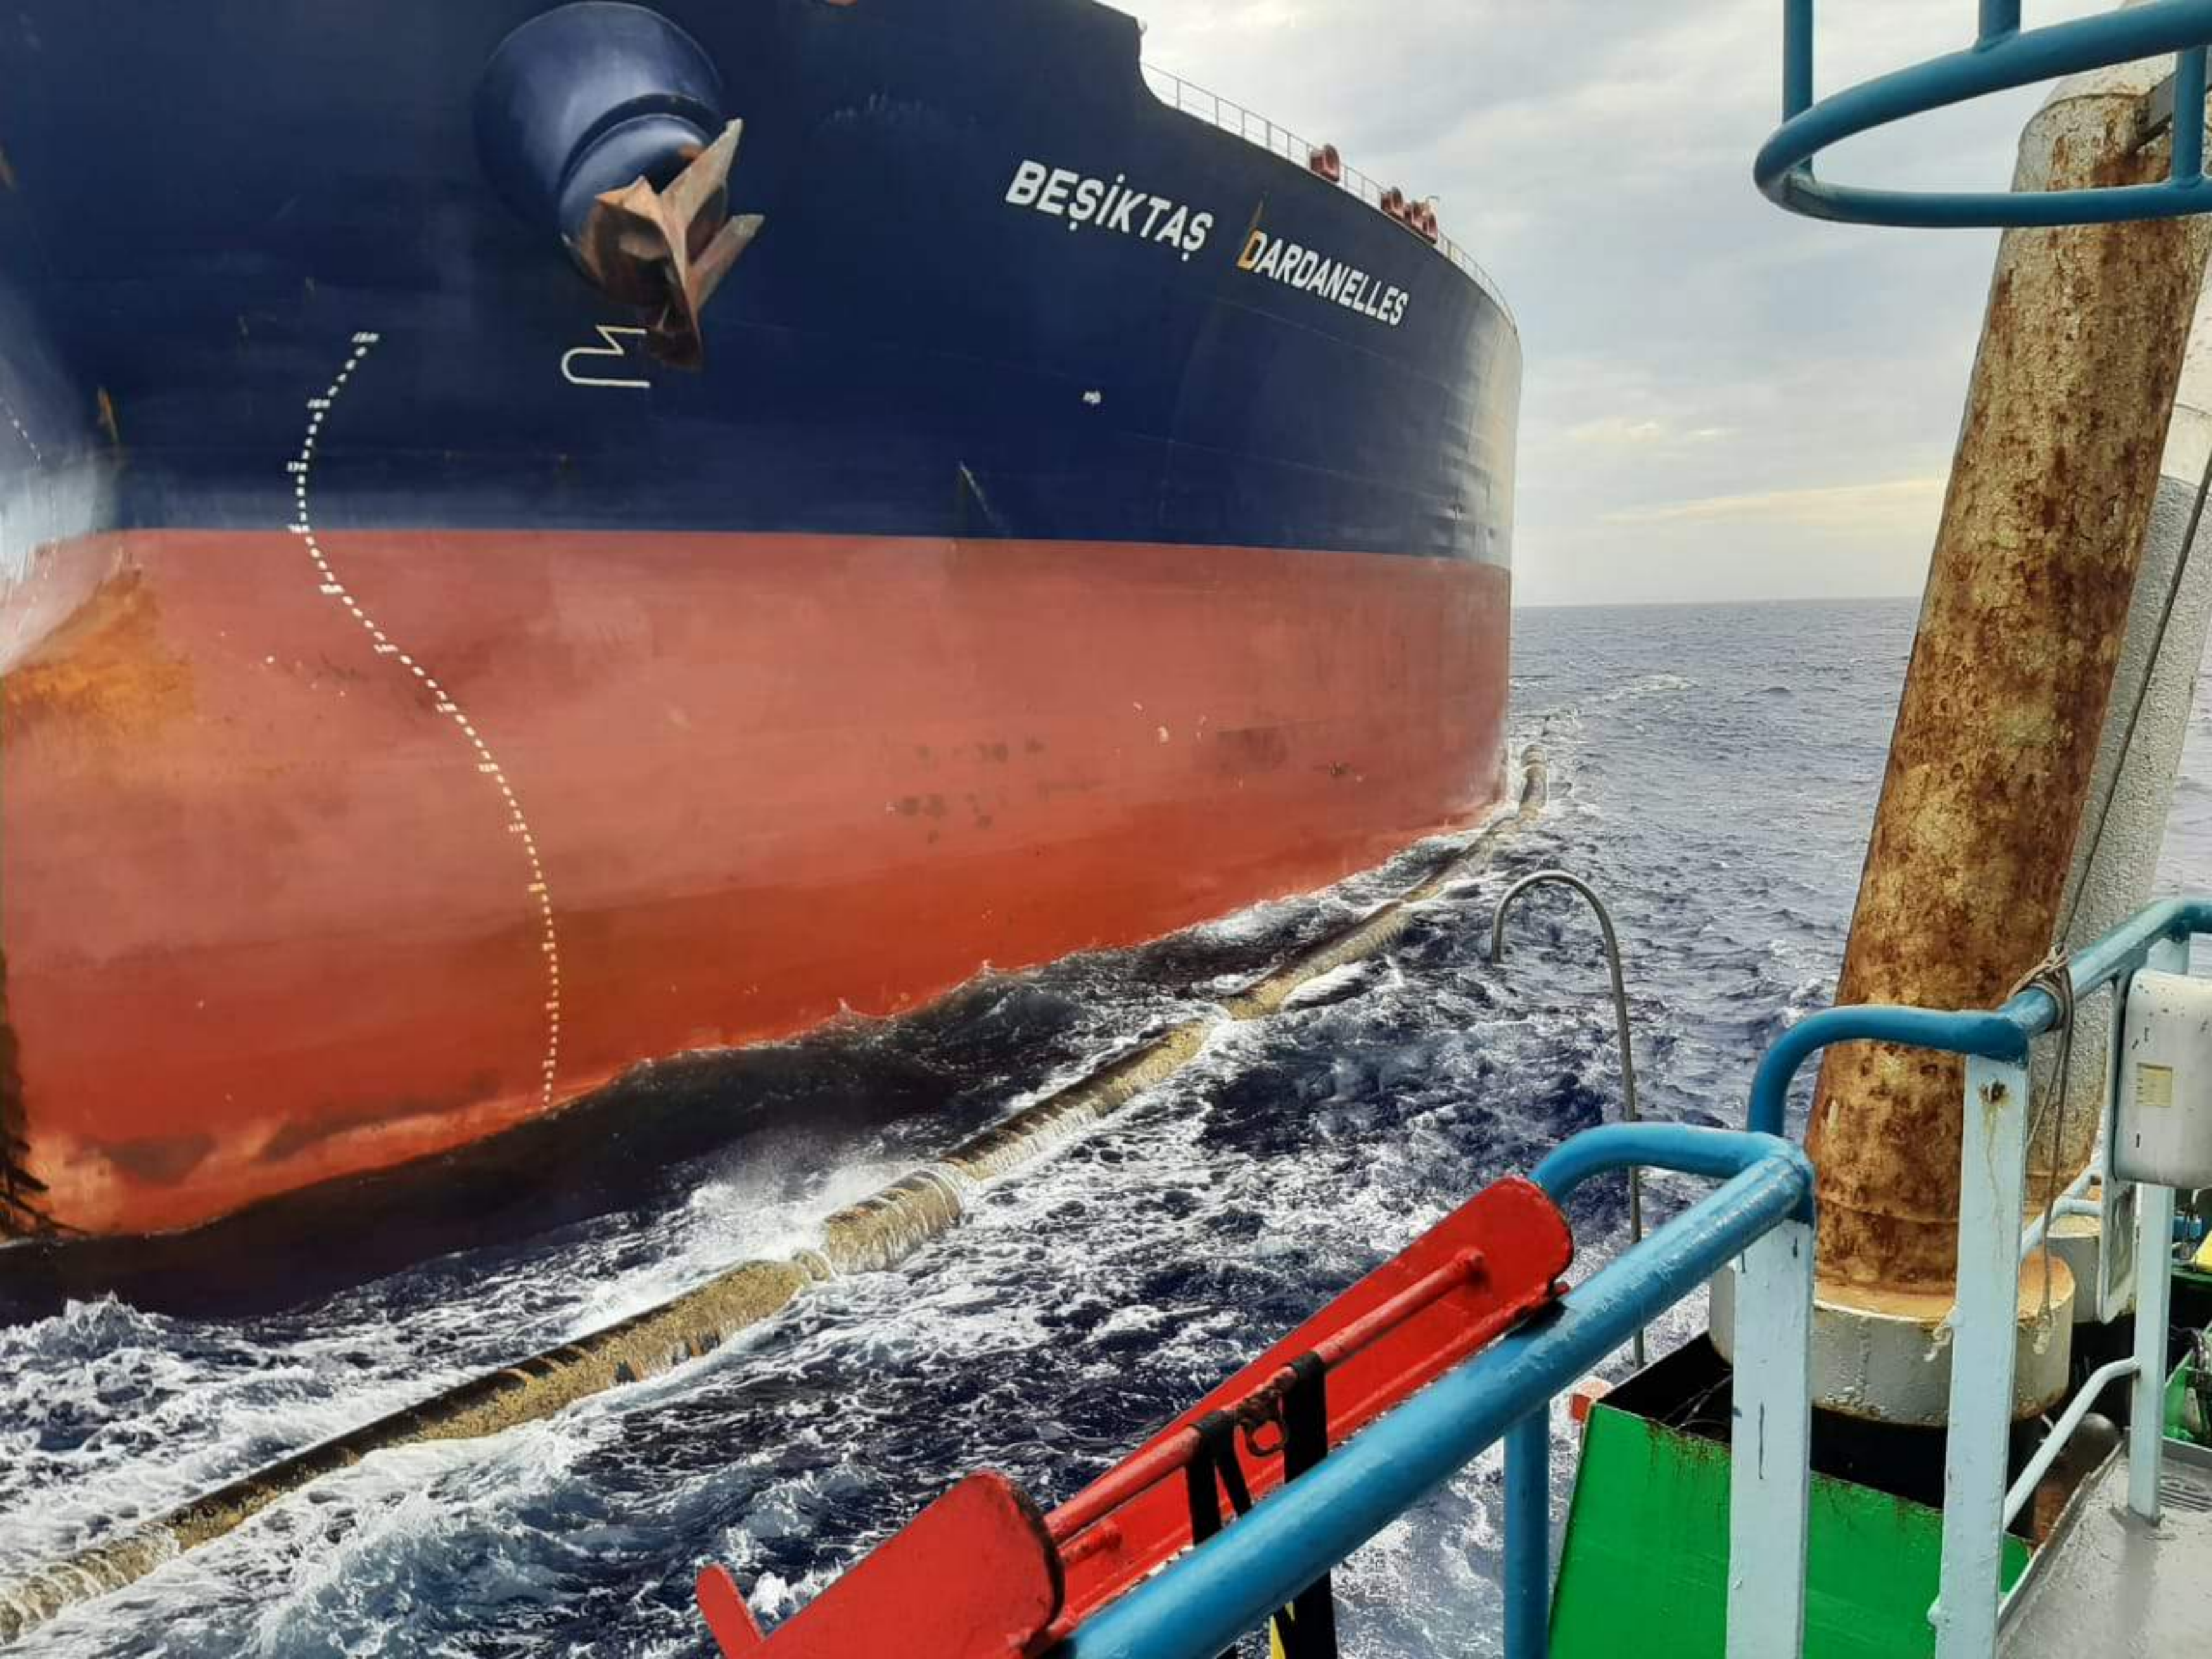
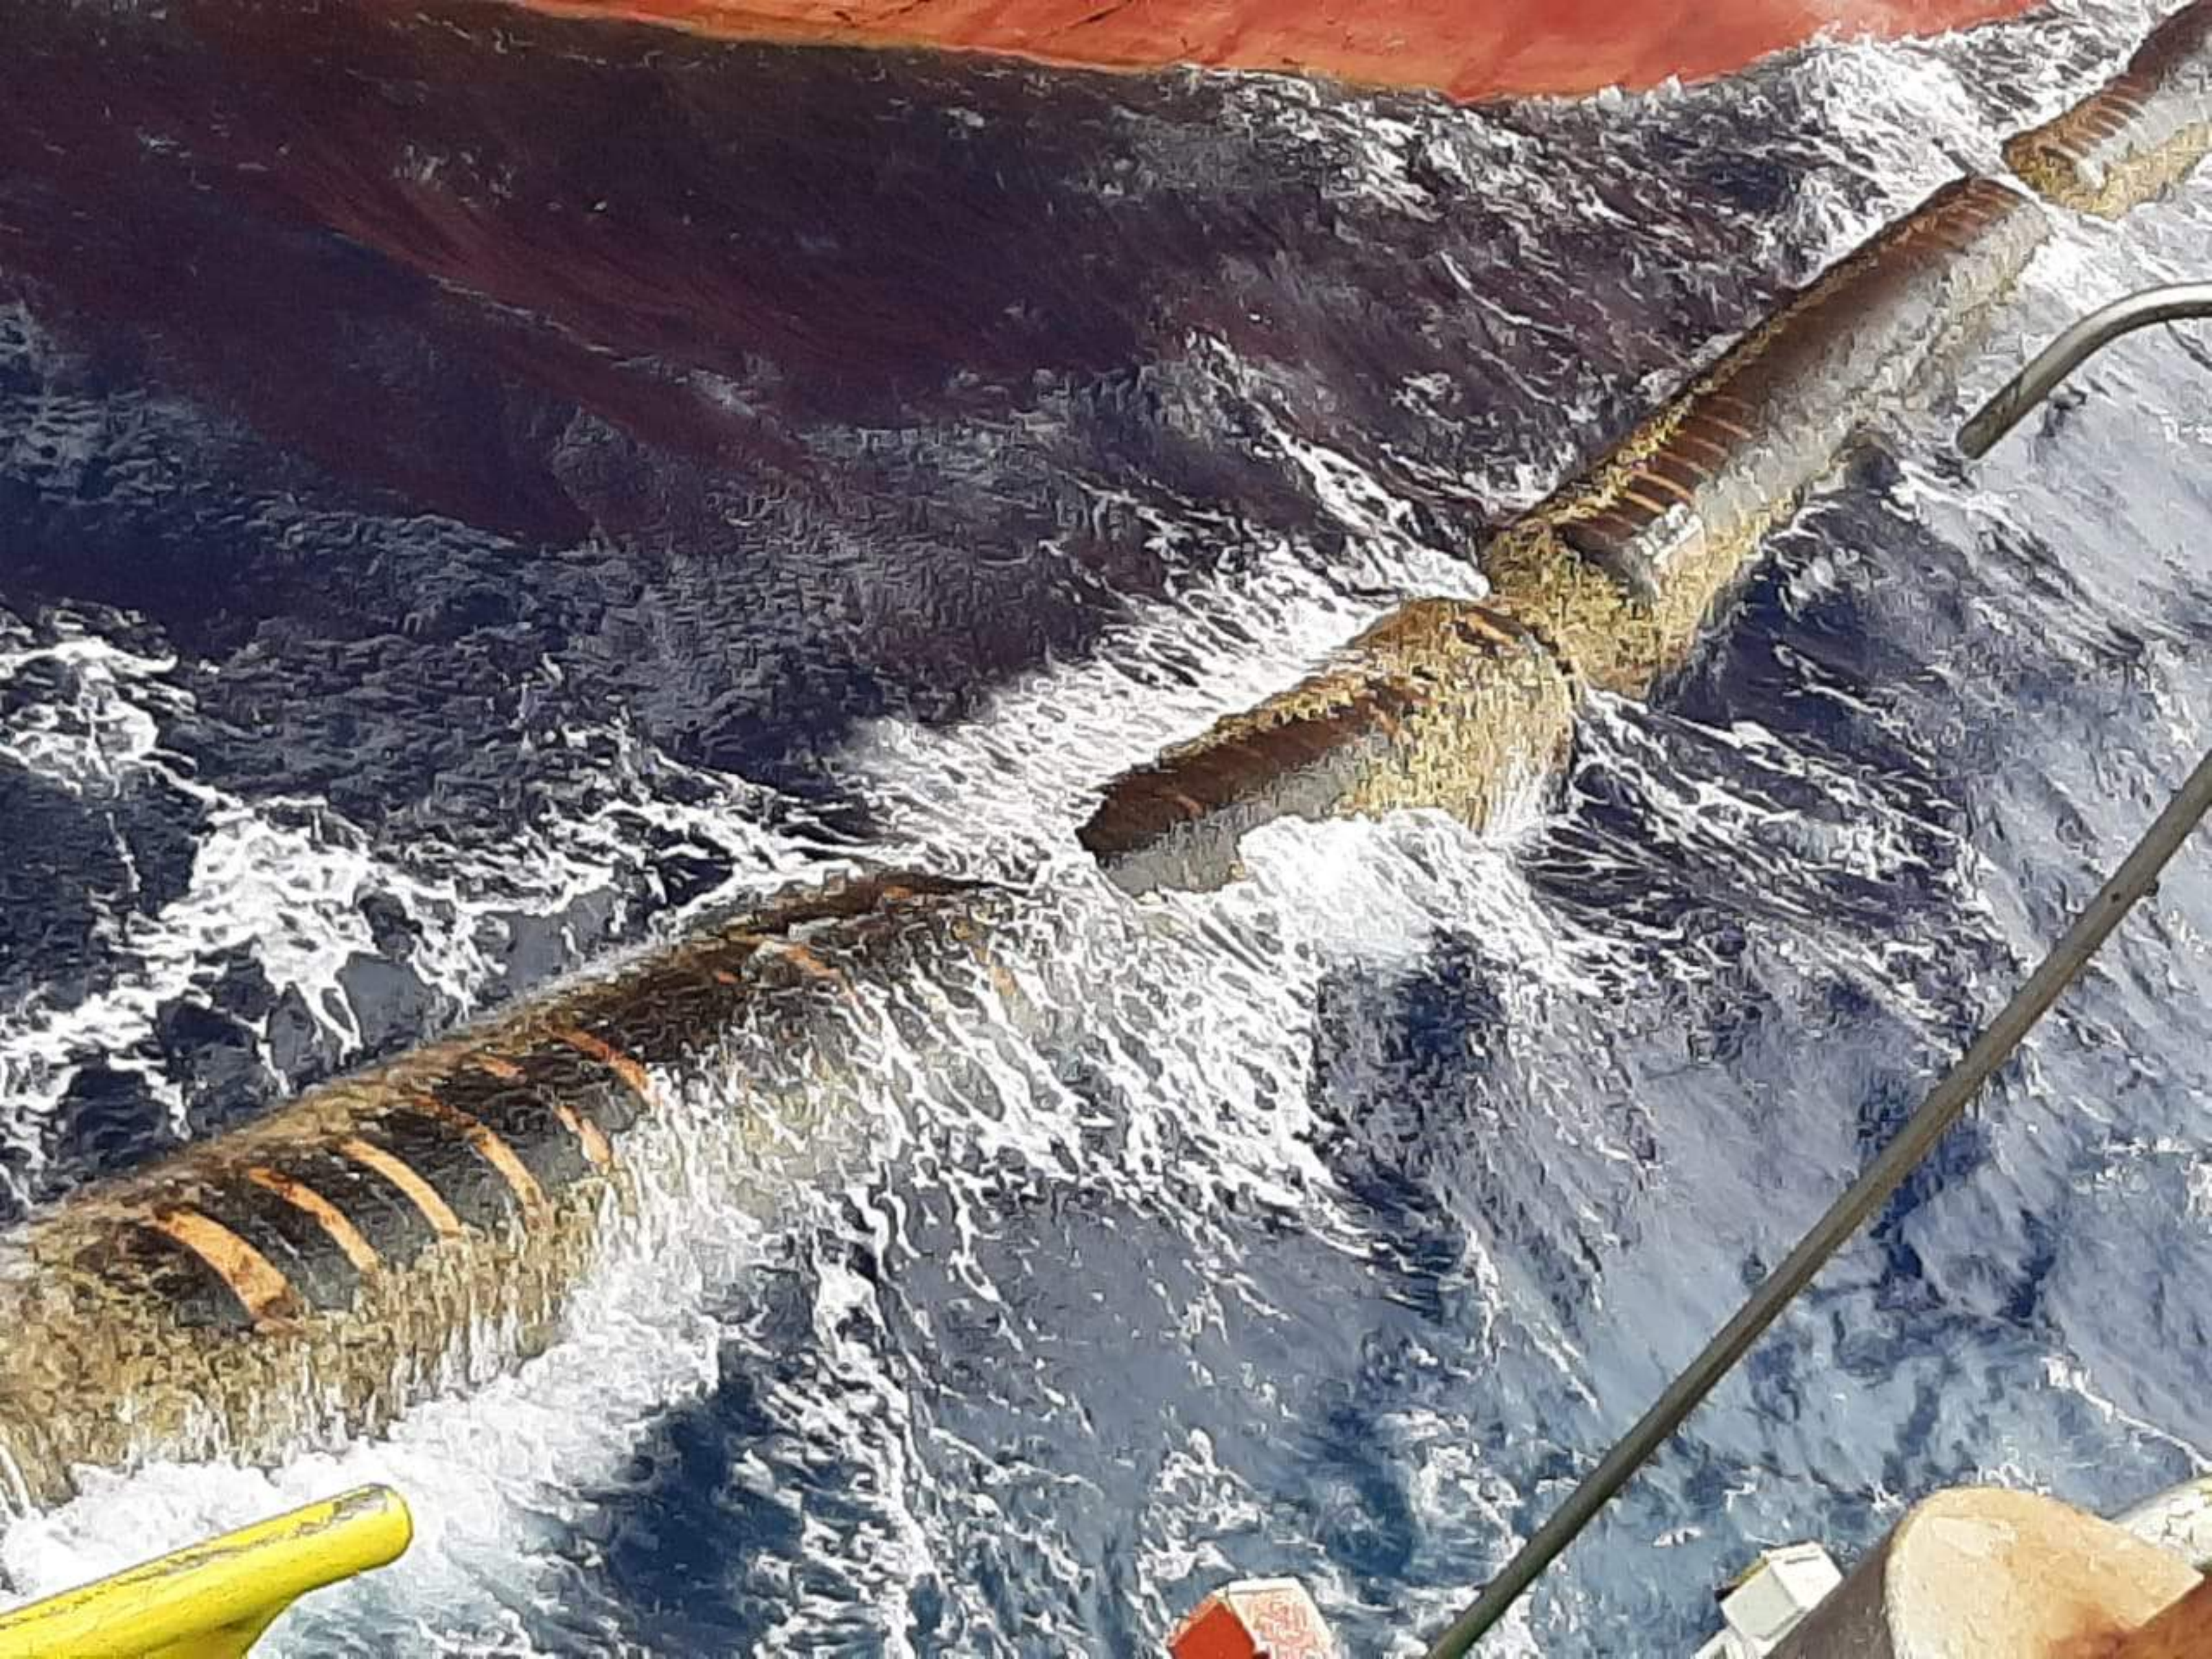
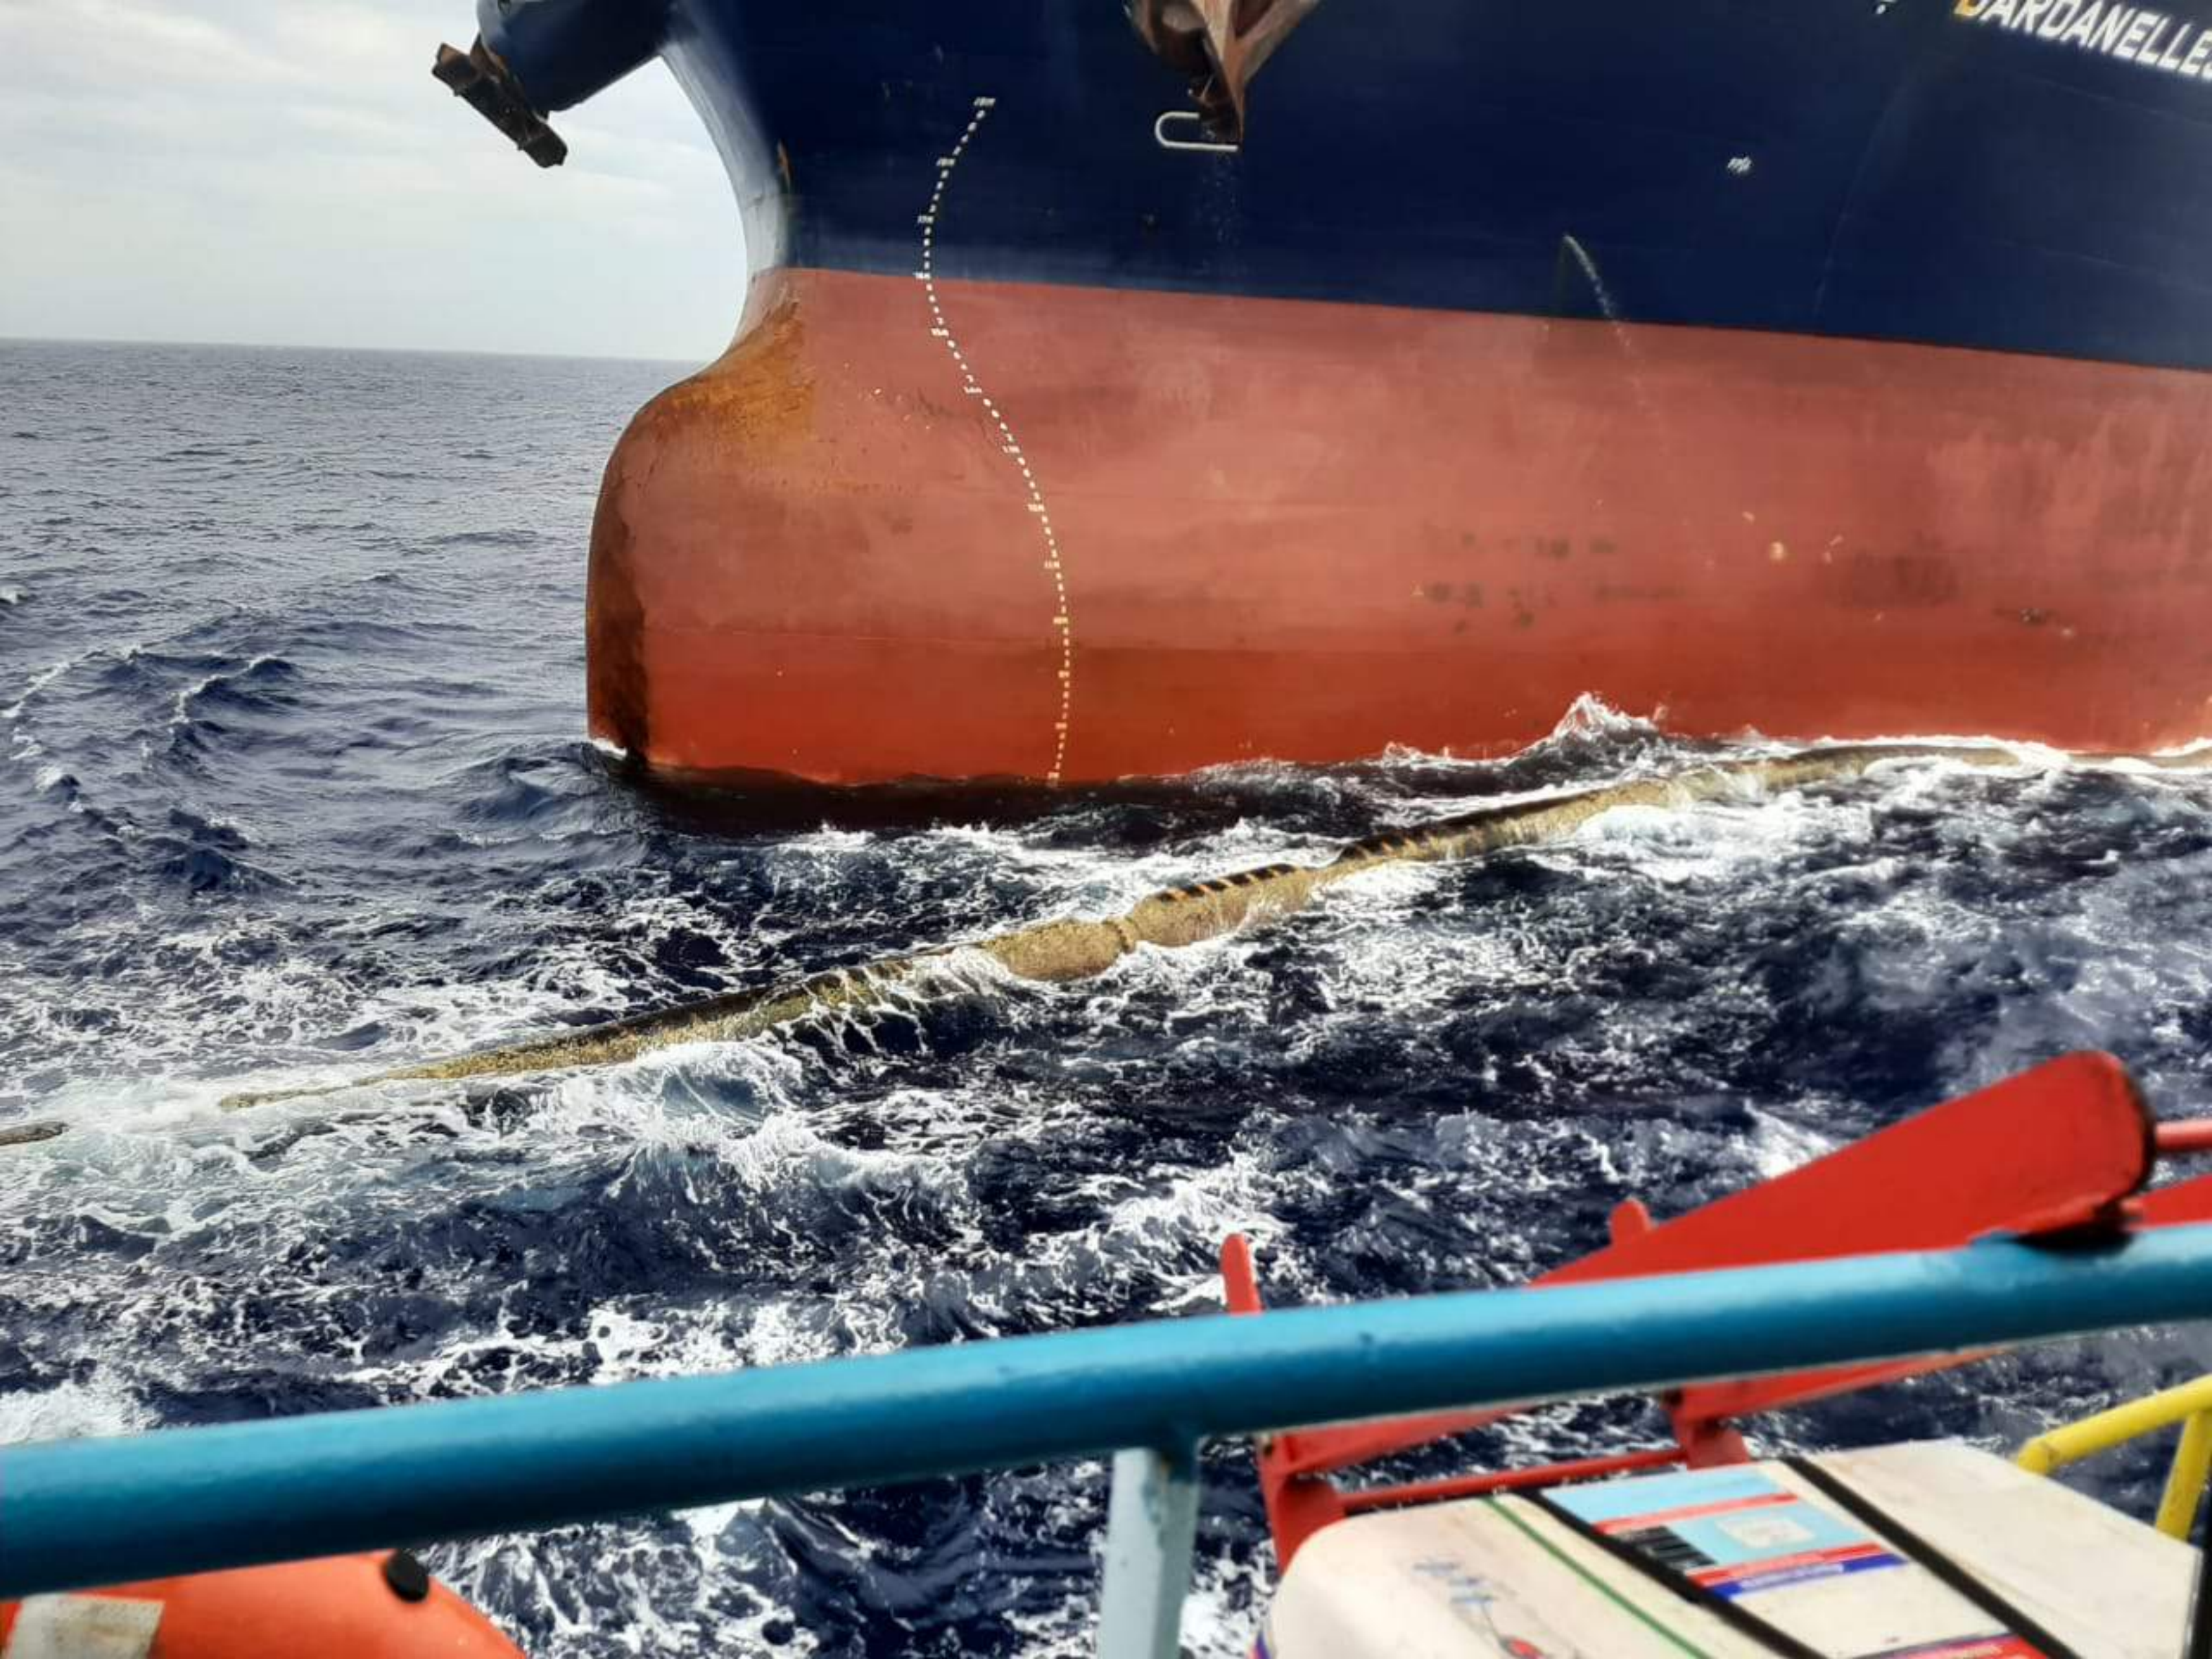
Step 04 – TS Luxento entangled communication and navigation antennas with hawser retrieving rope which is lower than the mooring hose.

- Communication, internet, navigation, anemometer antennas contact with the hawser recovery cable, near the stern of FPSO ES.

- Communication with Tranship insurance company - Done;
- Disseminate the Accident Report to Tranship Fleet- Done ;
- Repair of the damages on TS Luxento- Done ;
- Refresher the training of the Crew on the Stop Work Authority – Next pre-embark meeting.
