Request to leave broken piles
in place, P20101354

Deepwater Horizon - 3/12/2011

3/13/2011 Request to leave-in-place Seven (7) Steel piles, 30" and 36" diameter in the Rigolets; five (5) broke below the mud line, two (2) were cut at the mud line

Coastal Use Permit Number P20101354

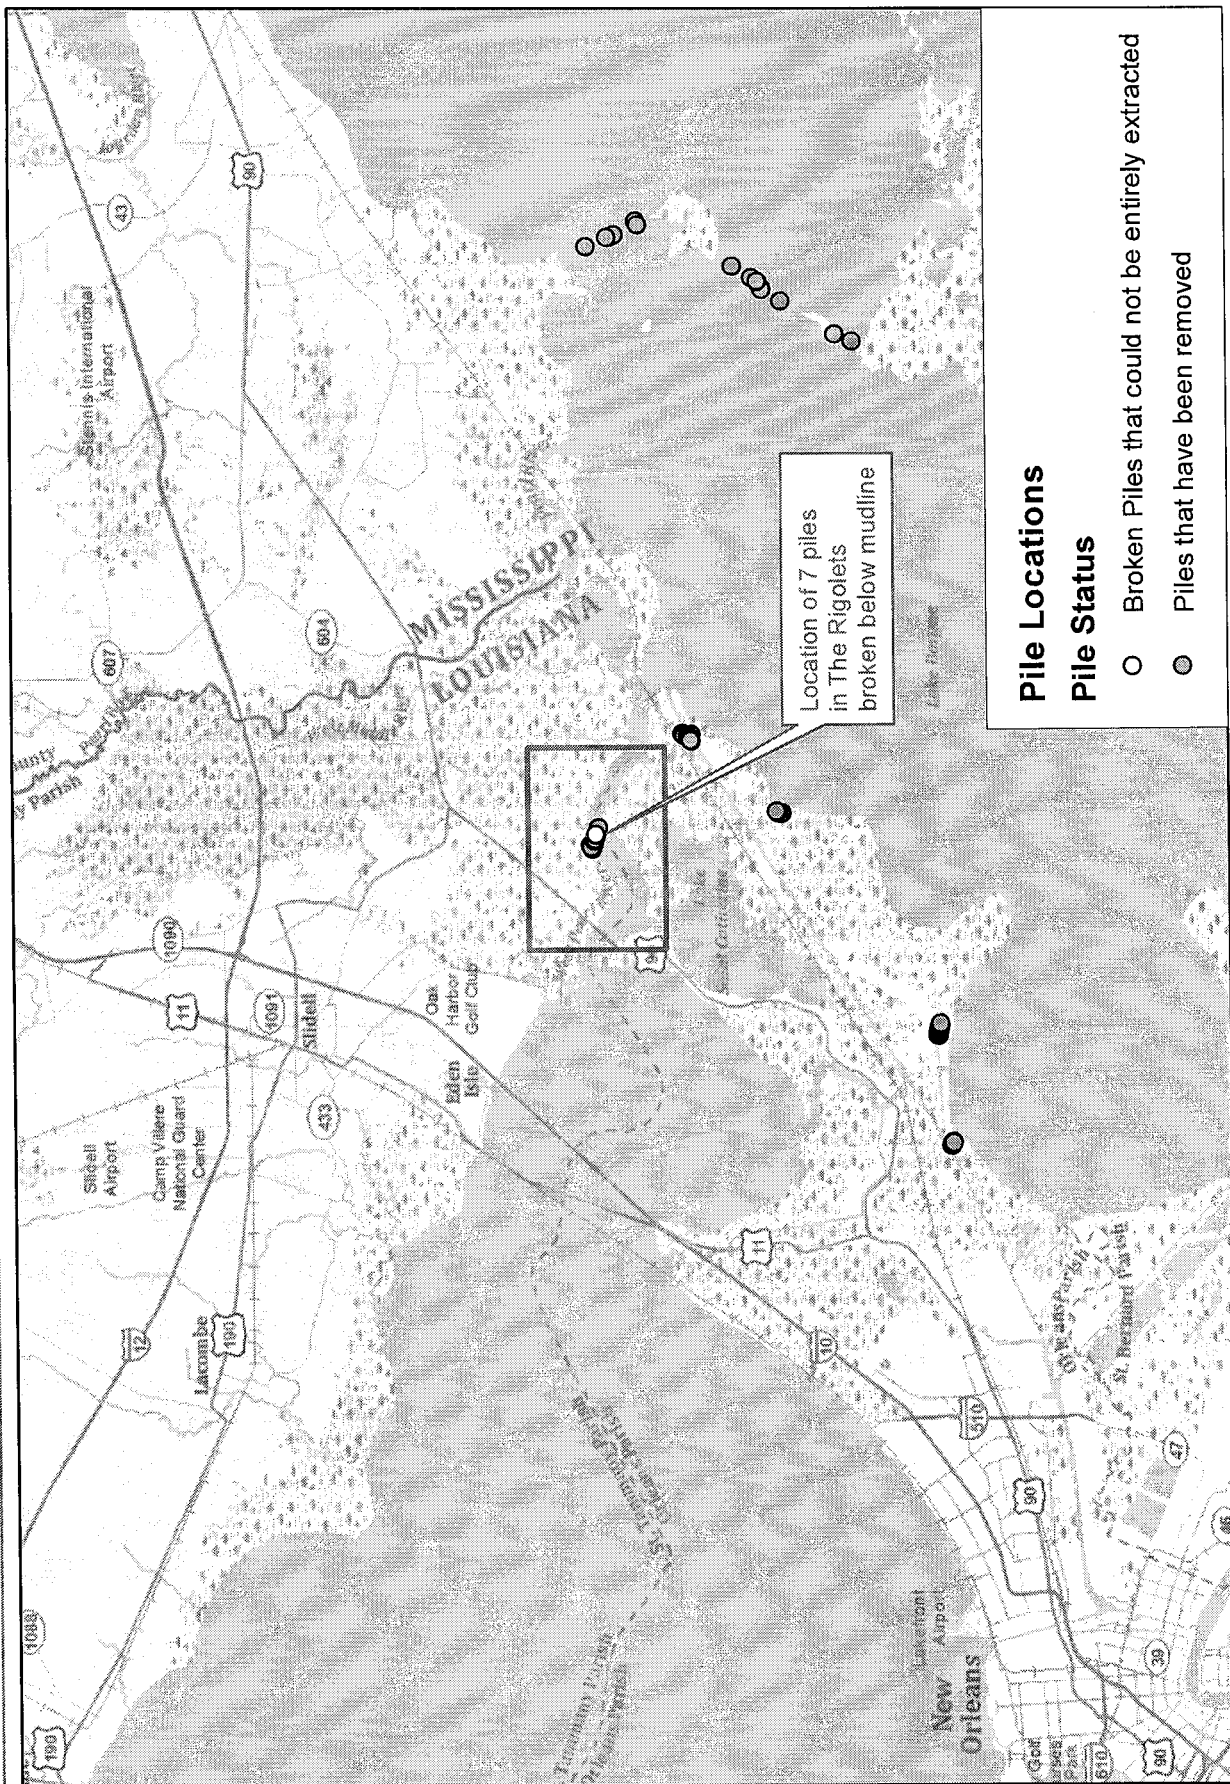
Pile Locations

Pile Status

- ☐ Broken Piles that could not be entirely extracted
- ☒ Piles that have been removed

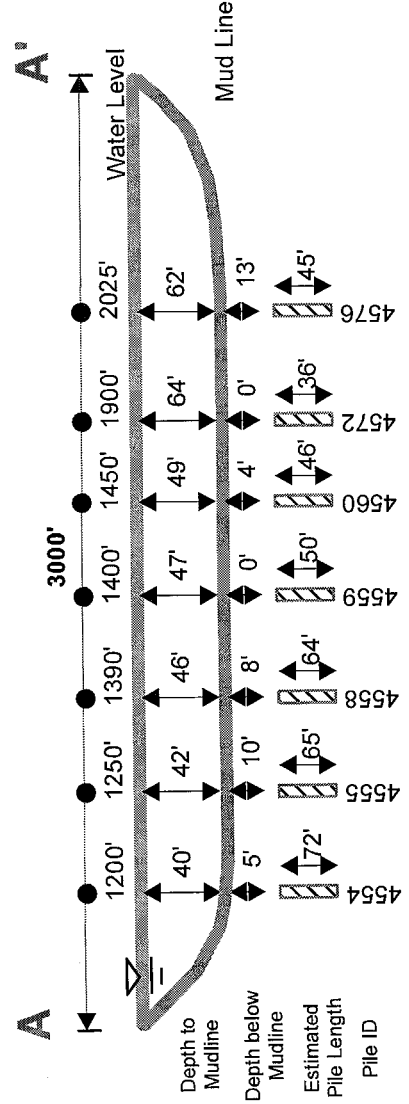
These 7 steel piles, originally ranging in length from 117 to 140 feet, broke during the extraction process on February 13 – 14. Five (5) broke 4 to 13 feet below the mud line. Two (2) others that broke above the mud line were cut at the mud line on February 17.

Reasons that these 7 steel piles stubs could not be removed and could not be driven deeper include the following:

- Currents during flood stage in this area of the Rigolets approach 3 knots which created serious safety exposures to the supporting dive team
- The lack of sufficient pipe wall thickness, poor welding and observed corrosion on all the piles that were removed from the Rigolets led us to believe that the broken, submerged steel would not survive additional mechanical (vibration) energy without disintegrating further; if they disintegrated during this process, it would pose additional and unacceptable safety hazards to our dive team

Because the mud line is relatively deep in this area (40 to 64 feet below the water surface at low water), because no portion of the remaining pile stubs penetrate the mud line, and given that this does not appear to be a dredge maintained waterway, we believe the buried piles pose no future threat to navigation or fisheries in the area.

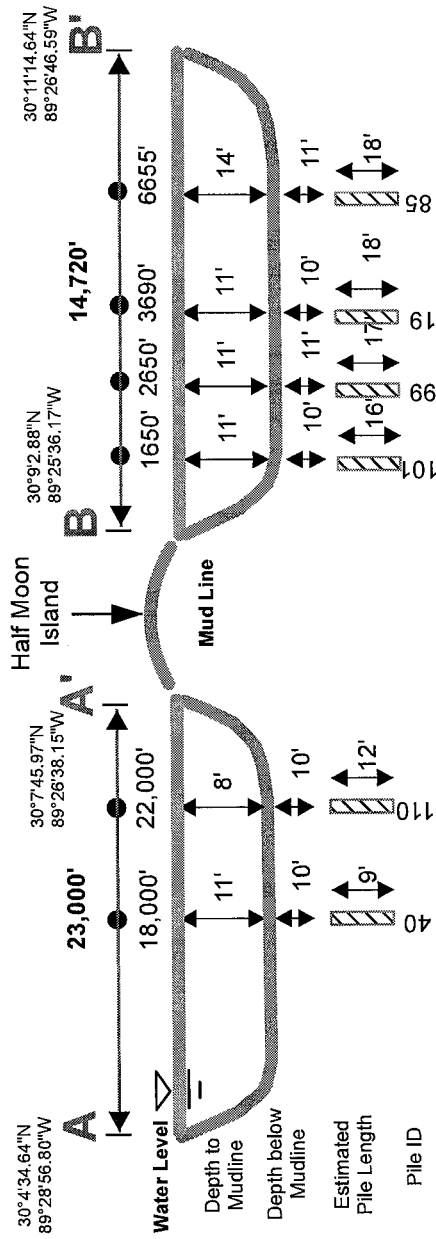
3/18/2011 Request to leave-in-place Six (6) Chromate-Copper-Arsenate (CCA)-treated wooden piles broken and driven below the mud line near Half Moon Island
