# UAS Pipeline Monitoring Burnt Lake Gas COOP Findings Report - TAP 10

May 6, 2019

**Silver Spring Energy Consulting Ltd.**

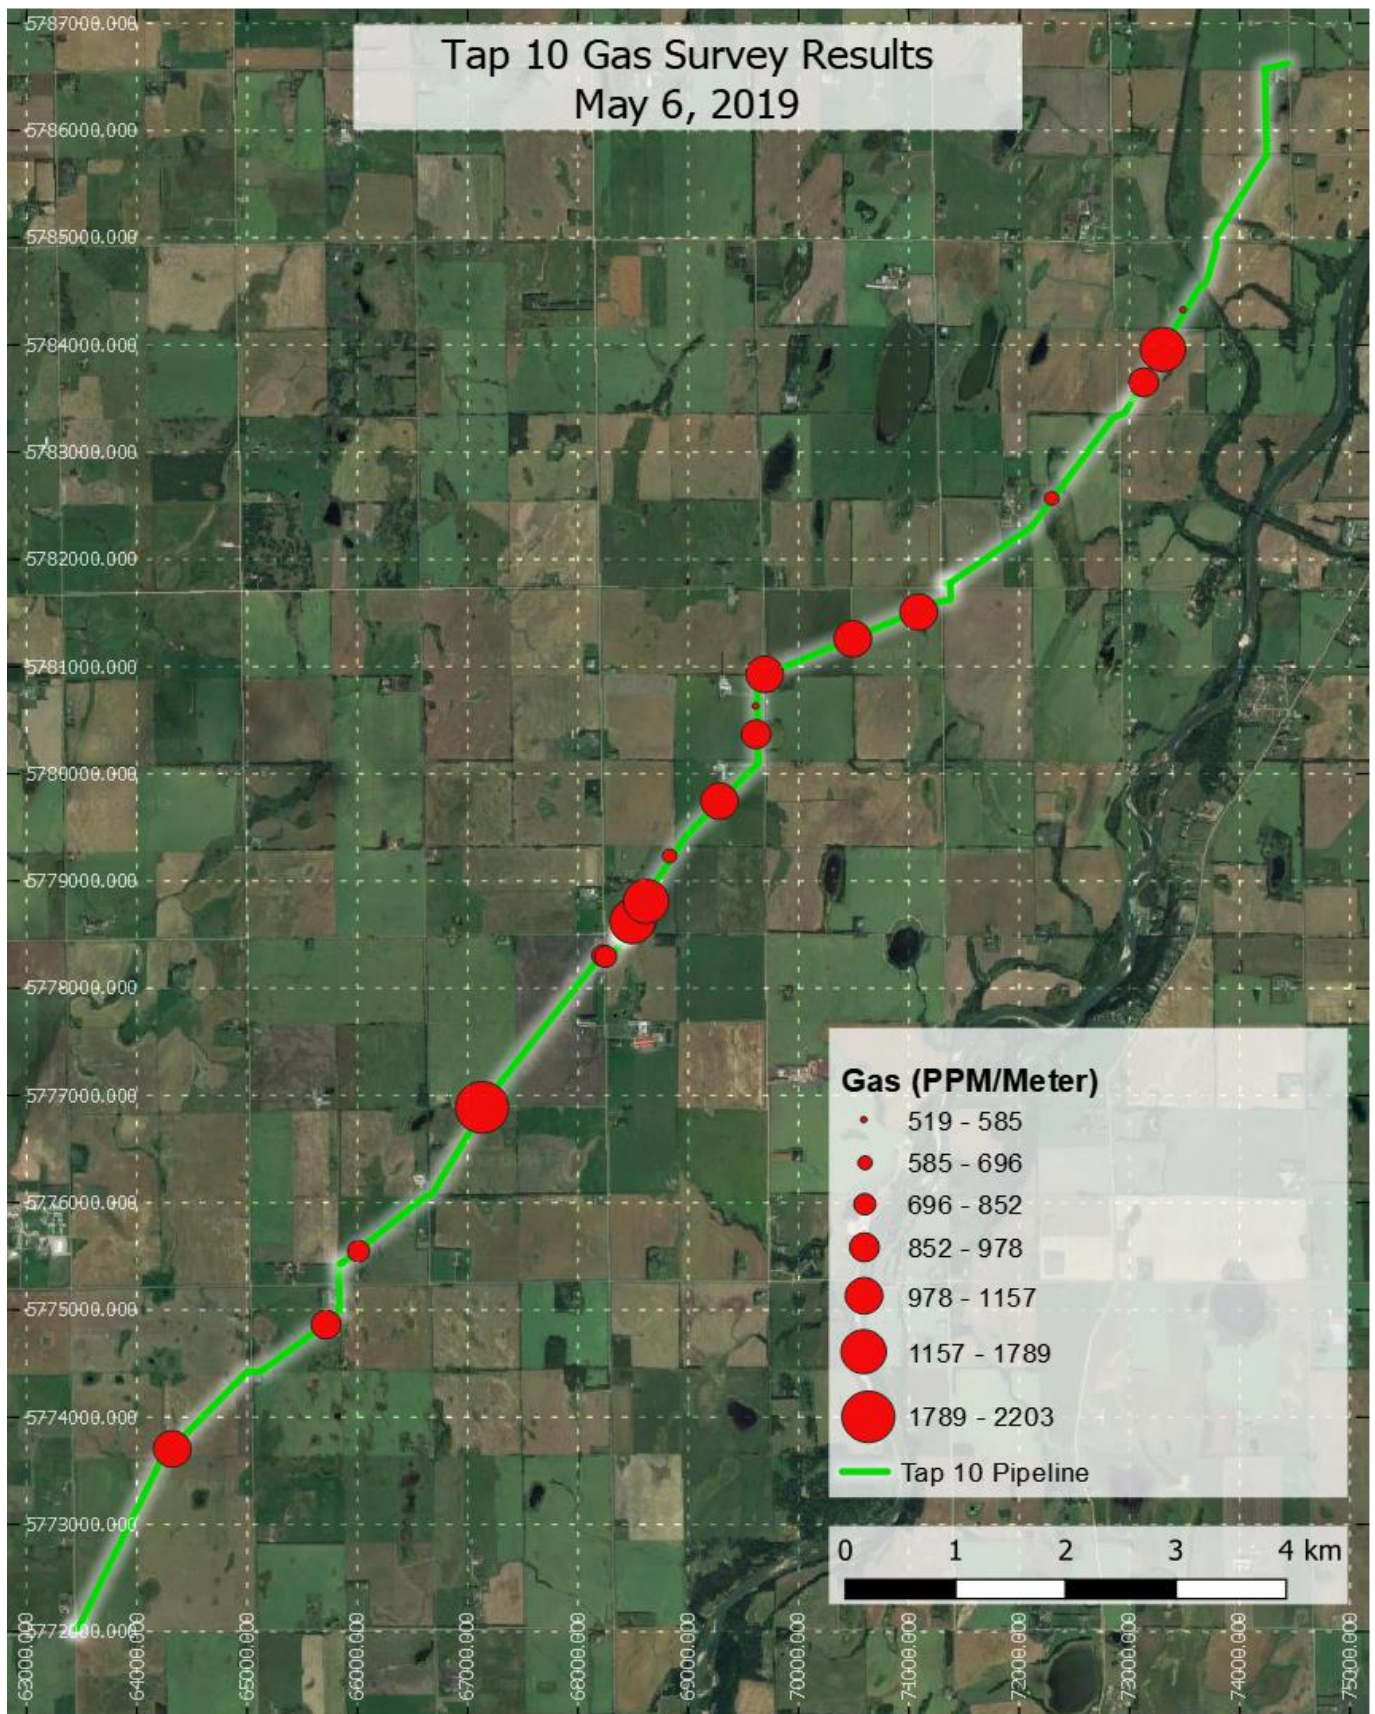
Flight operations were completed successfully. Methane readings collected for entire length of pipeline.

Results were interpreted from direct atmospheric methane readings of entire air column from UAV to ground level. Note that readings beyond 30m from pipeline location were excluded from these results.

Figure 2: Complete Pipeline Survey Map (see link for online interactive version)
