DILAPIDATION REPORT

17 Morrice Street
Lane Cove NSW 2066

TYRRELLS PROPERTY INSPECTIONS PTY LIMITED

Inspection date
2 DECEMBER 2016

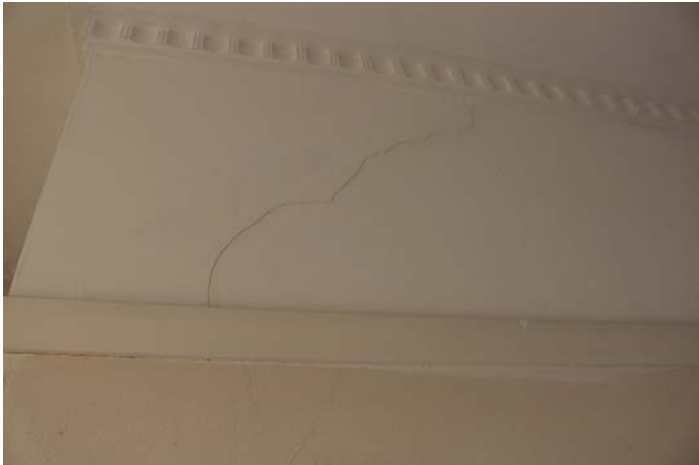
Photo 2.jpg

Item	Description	Photo No.
4.2.1	Entry – oblique cracking to upper east wall above picture rail approx. 700mm in length	2
4.2.2	Horizontal cracking between wall and cornice running length of wall above door	3-4

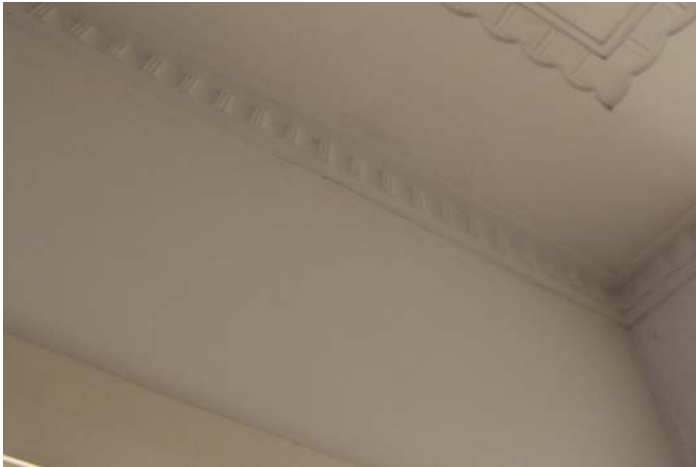
Photo 7.jpg

4.2.3	Cracking to northwest corner join between wall and cornice	5-7
4.2.4	Movement between picture rail and wall at northeast corner	8
4.2.5	Cracking to upper south corner and doorframe to lounge	9

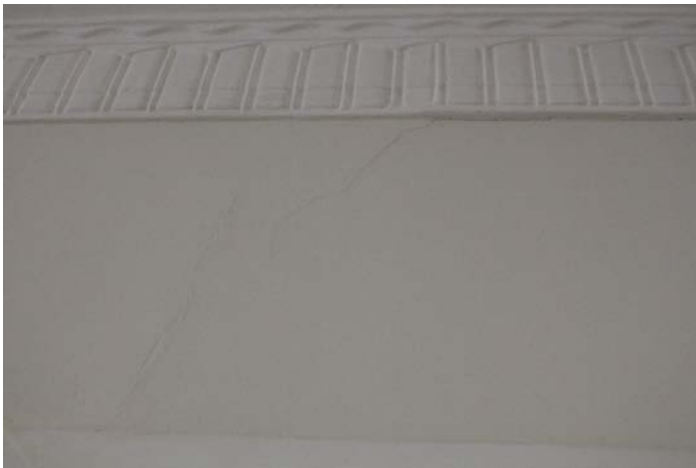
Photo 27.jpg

4.2.20	Lounge – oblique cracking to west wall above door	27
4.2.21	Cracking between south wall and cornice	28-29
4.2.22	Cracking between wall above fire place and cornice	30

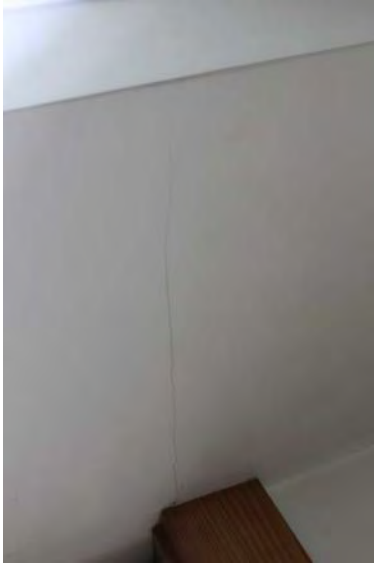
Photo 37.jpg

4.2.26	Movement between encased beam and north wall	34-35
4.2.27	Movement between rear northeast bulkhead and wall	36
4.2.28	Crack to bulkhead ceiling southeast corner	37

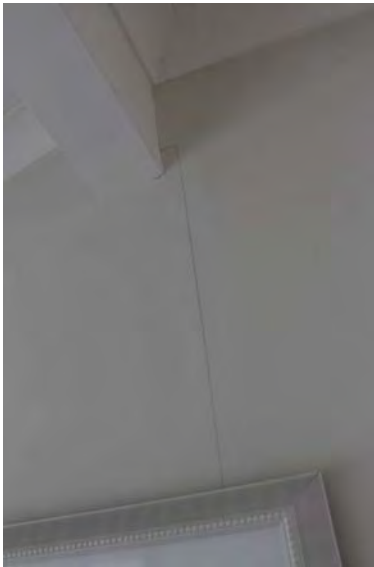
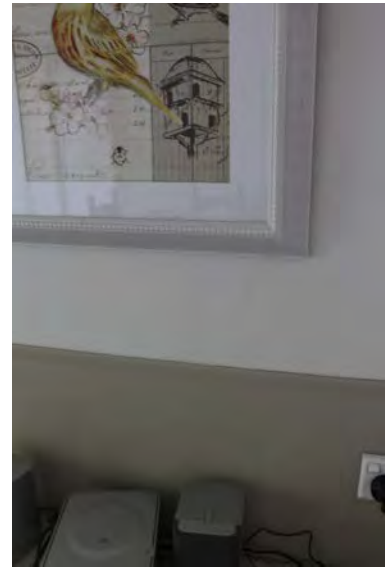
<i>Item</i>	<i>Description</i>	<i>Photo No.</i>
4.2.30	Vertical crack starting from south wall encased beam and ending at splashback panel	39-40
4.2.31	Movement to light well architrave mitre joins	41
4.2.32	Bedroom 1 – oblique cracking to east wall northeast corner above doorway	42
4.2.33	Horizontal cracking between wall and cornice starting from above entrance doorway to southeast corner	43-46
4.2.34	Movement to lower west skirting below window	47
4.2.35	Remediated/recoated crack to west wall above doorway to enclosed veranda	48
4.2.36	Enclosed veranda – remediated crack to east side masonry wall above doorway	49
4.2.37	Movement between doorjamb and lintel	50

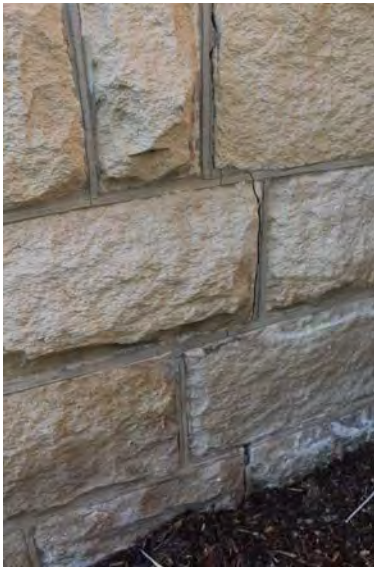
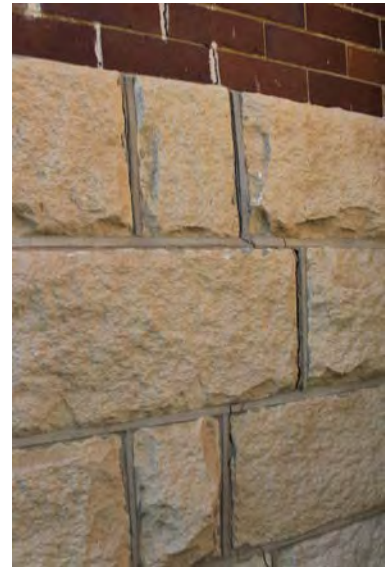
<i>Item</i>	<i>Description</i>	<i>Photo No.</i>
4.3.1	West elevation – cracking starting from ground through stone footings and then obliquely up to lower corner of south facing window	51-54

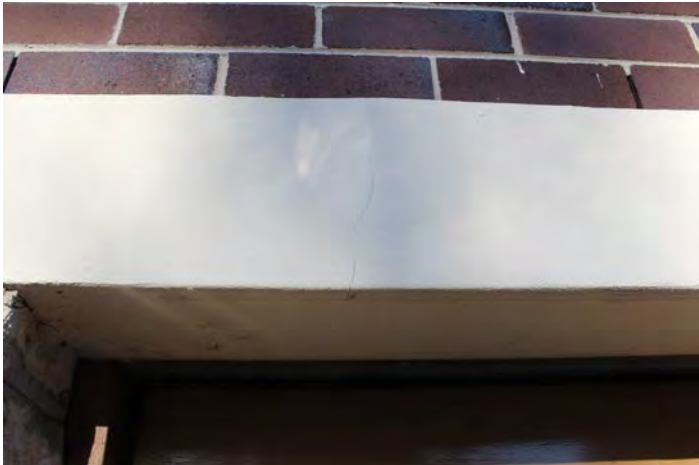
Photo 55.jpg

4.3.2	Hairline crack to top of upper left corner garage door opening	55
4.3.3	Crack to entrance pathway adjacent common path	56
4.3.4	General photographs of driveway showing cracks and overall neglect	57-61

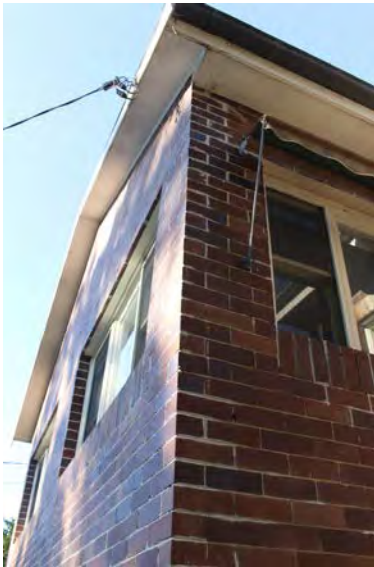
Photo 63.jpg

4.3.5	Cracking to entrance pathway adjacent AC unit	62
4.3.6	Remediated brickwork to southwest corner	63
4.3.7	South elevation - cracking to stone footings adjacent downpipe southwest corner	64

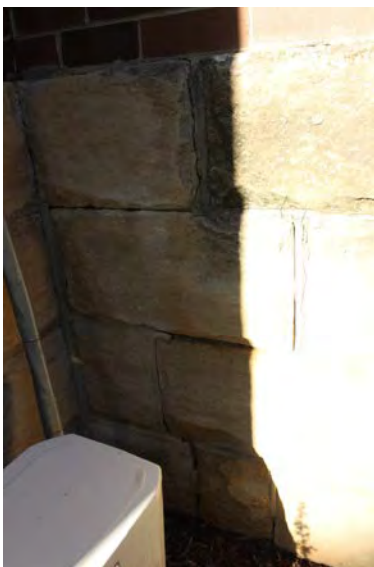
Photo 65.jpg

4.3.8	Cracking to stone footings to west wall below entrance landing	65
4.3.9	Cracking to eave board adjacent AC service penetration	66
4.3.10	Cracking to entrance pathway adjacent gully trap PVC sewage lid	67

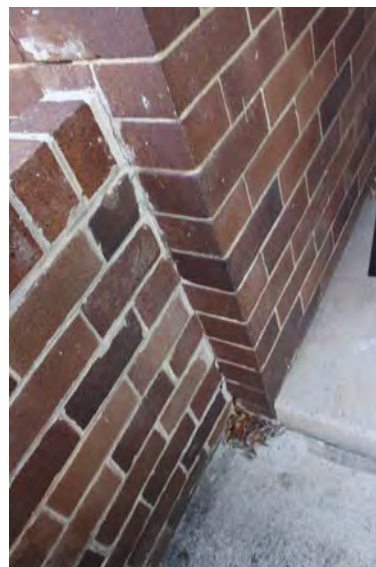
Photo 72.jpg

4.3.11	Cracking to footings adjacent ramp	68-70
4.3.12	Movement between lintel and top of entrance door trim	71
4.3.13	Movement between landing balustrade and dwelling wall	72

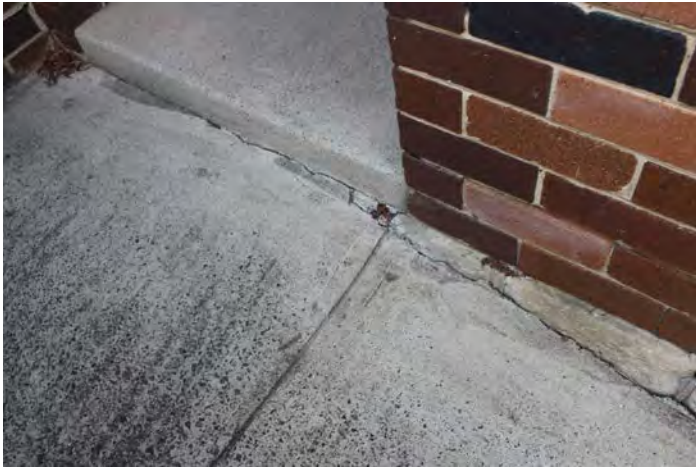
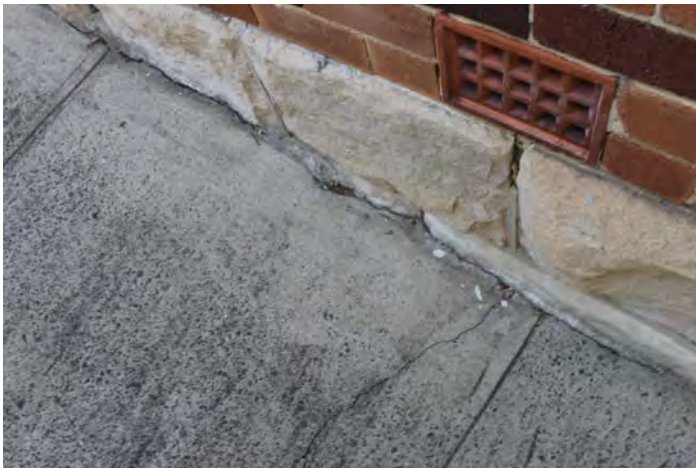
4.3.14	Movement between ramp path and entrance landing	73-76
4.3.15	Crack to ramp path	77
4.3.16	General movement/loose mortar to footings below lounge window	78

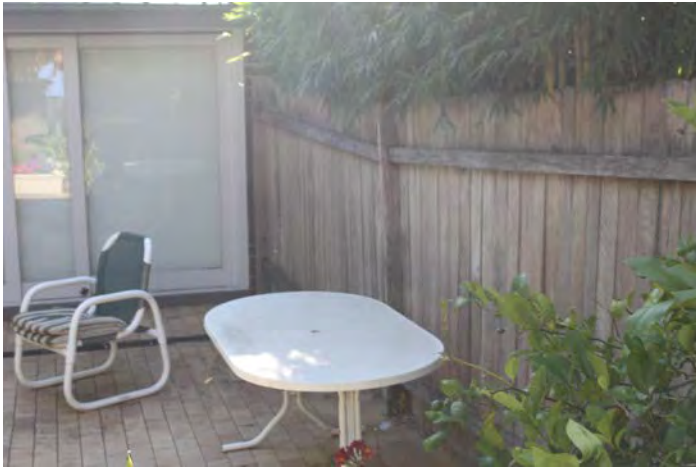
Photo 91.jpg

4.3.20	Lean and general neglect to north side fence	87-91
4.3.21	General cracking and neglect to upper rear yard paving	92
4.3.22	Garage – large crack running length of south wall	93-95

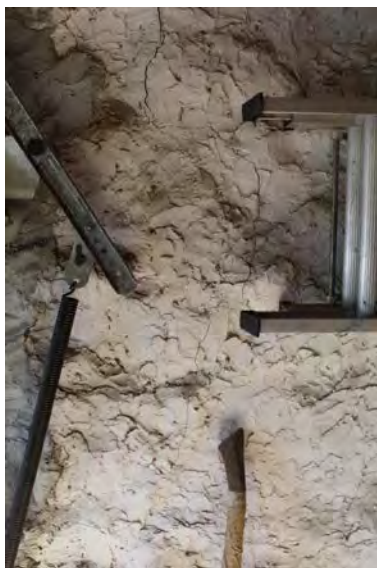
Photo 99.jpg

4.3.23	Cracking to north wall approx. 1.2 metres in length	96-97
4.3.24	Cracking to north wall adjacent garage door opening running approx. 2.0 metres	98-99
