Asbestos Survey 2013

The Owners Corporation for
Church Street Corporate Centre
410 - 422 Church Street
Parramatta NSW 2151

Strata Plan 58457

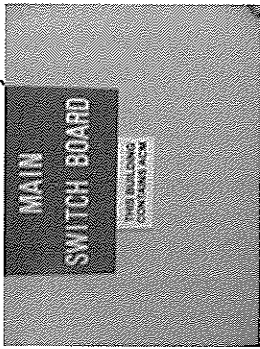
Common Property	No asbestos containing materials (ACM) identified.						
Photo 50: ACM sign fixed to main switchboard entry door
