## Dilapidation Assessment Report

Prepared for: Cape Cod Australia Pty. Limited  
Job address: 70 Middle Street, Kingsford.  
Property Owner/s: Mrs. Jessica Mander-Jones.  
Report reference: **RANDWICK COUNCIL**  
Development Application No: not available  
Date of assessment: 15<sup>th</sup> September 2017.

**Re: Dilapidation Report – No. 70 Middle Street, Kingsford.**

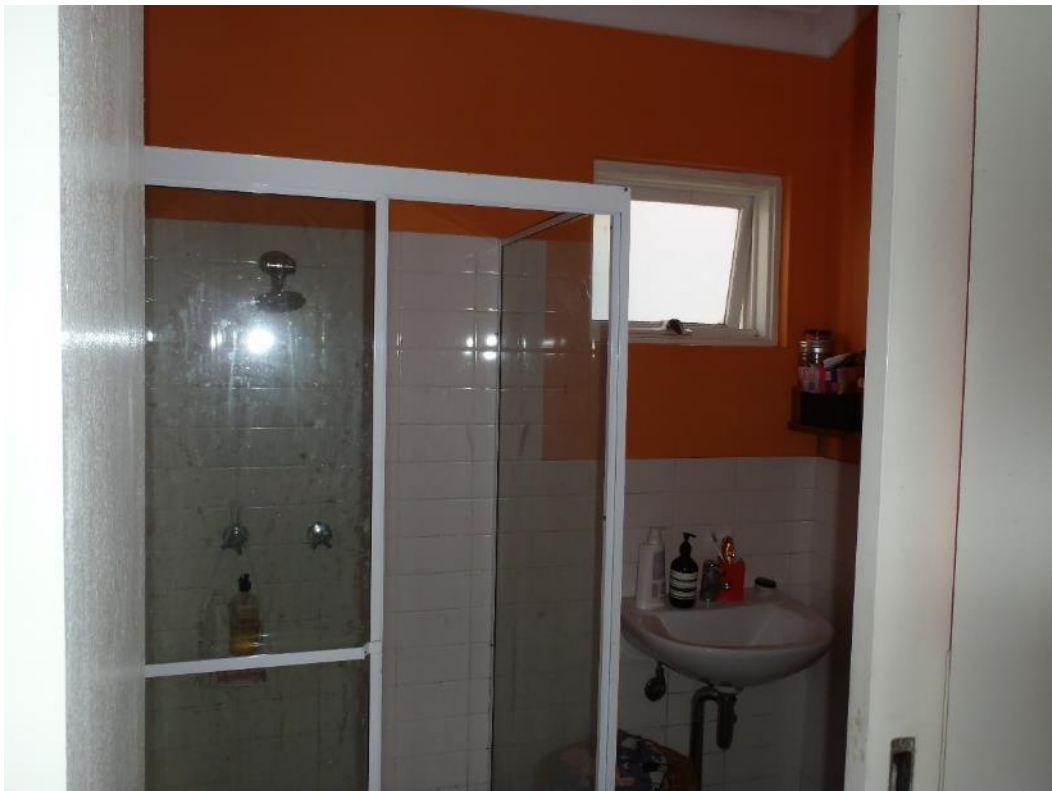
We did not observe any recent cracking to the ceramic wall tiles or to the painted cement rendered walls above the wall tiles. **[Photograph 31]**

**Photograph 30** shows mould growth and separation cracking between the cove profiled plaster cornice and the wall surface in the north-western corner in the Ensuite.

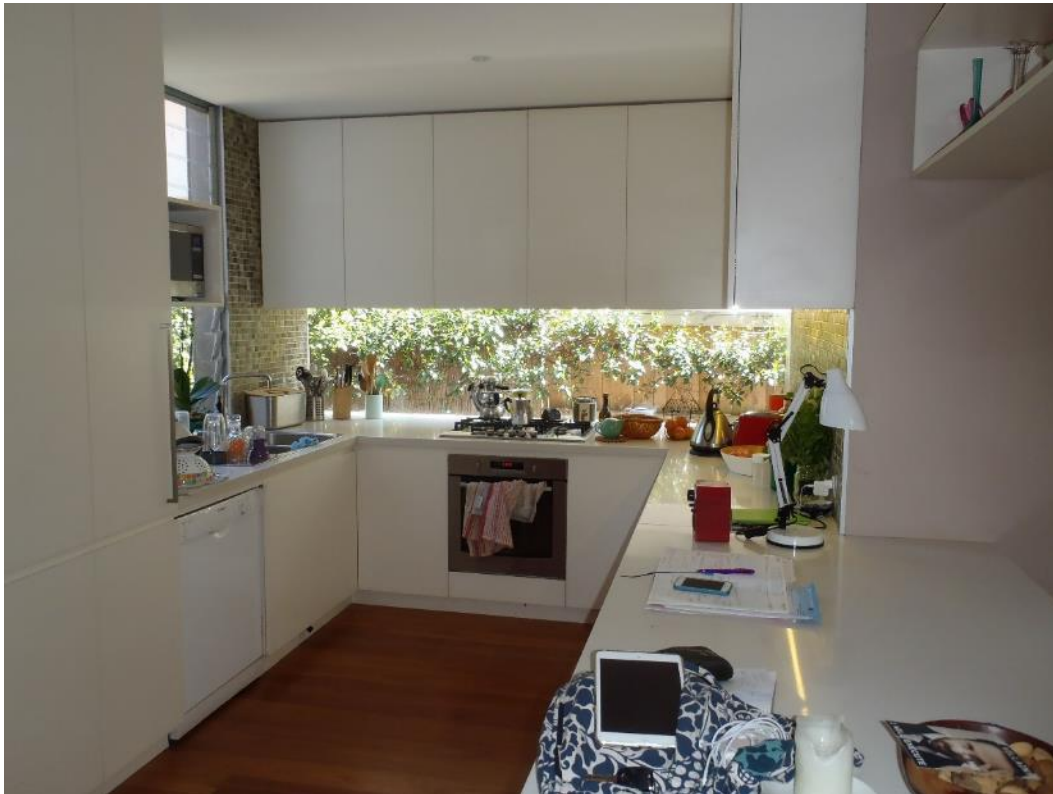
We noted separation cracking the tile grout at the wall to bench junction along the southern wall. **[Photograph 46]**

**Photograph 46** shows separation cracking the tile grout at the wall to bench junction along the southern wall of the Kitchen.

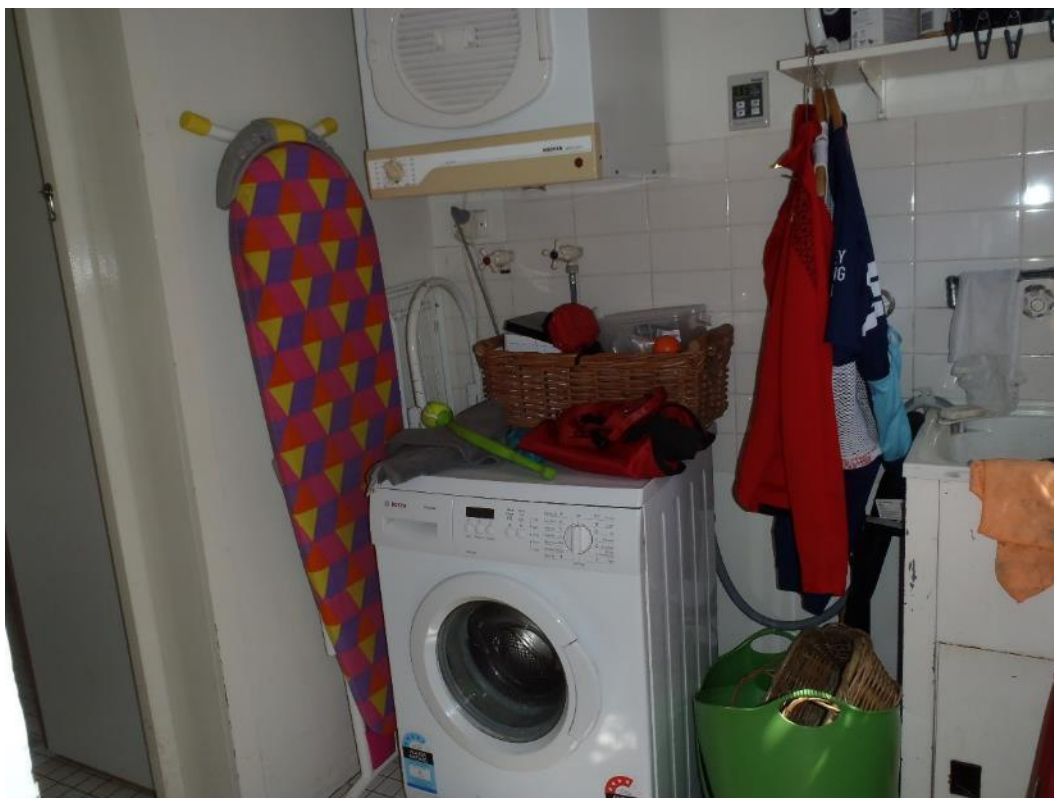
We noted cracking to the glass infill to the Laundry door. **[Photograph 59]**

**Photograph 59** shows cracking to the glass infill to the Laundry door.
