# The Dead VexRiscv

A bitstream-configuration bug in the openXC7 toolchain

How a dead serial console on the Arty S7 was traced to two missing BRAM width bits — and fixed

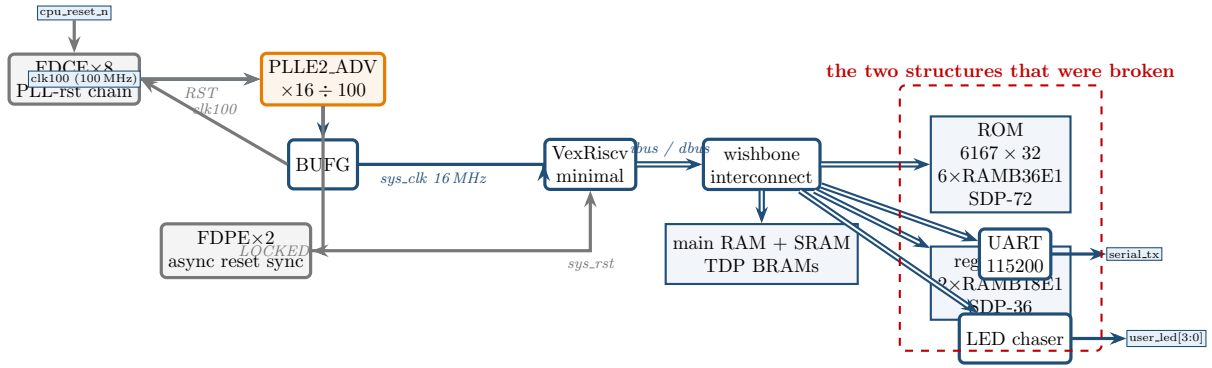
Figure 1: The LiteX SoC on the Arty S7. Clocking and reset are standard; the interesting parts are the two SDP (simple-dual-port) BRAM structures — the BIOS ROM and the CPU register file — highlighted in red.

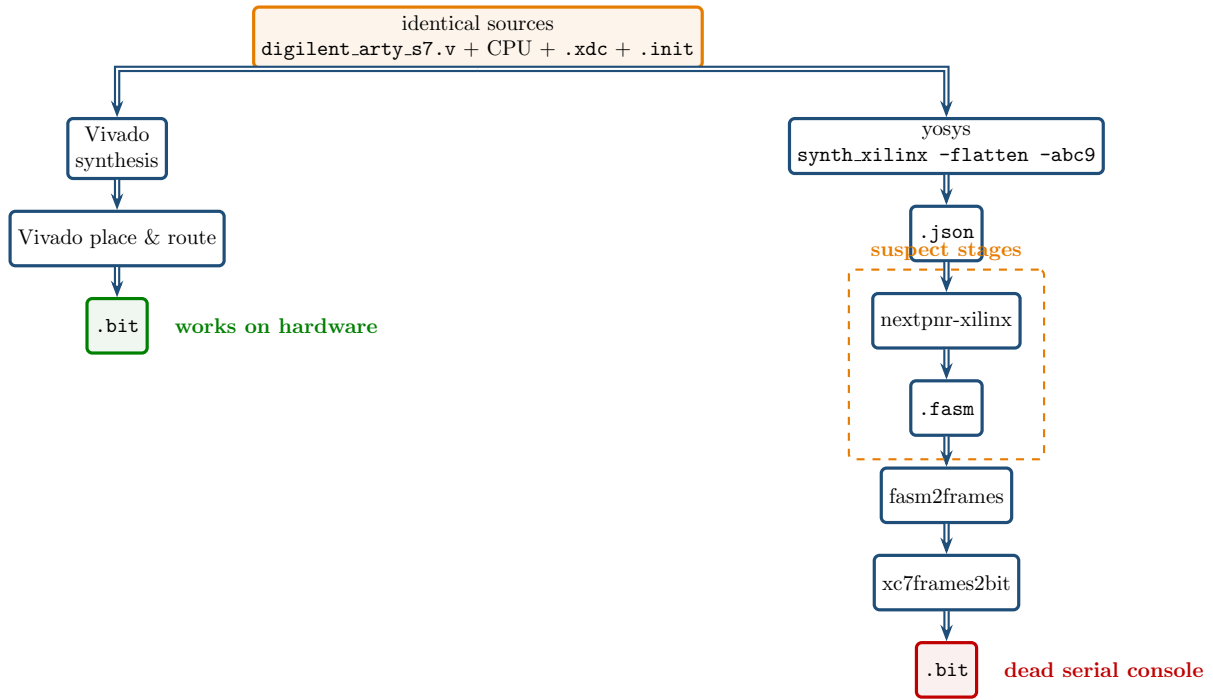
Figure 2: The two implementation flows. With identical inputs, a difference in behavior must originate in the implementation — the prime suspects are the openXC7 place-and-route and bitstream-generation stages (orange).

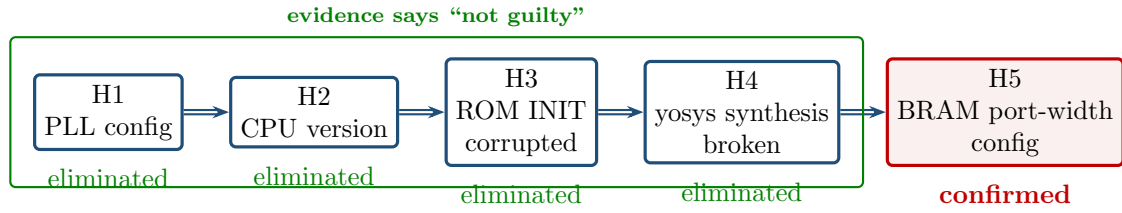
Figure 4: The hypothesis chain. Four plausible culprits were cleared with direct evidence; the fifth — a configuration-bit error in the BRAM tiles — explained every observation.
