**ABBOTT
ADD**

TECHNICAL SERVICE BULLETIN

SUBJECT:
Extended Waste Option

PRODUCT:
AxSYM® (83)

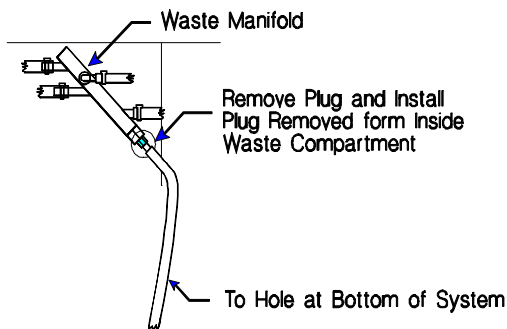
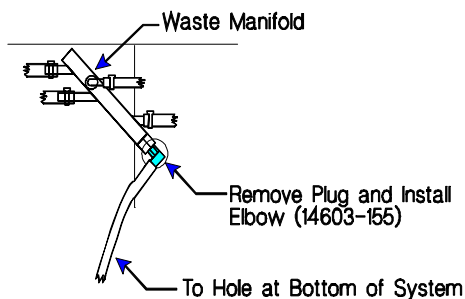
Figure 1

SERIAL NUMBER
300 to 536

SERIAL NUMBER
GREATER THAN
1000

S/N \geq 1000 Apply Teflon® tape and install the Elbow Fitting (14603-155) into the opening and direct the output down.

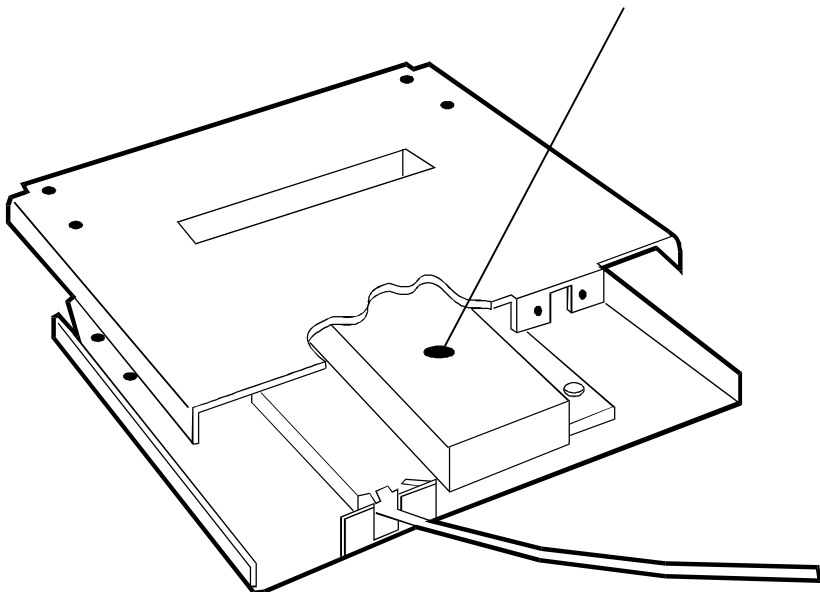
Figure 2

Pivot point were shoulder washers are installed

Where screw and washer secure the counterweight

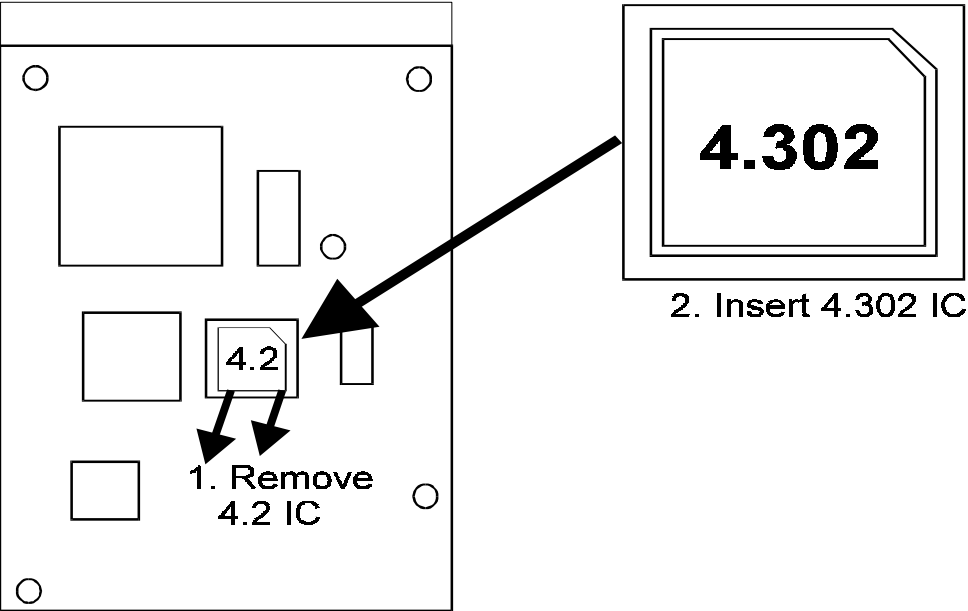
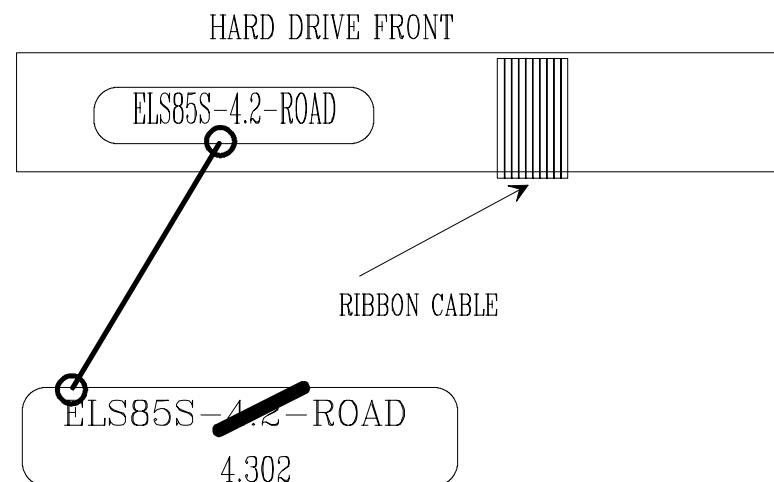
Figure 3.

Component side of Hard Drive

11. Install the new Speaker/Disk Drive bracket.
12. **Using the chip extraction tool provided** with the rev. 4.302 firmware, remove the 4.2 firmware from the Hard Drive and install rev. 4.302 firmware. Refer to figure 2 for location and proper orientation of the chip. Remark the Hard Drive with 4.302, refer to figure 3.

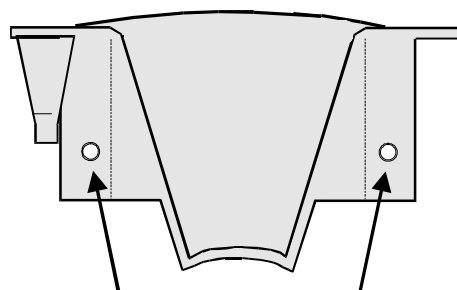
FIG 1

Remove screws

1. From the MAIN Menu perform a shutdown (F2). When instructed turn the AC power off.
2. Remove the Matrix Carousel Cover.
3. Pull the removable air deflector out.
4. Rotate Carousel until the red dot on the Carousel is facing out.
5. Remove the Matrix Carousel.
6. Remove the inside air deflector - 2 screws (refer to Fig 1).
7. Install the new air deflector in reverse order.

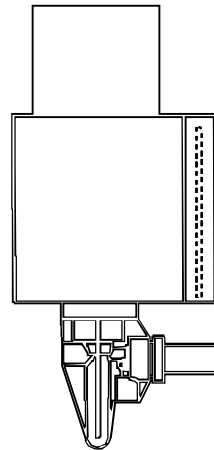
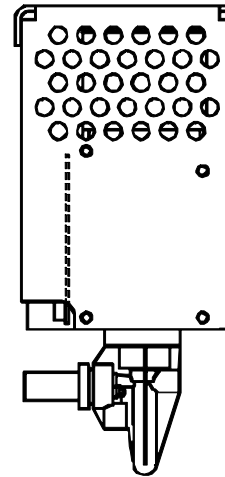
Figure 1

WITHOUT CAGE

WITH CAGE

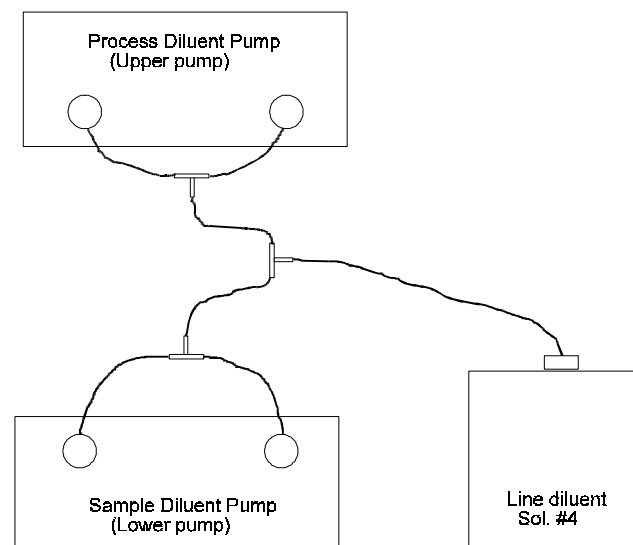
Figure 3 - Diluent Pump Inlet Tubing Routing

IMPORTANT: Review Figure 3 before attaching any tubing to the diluent pump (front) input side. Once any of the new tubing is installed it cannot be removed. It is a very tight fit. Cutting the tubing back off makes it too short! (It may be helpful to use Figure 3 and label the tubing "upper" and "lower" before continuing.)

10. Using Figure 3, install the correct ends of the Buffer Supply tubing set to the inlet ports on the sampling pump. Hold the back of the pump while installing the tubing. Push the polyurethane tubing completely onto the inlet ports. Wetting the tubing with DI water can be helpful in installing the tubing.
11. Install a tubing tie wrap (14276-108) over the tubing at the inlet ports as shown in Figure 2. Do not use cable tie wraps on tubing. Use only the tubing tie wraps provided in the TSB kit.
12. Carefully secure the sample diluent pump to the Supply Center back wall. Be sure not to crush any tubing!
13. Remove the upper (processing) diluent pump from the Supply Center wall.
14. Remove the two 6" pieces of tubing from the circle "T" fitting to the output (back) side of the sample diluent pump.

19. Using Figure 3, install the correct ends of the Buffer Supply tubing set to the inlet ports on the processing pump. Hold the back of the pump head while installing the tubing. Push the polyurethane tubing completely onto the inlet ports. Wetting the tubing with DI water can be helpful in installing the tubing.

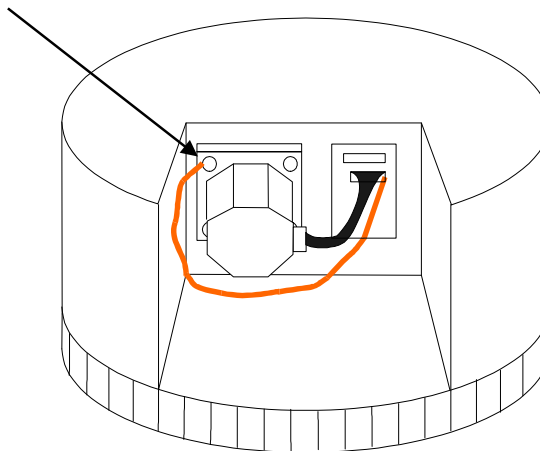
Figure 3

Ground Connection

1. During removal, check the area of the motor body where the ground screw is attached. If the area is brush metal, do not remove the motor from the bracket. Steps 3 to 16 are not required for that Motor Assembly
 2. Label motors as they are removed. The Process and Matrix Motors are the same size and type.
 3. Note the orientation of the of the motor as it is mounted on the bracket.
 4. The motors have four mounting holes. Note/mark which is “used to attach the ground wire”. Refer to Figure 1.
3. Turn over the Transfer Assembly, and remove connector to the R-Axis Motor. Refer to Figure 3.

4. Remove the four screws holding the R-Axis Motor. Mark which mounting hole is "used to attach the ground wire".
