ABBOTT ADD	INDEX INSTRUMENT SERVICE ADVISORY
--	--

PRODUCT: ALCYON (TM) 300i Rev 1 (120)	DATE: 17-AUG-1999
---	-----------------------------

ABBOTT ADD	INSTRUMENT SERVICE ADVISORY
--	------------------------------------

SUBJECT: Dual Voltage Heater	ISA#: 120-018
ORIGINATOR: Emil Jivan	PRODUCT: ALCYON® 300i Rev 1 (120)
APPROVED: Kathy Jennings 17-AUG-1999	EFFECTIVITY DATE: 17-AUG-1999

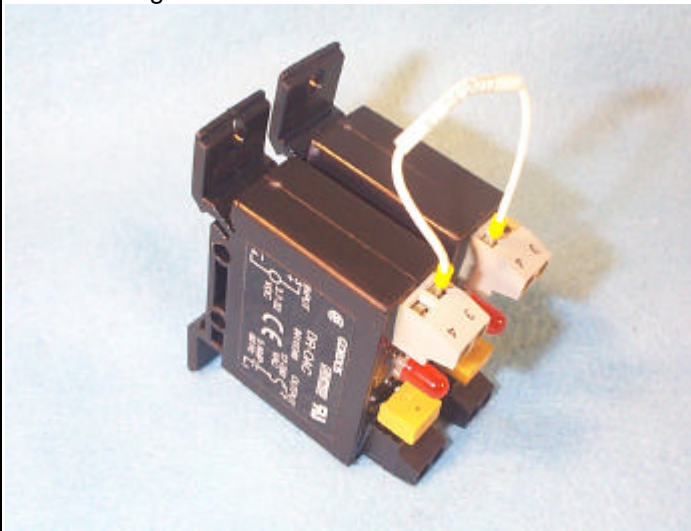
Figure 2

| 1 | Connect Jumper Cable between Terminal 3 of one Relay and Terminal 4 of the other Relay. Secure Cable by tightening the screws. | See Figure 2. |

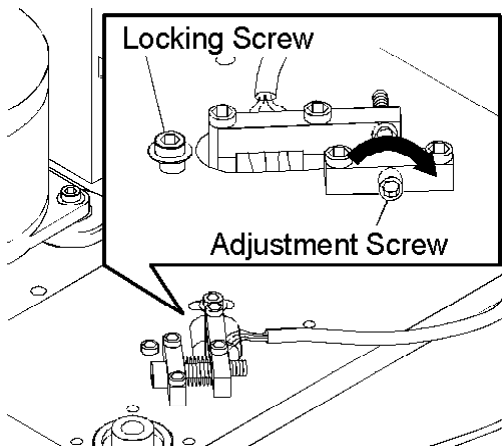
Figure 1

To adjust the Carousel clockwise

b) turn the Adjustment Screw clockwise (see Figure 1) to adjust the Carousel in a clockwise direction OR turn the Adjustment Screw counter-clockwise (see Figure 2) to adjust the Carousel in a counter-clockwise direction.

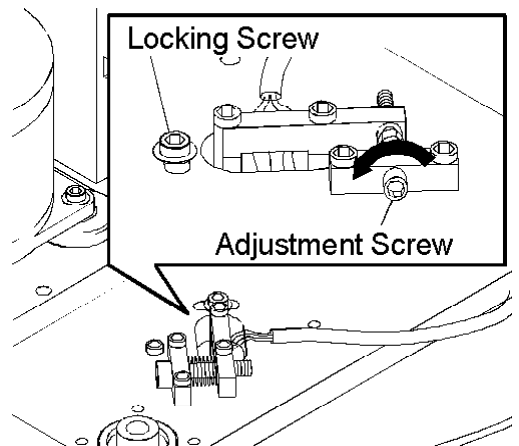
Figure 2

To adjust the Carousel counter-clockwise

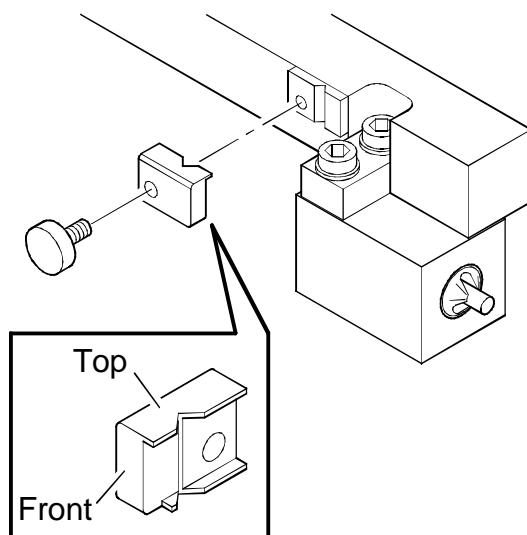
Note the differences between the old and new clamps. As shown below, the new clamp has a V-shaped notch in the top and bottom of the clamp. The older clamp had a square notch and only at the top.

NOTE: After changing the Sample Probe Clamp, verify all aspects of the mixing function and make adjustments to the Mixer and Sample Arm as necessary.

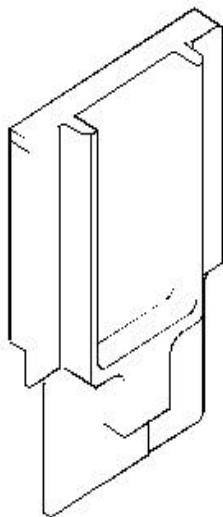
Cuvette Loader Alignment Tool - 2-83440-02

A new, improved Cuvette Loader Alignment Tool has been released. The tool is taller than the original to provide better rail engagement during the alignment procedure. Additionally, some of the original tools in stock were found to be out of specification for the 34mm rail spacing. The catalog number has changed to 2-83440-02 (was 2-83440-01).
