VESSEL: M.V MORANDI

DATE: 2ND JAN 2024

UNDERWATER SERVICE REPORT

Report Number	NSPL – 01- 24- 1835	U/W	STILL PHOTO INSPECTION. BOROSCOPE X3 SCRUBBER. CCTV WITNESS BY PAINT INSPECTOR
Attendance Date	2 ND JAN 2024	Services	
Location	AEBC	Performed

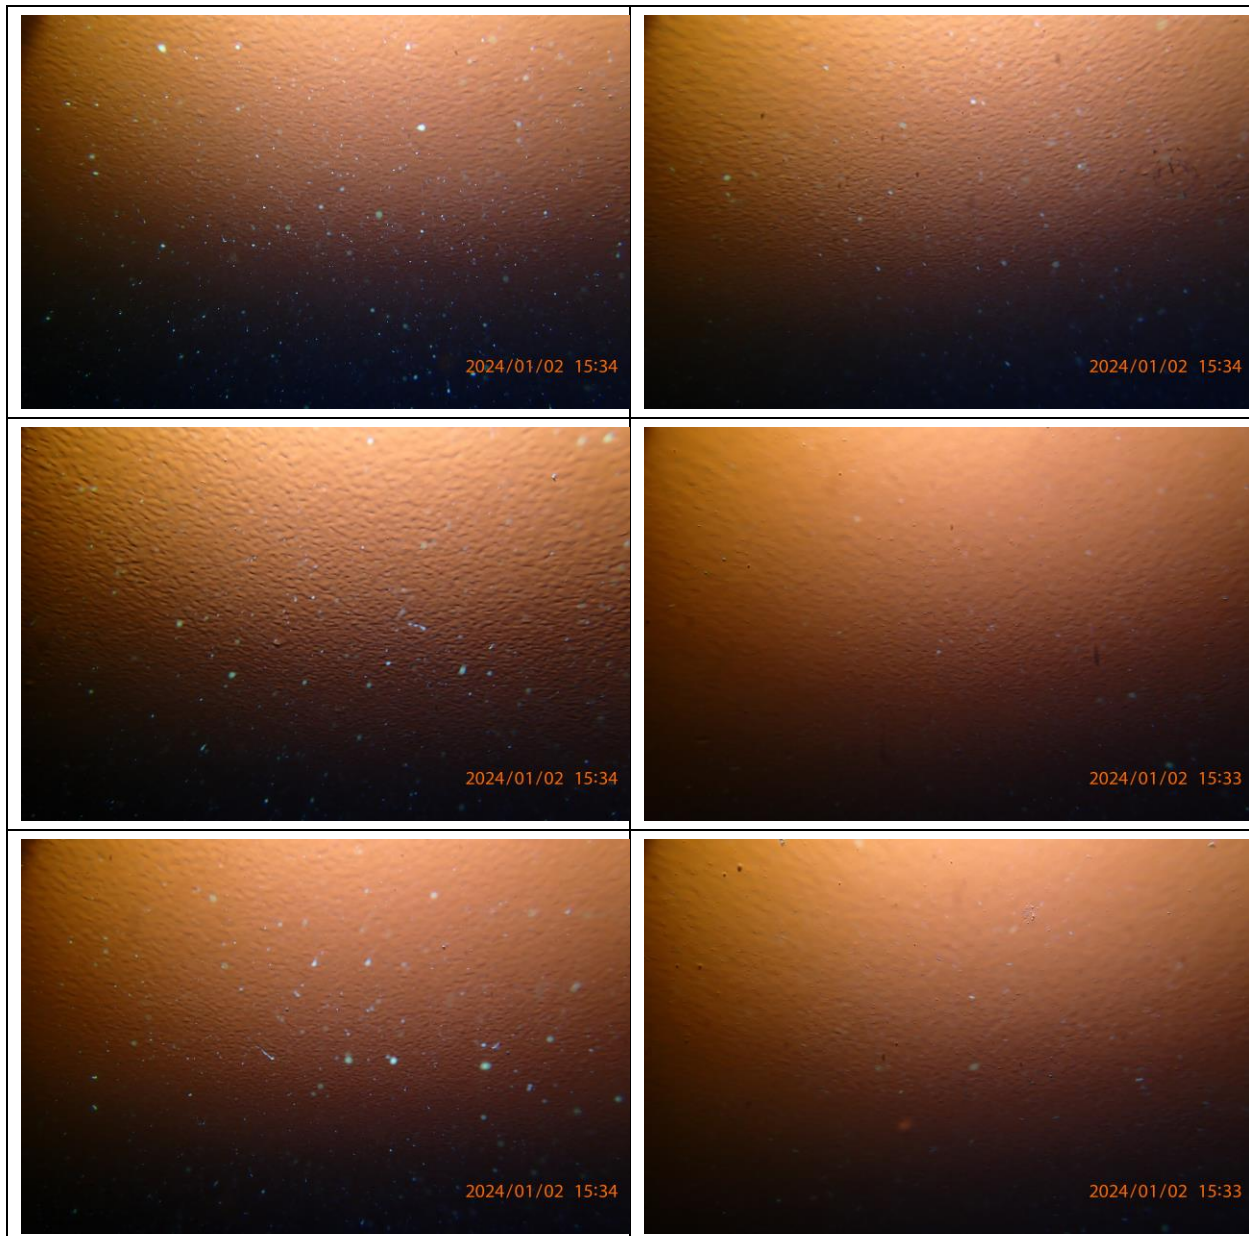
MIDSHIP AREA (BOTTOM)

1. Bulbous bow on port and observed to clean.
2. Vertical sides on both Port and Starboard were clean.
3. The Flat Bottom was observed to clean.

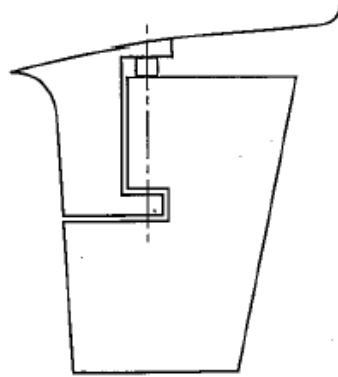
PORT

Remarks: NO VISIBLE DAMAGE OBSERVED.
