Deepwater Horizon Accident

Gulf of Mexico on Tuesday, April 20, 2010

Mahmoud Farag Radwan

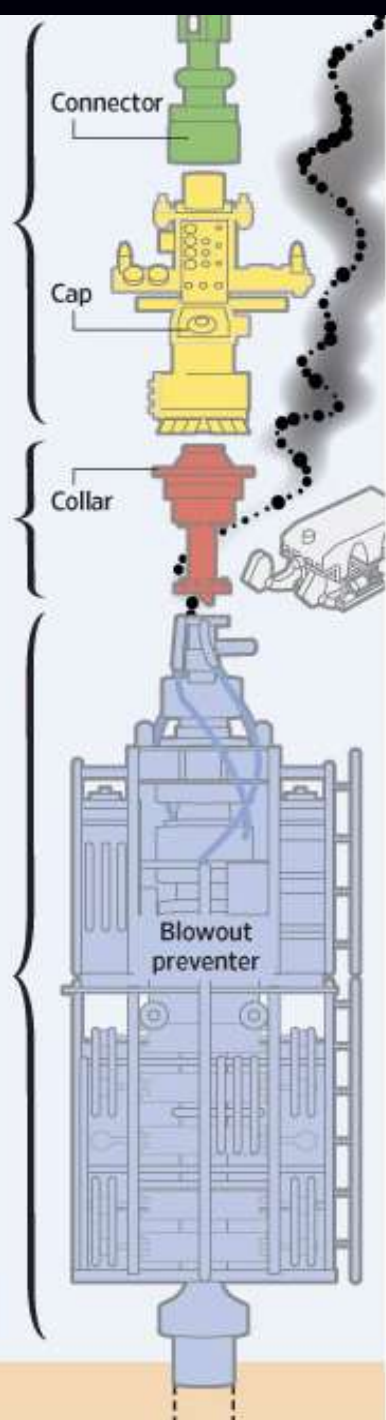
The initial collar and cap didn't work because of the force of the oil flowing from the blowout preventer.

In this drawing you get a sense of the size of the blowout preventer.

A man is standing on the left for scale.

After a number of attempts, on July 15, a 75-ton cap stopped the oil flow

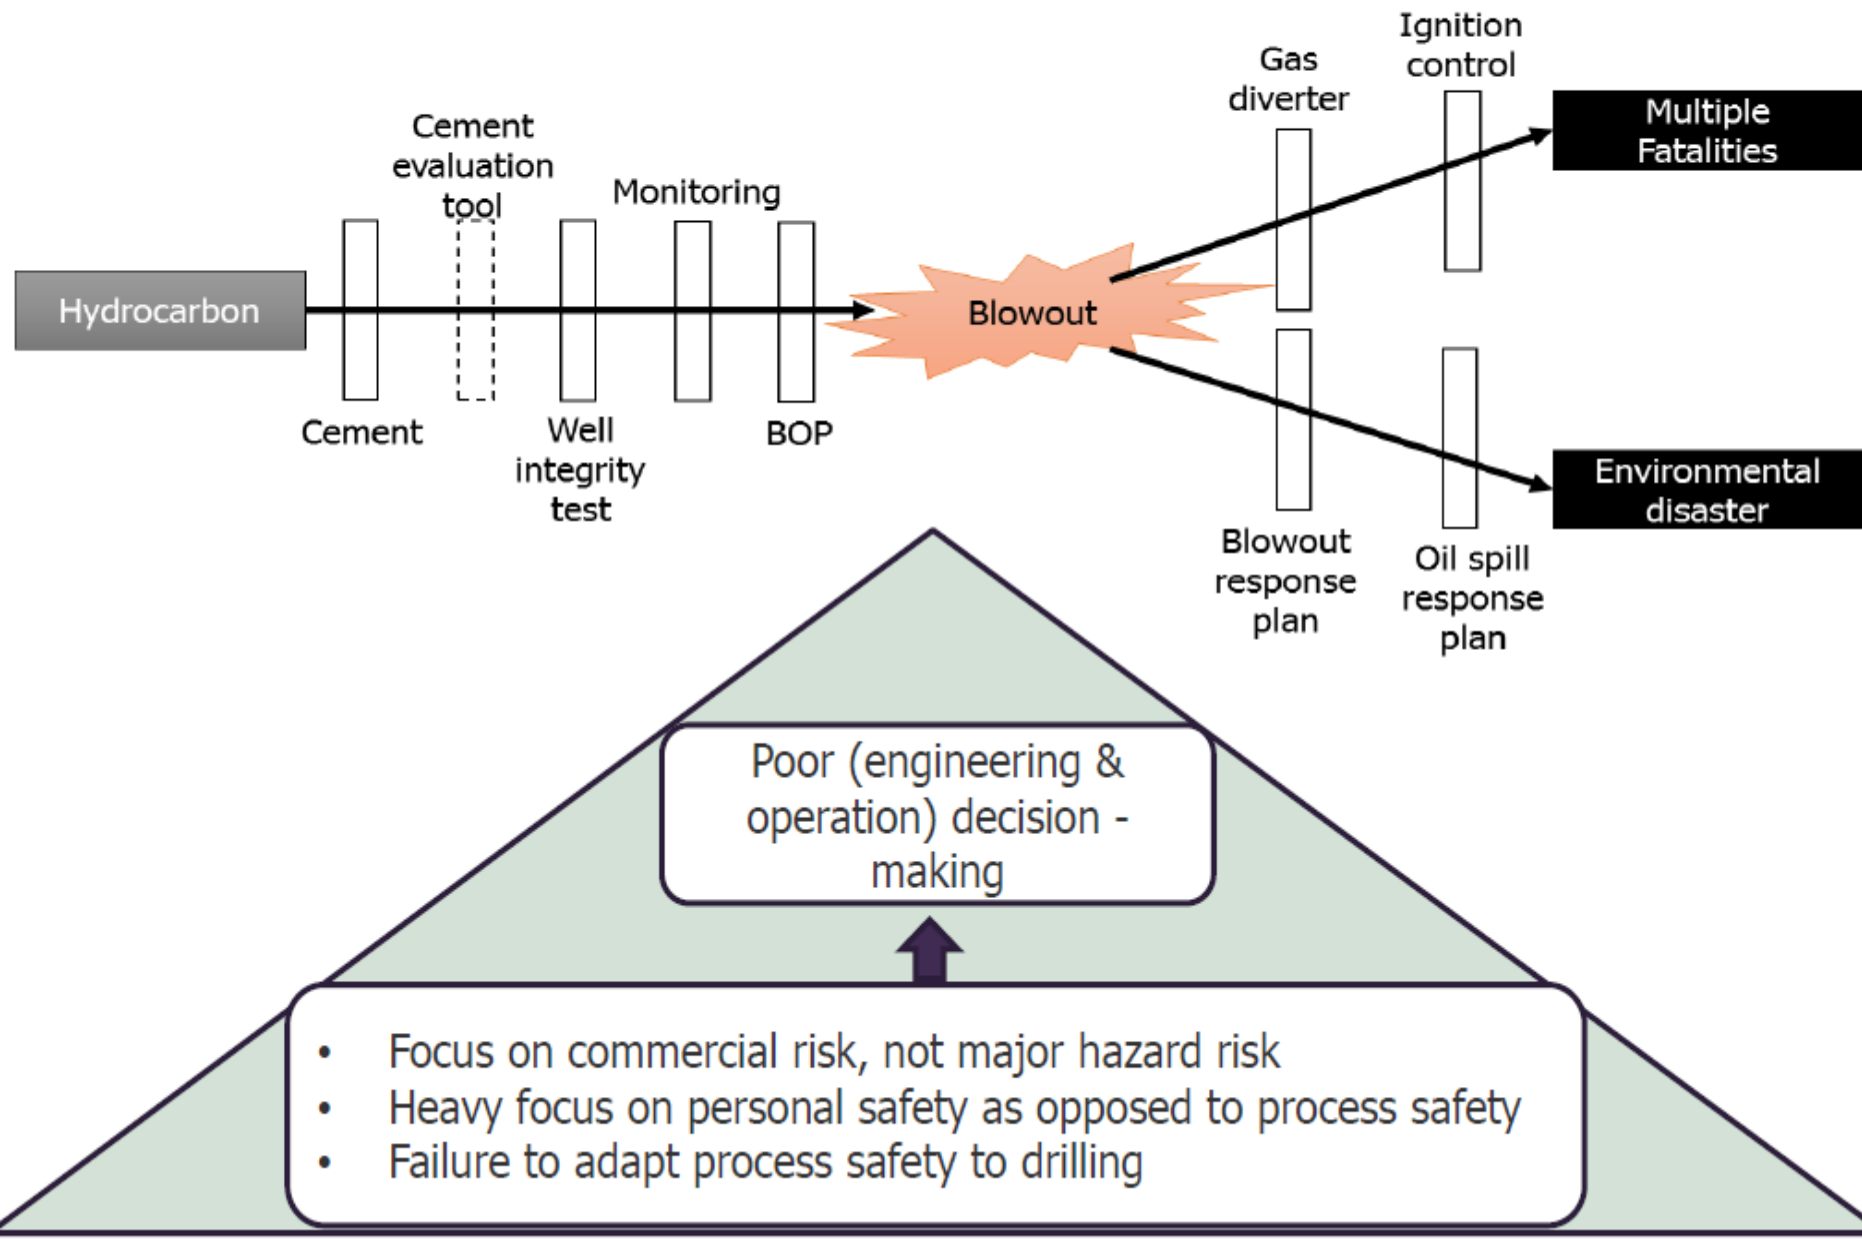
Eight Barriers Were Breached

Well integrity was not established or failed

- ① Annulus cement barrier did not isolate hydrocarbons
- ② Shoe track barriers did not isolate hydrocarbons

Hydrocarbons entered the well undetected and well control was lost

- ③ Negative pressure test was accepted although well integrity had not been established
- ④ Influx was not recognized until hydrocarbons were in riser
- ⑤ Well control response actions failed to regain control of well

Hydrocarbons ignited on the *Deepwater Horizon*

- ⑥ Diversion to mud gas separator resulted in gas venting onto rig
- ⑦ Fire and gas system did not prevent hydrocarbon ignition

Blowout preventer did not seal the well

- ⑧ Blowout preventer (BOP) emergency mode did not seal well
