## Chapter 4.6 | Negative Pressure Test

The negative pressure test performed at Macondo showed repeatedly over a three-hour period that the well lacked integrity and that the cement had failed to seal off the hydrocarbons in the pay zone. BP well site leaders, in consultation with Transocean rig personnel, nevertheless mistakenly concluded that the test had demonstrated well integrity and then proceeded to the next phase of temporary abandonment.

The Chief Counsel's team finds that the failure to properly conduct and interpret the negative pressure test was a major contributing factor to the blowout.

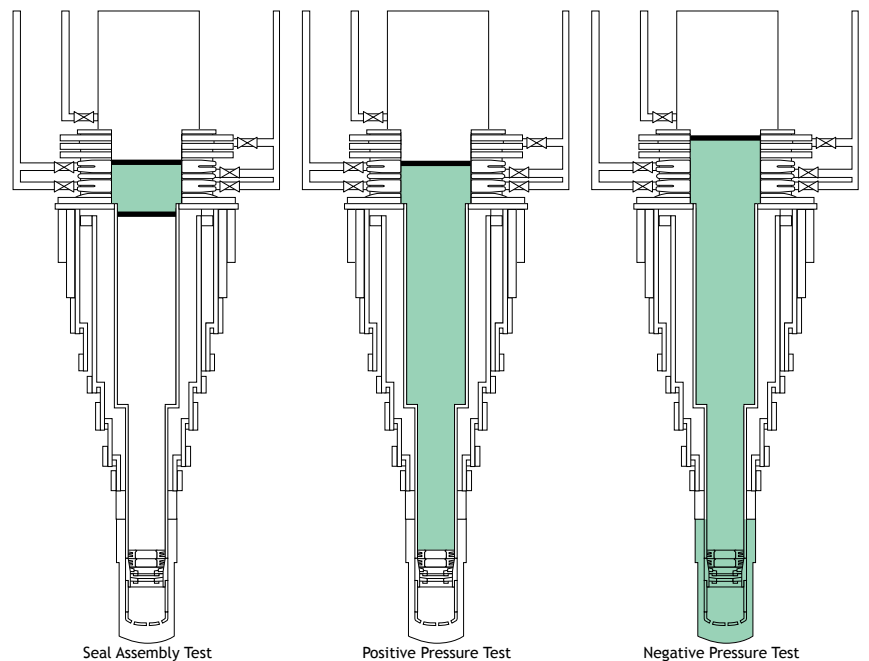
**Figure 4.6.1. Well integrity tests.**

The rig crew conducted three pressure tests as part of the temporary abandonment procedure to verify the integrity of the well. From left to right: the seal assembly test, the positive pressure test, and the negative pressure test. Test regions are shown in green.

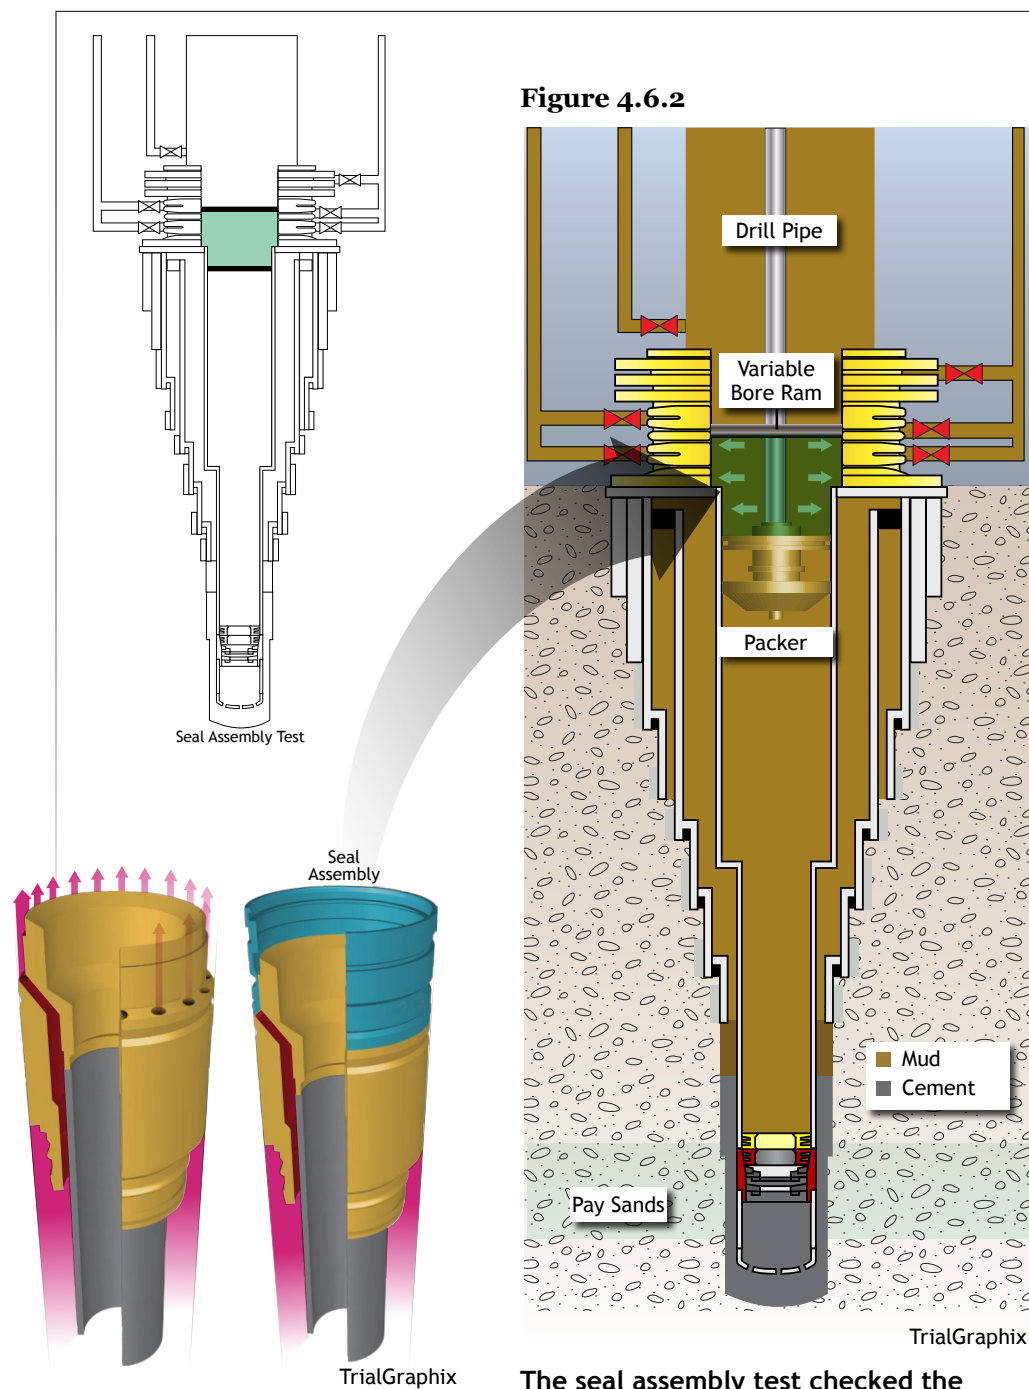
Figure 4.6.2

The casing hanger, as described in Chapter 4.1, has flow passages that facilitate the flow of fluids during normal drilling operations. The seal assembly (blue) is fitted atop the casing hanger to halt annular flow after the primary cement job is complete. Together, the two bind the casing to the wellhead.

The seal assembly test checked the integrity of the interface between the casing and the wellhead. After lowering a packer into the well, the rig crew closed a variable bore ram around the BOP, sealing the space above and below the seal assembly. The rig crew then pumped fluid into this space, increasing the pressure inside it. If fluid did not leak out of the seal assembly, the pressure would remain constant.

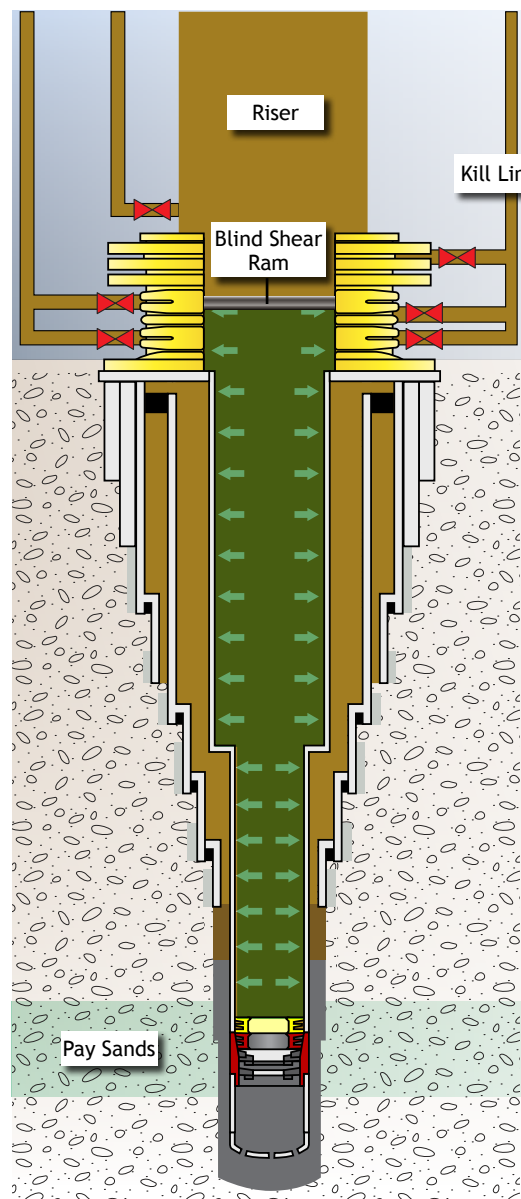
Figure 4.6.3

The positive pressure test checks the integrity of the well by testing whether the casing and wellhead seal assembly can contain higher pressure than surrounds them. The *Deepwater Horizon* crew increased the pressure in the production casing string by pumping fluid into it through the kill line. If fluid does not leak out of the casing, the pressure again remains constant.

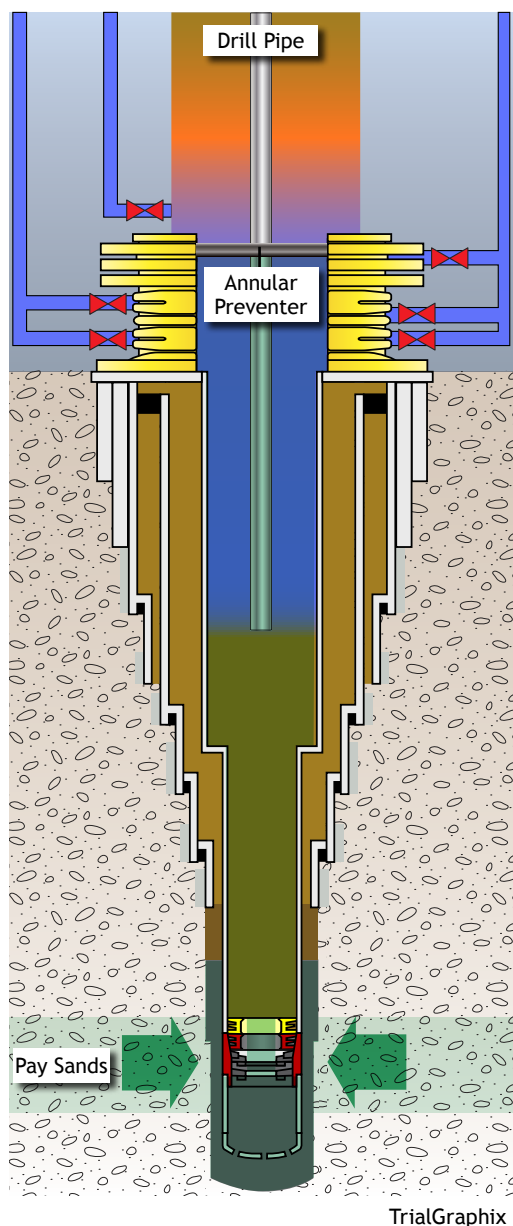
Figure 4.6.4

By moving mud from the production casing into the riser (displacement), the rig personnel reduced the pressure inside the well below the pressure outside the well (underbalancing). If there was good well integrity, the pressure inside the well would remain constant during the negative pressure test. If there was a leak of hydrocarbons into the well, the pressure in the well would rise (if the drill pipe or lines to the rig were closed) or fluid in the wellbore would be forced up and flow out at the rig (if the lines were open).

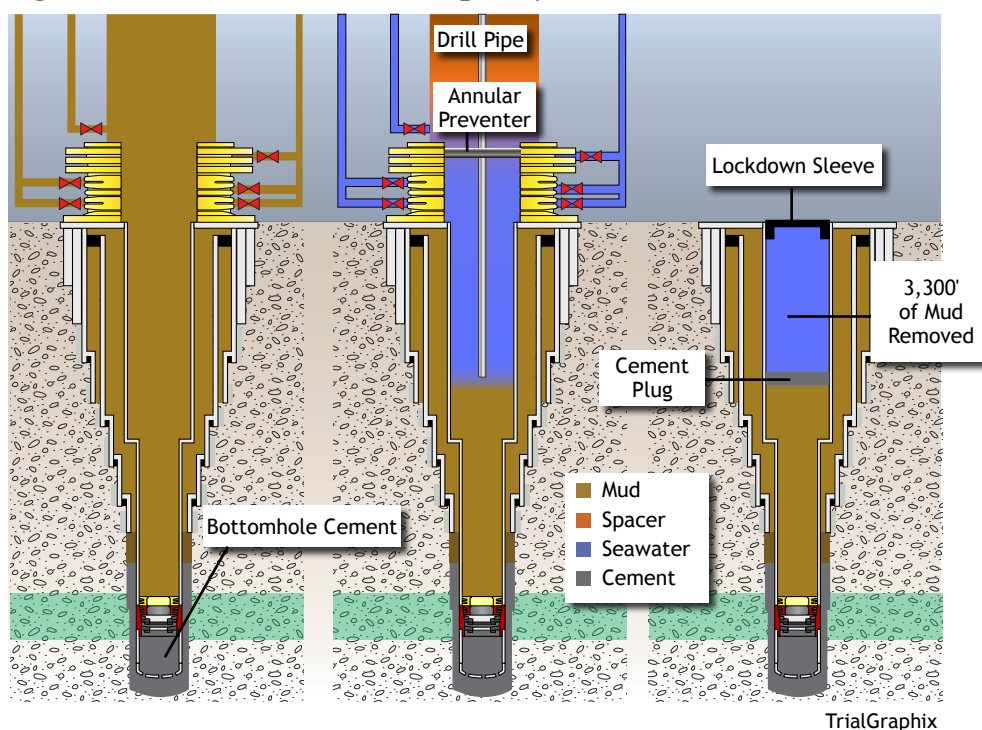
Figure 4.6.5. End of cement to temporary abandonment.

After the final casing string was cemented, heavy drilling mud filled the riser and the well (left). After the temporary abandonment planned for Macondo, the riser and its drilling mud would be removed. The drilling mud in the final casing string would be replaced with lighter seawater to a depth of over 8,000 feet below sea level (right). The removal of the hydrostatic pressure this drilling mud applied to the bottom of the well would increase the stress on the casing, seals, and cement. The negative pressure test simulated the conditions of temporary abandonment to confirm the integrity of the well in a controlled environment (middle).

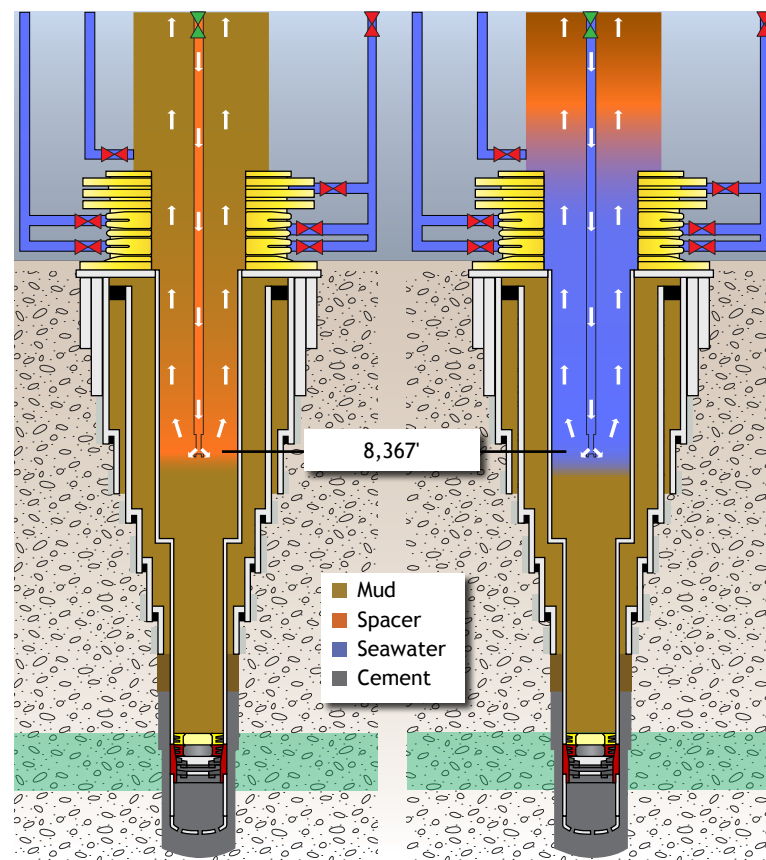
**Figure 4.6.6. Preparations for the negative pressure test.**

To prepare for the negative pressure test, the rig crew needed to displace the mud in the drill pipe and casing string from a depth of 8,367 feet to above the BOP. The crew did so by pumping spacer fluid (left) and then seawater (right) down the drill pipe until the mud was above the BOP.

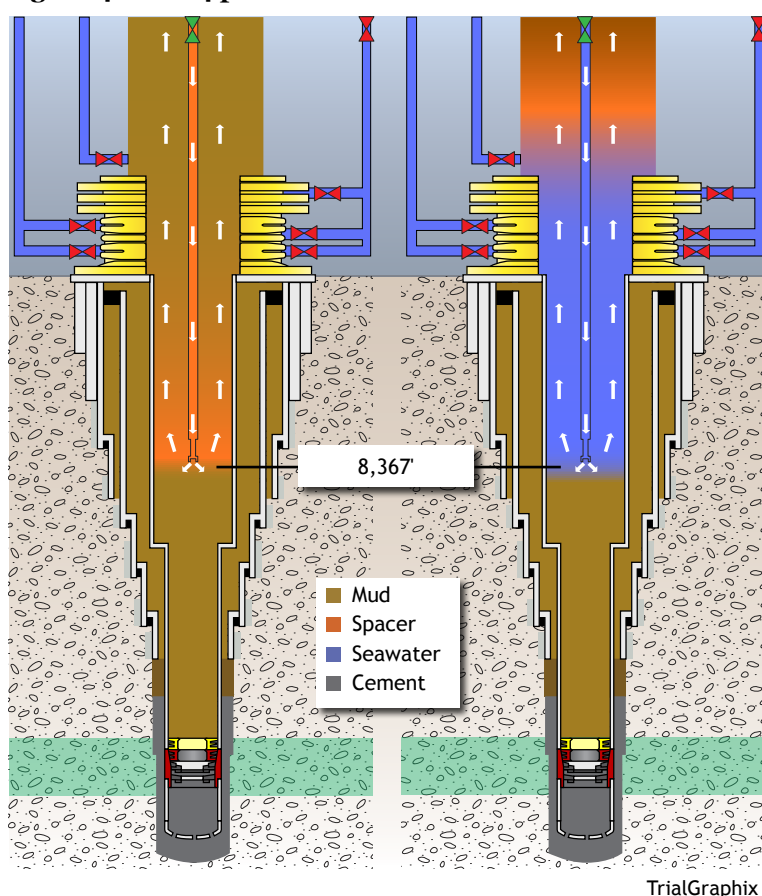
Figure 4.6.10. 4 p.m.

The crew displaced the mud in the drill pipe and in the casing from 8,367 feet to above the BOP. The crew first pumped a spacer fluid down the drill pipe, which forced the mud out and up the casing and the riser (left). Following the spacer, the crew pumped seawater into the drill pipe. This forced the spacer and the mud up the casing. The crew’s intent was to pump enough seawater to displace the spacer and mud above the BOP (right).

Second, the lost circulation materials that BP combined to create its spacer created a risk of clogging flow paths that could be critical to proper negative pressure testing. Much as blood clots to stop a bleeding wound, viscous lost circulation materials are designed to plug fractured formations to prevent mud from leaking out of a well. M-I SWACO therefore warned BP before the negative pressure test that spacer composed of lost circulation material could “set up” or congeal in “small restrictions” in tools on the drill pipe.<sup>16</sup>

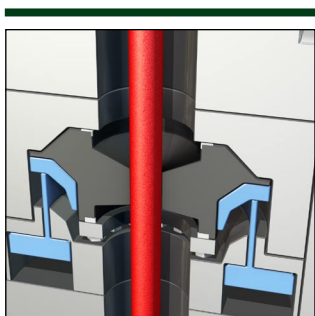
**Annular Preventer.** The annular preventer is a hard rubber donut that surrounds the drill pipe; when activated it expands and fills the space around the drill pipe, sealing the well below (see also Figure 2.9).

At 5:10 p.m., the rig crew apparently noticed that the level of fluid in the riser was falling.<sup>41</sup> Spacer in the riser was leaking down through the annular preventer and into the well below the BOP.<sup>42</sup> Unlike many other indications, the crew could observe the fluid levels in the riser with their own eyes. When one rig crew member arrived on the rig floor, he saw others standing around the rotary table and using a flashlight to peer down into the riser to see how much fluid was missing.<sup>43</sup>

In response to the dropping levels of fluid in the riser, Harrell instructed the rig crew to tighten the seal of the annular preventer against the drill pipe as shown in Figure 4.6.14. Wyman Wheeler, the Transocean toolpusher on duty at the time, then topped off the riser with 20 to 25 barrels of mud, and the fluid level in the riser stayed steady.<sup>46</sup> The crew had thus identified and eliminated a leak in the well system that could have explained the anomalous pressure readings they had seen and their inability to bleed the drill pipe pressure to 0 psi.<sup>47</sup> By this time Kaluza returned to the rig floor.<sup>48</sup>
