Mid Term Evaluation of Soil Piping in Highland and Foothills of Kerala to avoid Disaster

DRAFT REPORT

Indian Institute of Public Administration

Date of report: 16th February, 2015

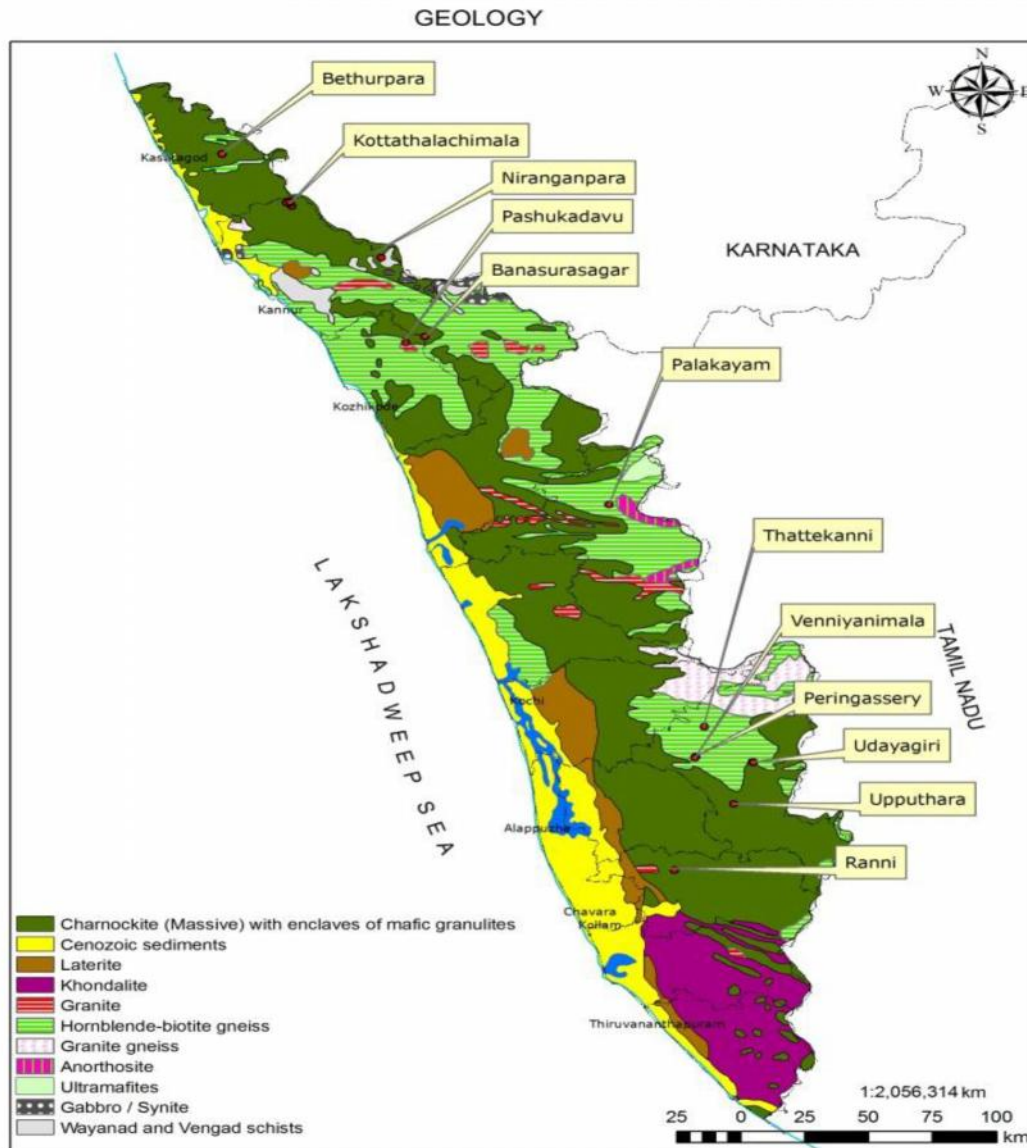
Figure 2: Map of soil pipe affected area

The map in the Fig. 2 shows the various districts of Kerala, affected by incidences of soil piping.

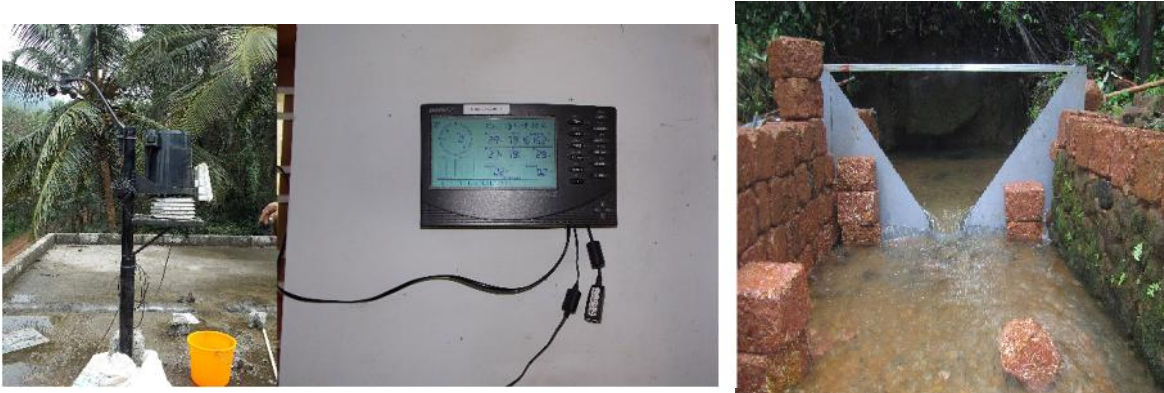
Figure 8 : AWS, V-Notch and AWS display at Thirumeni

A meteorological station is established in this building for this project. This location is selected for uninterrupted power supply. The meteorological data is being collected using an AWS, Automatic weather station. This AWS was supplied by the SEOC, Government of Kerala. Discharge data is measured at an outlet using a V-notch constructed for this purpose.
