## Stellaris® LM3S9B92 RevC Errata

This document contains known errata at the time of publication for the Stellaris® LM3S9B92 microcontroller. The table below summarizes the errata and lists the affected revisions. See the data sheet for more details.

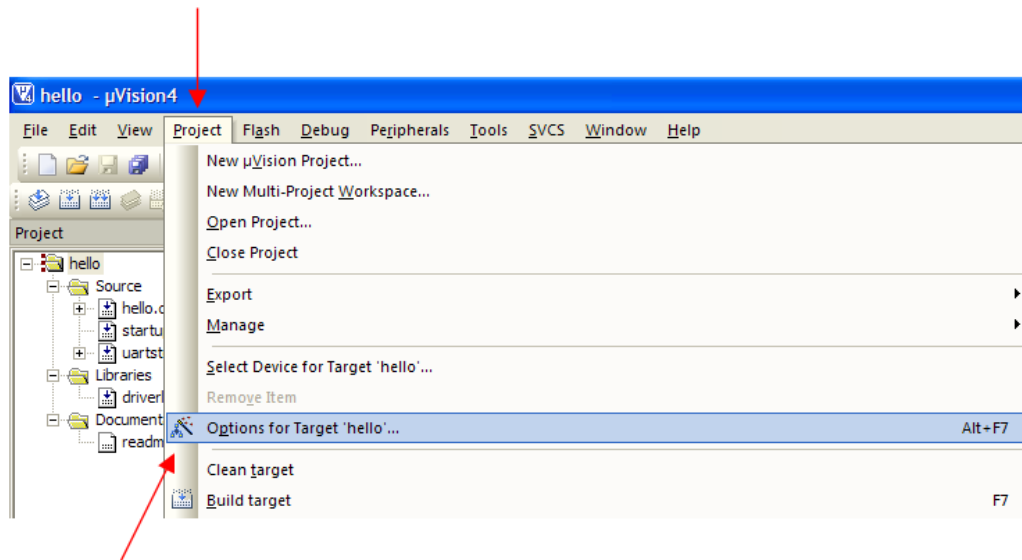
**Figure A-1. Navigating to the “Run to Main()” Option**

If the debugger is configured to simply reset/connect, it attempts to disassemble code in a protected region of Flash memory. The simple solution is to configure the debugger to “load/run to main”. With this configuration, the patch code gets run and the Flash interrupt gets enabled. The PC runs to the main() function when the debugger starts. This option can be found in: Project □ Options for target '<project name>' as shown in Figure A-1 on page 16.

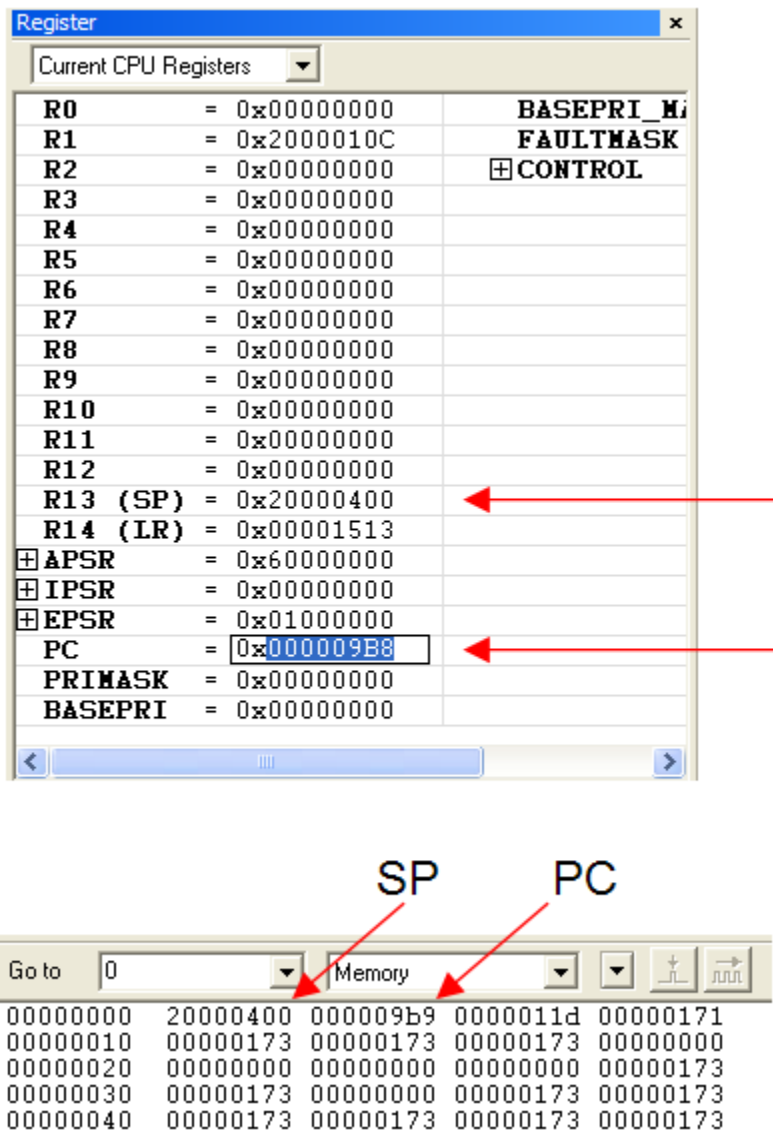
Figure A-9. Manually Configuring the PC and SP Registers

IAR has problems executing code at address 0x0000.0000 if it is not the main() application (such as bootloader examples). As a result, the PC and SP must be manually loaded. The values to load can be found at address 0x0000.0000 and 0x0000.0004 in the memory window and loaded into the PC (0x000009B8) and SP (0x20000400) as shown in Figure A-9 on page 23.

Set a breakpoint at the main() function and run the program. This process causes the Flash memory interrupt to be enabled and the debugger to operate as expected. Note: Every time you startup the debugger or do a reset in the IDE, you need to perform this sequence.
