## EE371 Debug Examples

Intel Corporation  
jstinson@mipos2.intel.com

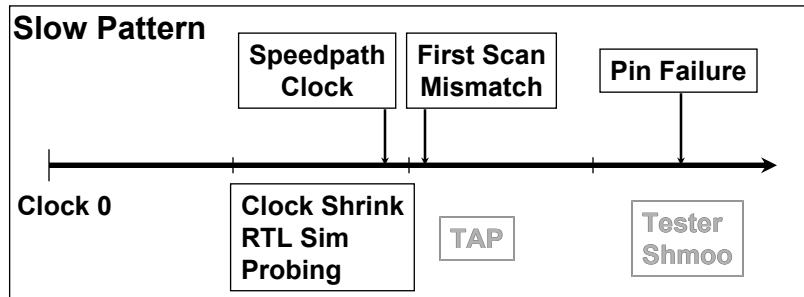
## Pattern Timeline

- Production test platform suspected
  - A timing setup problem
  - How could silicon act this way?

- Debug test platform confirmed
  - Unlikely two diff't platforms had same timing error
  - Now we had to do the debug...

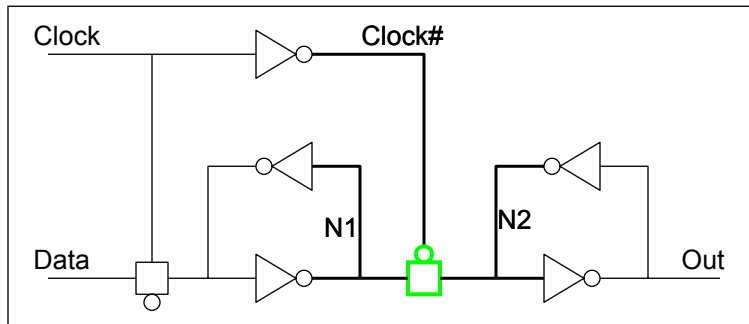
## Scan MSFF Analysis: Pass

- Scanout stopped working in failure region
  - Deduce scan chain itself was broken
- Probing was only way to root cause
  - Laser Voltage Probe was able to narrow failure down to Scan MSFF
  - Three different mechanisms observed

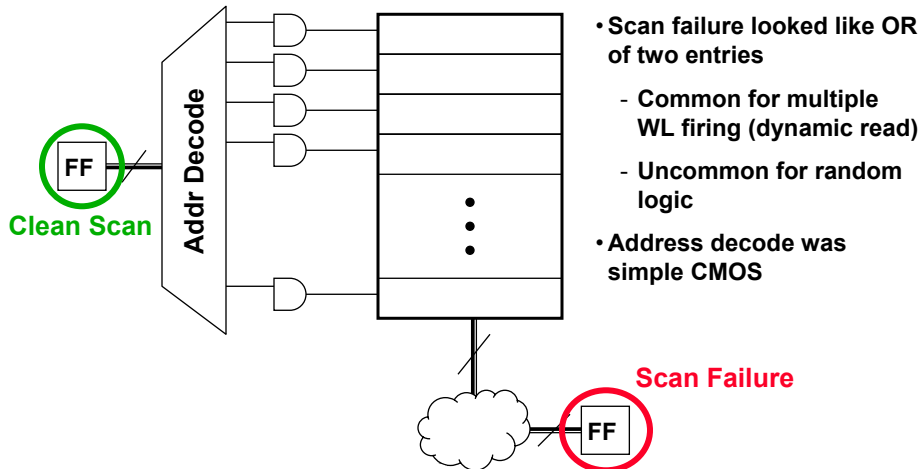
## Scan Analysis

- Used a fancy self-resetting mechanism
  - Self-reset WL prevented read→write min-delay
  - Pulsed WL read array for short period of time
