# FAILURE ANALYSIS OF WELD-REPAIRED B-1900 TURBINE BLADE SHROUDS

Erik M. Mueller<sup>1</sup>, Luis Carney<sup>1</sup>, Sun Tai Ngien<sup>1</sup>, John L. Yadon<sup>1</sup>

<sup>1</sup>NAVAIR, ISSC Code 4341, Building 793, NAS JAX, Jacksonville, FL 32212-0016

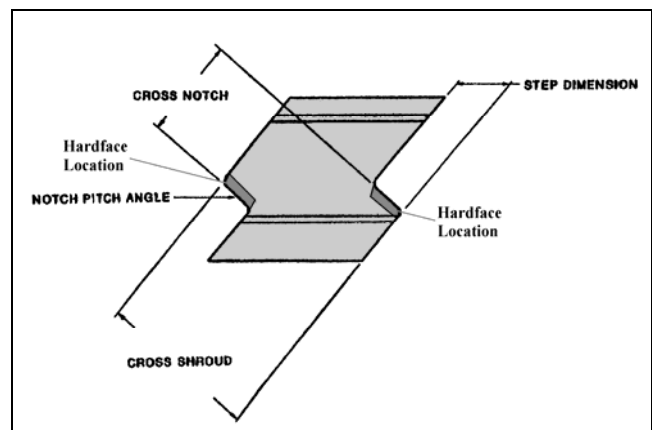
Before the final heat treatment, the Z-notch tips were hardfaced by GTAW with Stellite 694 (Co-28Cr-5Ni-19.5W-1V) in the locations illustrated in Figure 3. After machining, the entire blade was then coated with a Cr-based vapor deposition to a minimum

Figure 3. Illustration of the hardface locations of the turbine blade shrouds (dark grey). Other dimensional definitions are also identified for checking compliance with geometrical specifications.

The dimensions of the shroud were compared against the drawing design specifications. The results are listed in Table I and refer to the dimensions shown in Figure 3. While generally conforming to specification, the cross notch is larger than called for, while the step dimension is less. The M720 blade appeared to deviate furthest from specification.

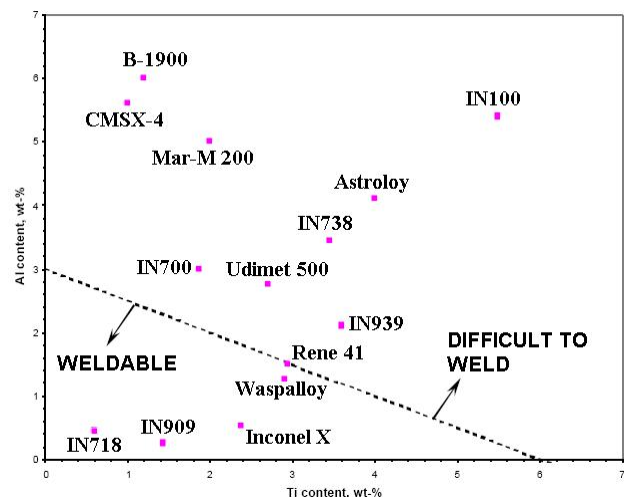
A number of issues led to the fatigue failure. It was difficult to determine which specific causes initiated crack formation, or merely aided propagation. The primary problem, as has been reported, appeared to be the low weldability of the B-1900 casting alloy. As shown in Figure 19, the Ti and Al content of the B-1900 compositions places it in the “difficult to weld” region [5, 22].

Figure 19. Weldability assessment diagram for various nickel-based superalloys [5, 22].
