ANALYSIS OF SURFACE CHEMICAL CONTAMINATION ON EX-SERVICE INDUSTRIAL GAS TURBINE COMPONENTS

Keywords: "Thermal Barrier Coatings, Surface Deposits, Iron Oxide, Industrial Gas Turbine"

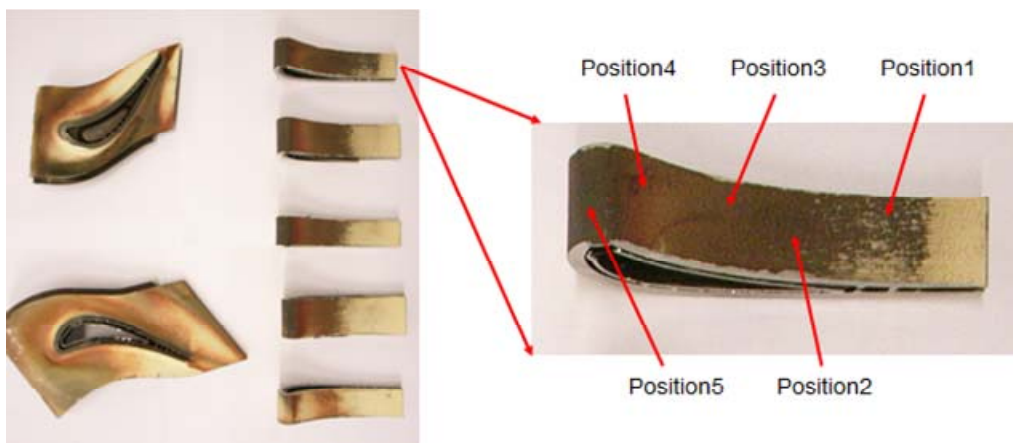
Figure 1 Sectioned blade pieces and areas selected for SEM examinations

and morphology, a range of techniques were used. Surface and cross-sectional scanning electron microscopy (SEM) were conducted on five selected positions across the pressure side of the discoloured nozzle guide vane. Figure 1 illustrates position 1 to 5 on a sectioned vane piece. This particular vane piece has 4 different colours of deposits: black, light brown, dark brown, and red. SEM examinations were performed on sectioned vane pieces with various TBC discolorations. Field-emission-gun scanning electron microscopy (FEGSEM; LEO Gemini) was used to examine the surface and cross-section of sectioned pieces. The in lens secondary electron mode was employed and images were taken at 5 KV with a working distance of 7 mm. For cross-sectional images of the surface deposits, backscattered electron mode (BSE) was selected to show the phase contrast within the deposit layer. Oxford Instruments ISIS EDS was used to perform surface and cross-sectional mappings to determine the elemental composition and distribution of the deposits. X-ray diffraction was conducted on discoloured TBC surfaces using Philips PW 1710 diffractometer with Ni filtered Cu K α radiation. A step size of 0.04° and scan step time of 30 s per step size was set for all XRD spectra.

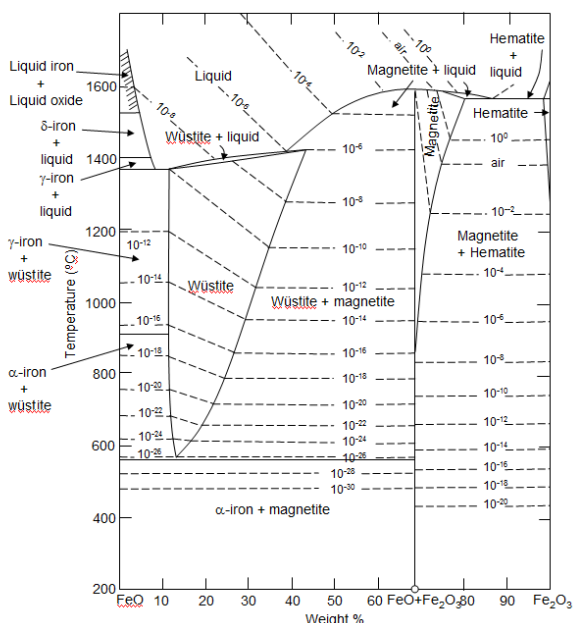
In order to understand the formation of these phases it is necessary to consider the thermodynamic stability of the various iron oxide phases under typical GT operating conditions, specifically with respect to temperature and oxygen partial pressure. The air stream inside the combustion chamber experiences temperatures at over 2000°C and most Fe containing impurities are in the form of liquid phase. Once the hot gas stream exits the combustion chamber, it is then cooled to approximately 1160°C just before entering the first turbine stage (TIT). The combustion gas is then mixed with internal cooling air guided from compressor stages, resulting in an oxygen partial pressure of 0.96 atm. The $\text{Fe}_2\text{O}_3/\text{Fe}_3\text{O}_4$ pressure-temperature phase diagram adapted from Chiang et al. (Figure 20) [9] was used to predict the phase changes. Through following the cooling curve at a constant oxygen partial pressure (1 atm), magnetite is the first phase to fully solidify at 1590°C. Then at 1365°C, the hematite phase solidifies and co-exists with magnetite.

Figure 20 $\text{Fe}_2\text{O}_3/\text{Fe}_3\text{O}_4$ pressure-temperature phase diagram [9]
