**MASTER MECHANICAL ENGINEERING  
SPECIALITE ADVANCED MANUFACTURING**

**Thèse de Master MENG-AM**

Analysis of welding problem and cracking of bolt hole  
that caused two leakage issues of C84E backlight in PSA

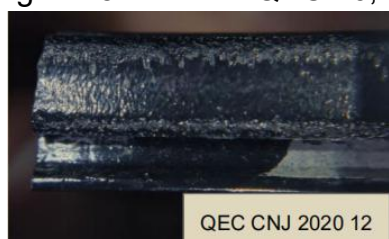
Figure. 1. Incident QEC 12

Each photo of the incident light part welding joint: Figure. 1. Incident QEC 12, Figure. 2. Incident QEC 17, Figure. 3. Incident QEC 24 1#, Figure. 4. Incident QEC 24 2#, Figure. 5. Incident QEC 26, Figure. 6. Incident QEC 36.

1. For the 6 defect lights from PSA Rennes, the lens and housing are separated from the welding joint.
2. From the macroscopic side : the surface of the housing welding joint is smooth.
3. There is no other material left over the housing welding line.

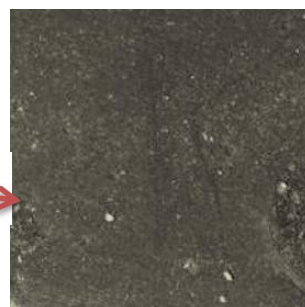
The two figures Figure 8 & Figure 9 show the surface of the joint after the separated, it's obviously that the surface is smooth and there isn't so much material left on each side.

Figure. 9. Zoom of the joint part

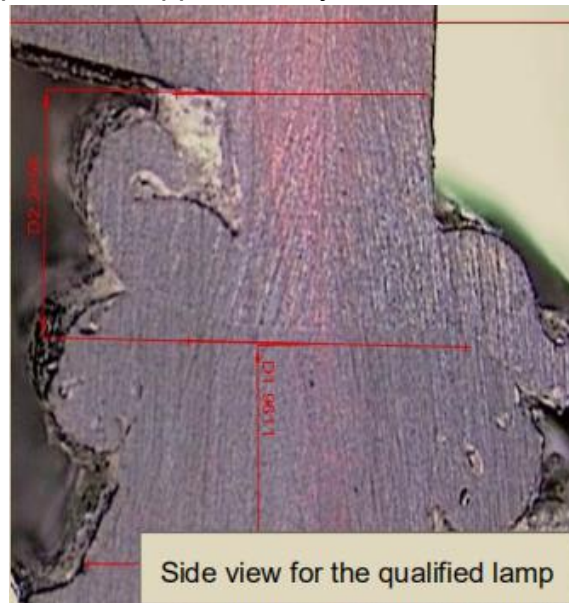
Bellow the figure 10 shows the qualified conjoint of the lens and housing. For the welding problem, the problem happened only on a certain area of the welding parts.

Figure. 10. The section view of the qualified light after welding, averagely welding and strongly connected.

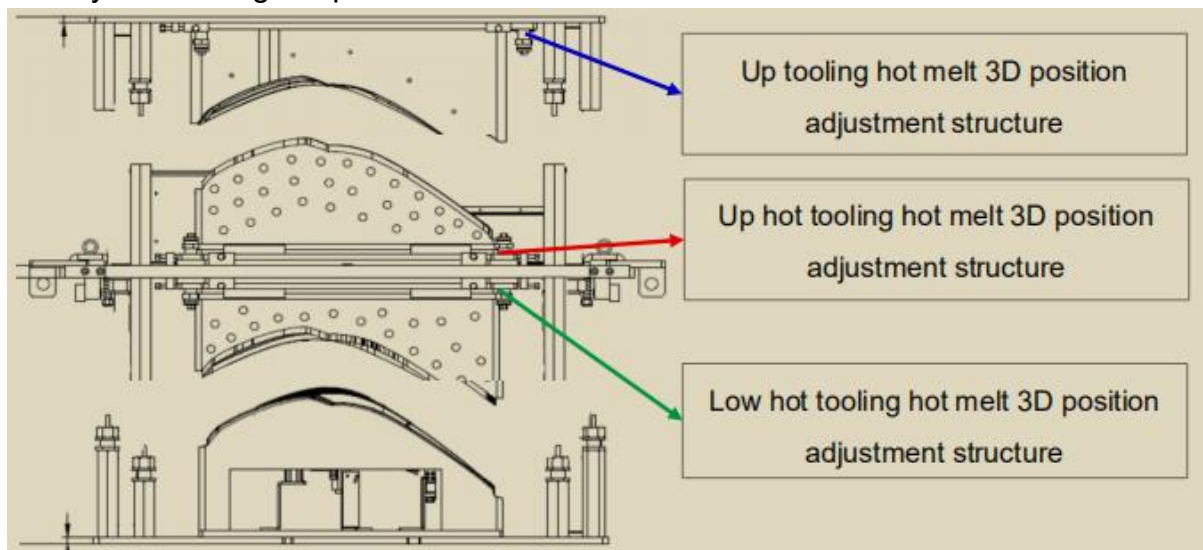
For the hot tooling device, there is some structures that help adjustment during the process of softening. Bellow the figure 23 shows the main 3D position adjustment structure. The up ones and the lower ones will help modify the horizontal level of both holders of the lens and housing. All the adjustment might be mini since the height changes only by rolling the bolt on the bar. Even so, the height still can move little by little during the production.

Figure. 23. The hot tooling 3D position adjustment structure

**Testing fact:** If we adjust these mandril, circle around of the welding line is nonuniform. The phenomenon is same with the defect lights.

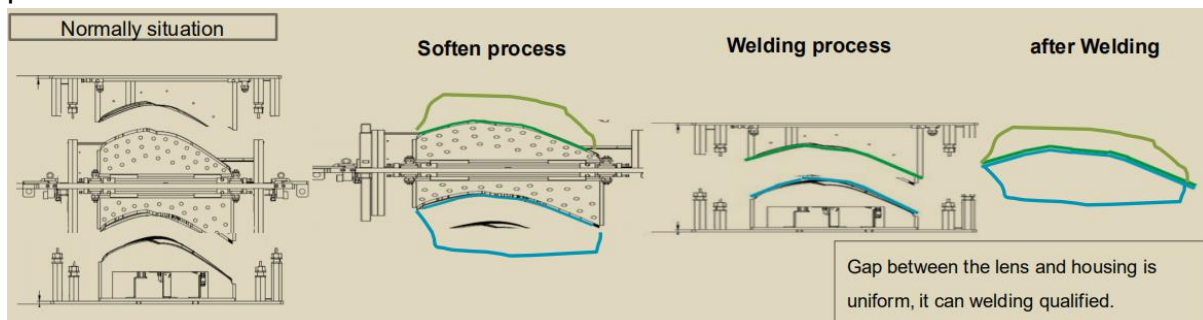
As is shown in the figure 24, the normal situation for the soften process, welding process and after welding. All the parameters are perfectly matched in the normal situation, so for the welding joint they are perfectly connected.

The green line is the lens welding line and the blue line is the housing welding line. Every part of the line is heated en average. So the welding effect is qualified and the connection is strong enough with the qualified pressure. The figure shows well the process and the line is matched well.

Figure. 24. The normal situation of soften process, welding process and after welding, the green and blue lines are connected perfectly. Blue part represents the housing and the green part represents the lens.

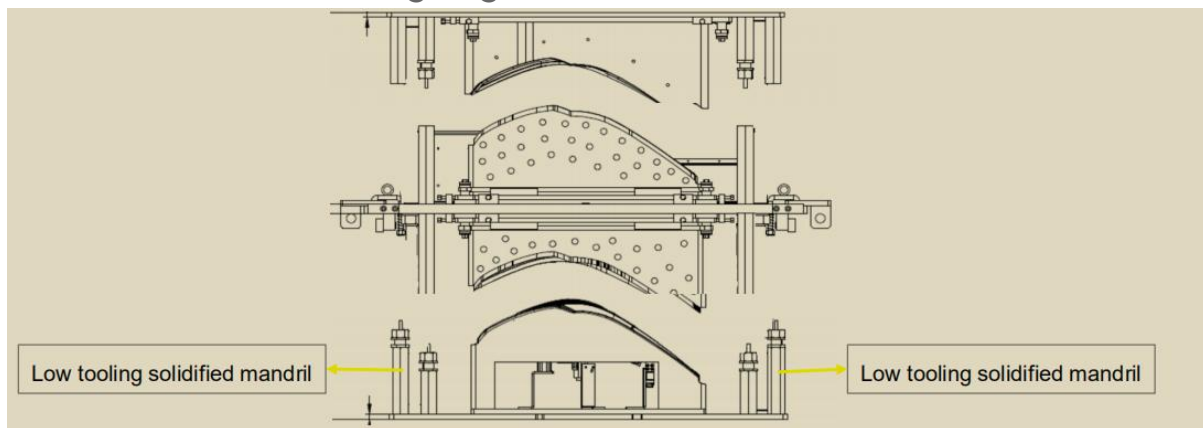
Figure. 26. Around the tooling are the mandril, they are used to adjust the welding height

**Investigation results:** During the welding process, use these structure shown in figure 26 to adjust the motion trail of the up tooling. If we adjust these mandril, circle around of the welding line is uniform. However, the phenomenon for the defect is different from these defect lights, their circle around of the welding line of the defect lights is nonuniform.

Incident QEC CNJ 2019 292(One incident happened in 2019, it was a leakage problem after sale) was caused by these mandril adjustment. And if the process engineer adjusted these mandril, they will record the detail information of adjustment. But during the investigation, there is no record of adjustment on those days.

This is not the root cause for this issue since no record was found.

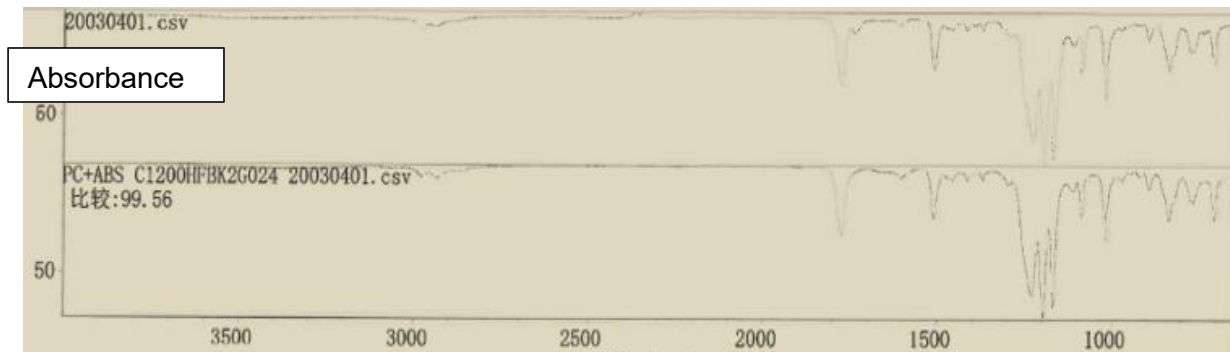
Material test results are OK. The degradation can happen after reprocessing of polymer. And this is the reason of the breaking of poly butadiene bonds. What's more, for certain additives, its effectiveness will be lost as a result of the reprocessing in ABS.[1]

Figure. 27. The fault light material is compared with the results of the analysis of the qualified material. Since the material used in the bad welding shared 99.56% similarity, we can conclude that the material used is qualified shown in figure 27.

**Conclusion :** Cutting some material from the lens and housing of defect lights to do the material test. And the test result shows the material are qualified.

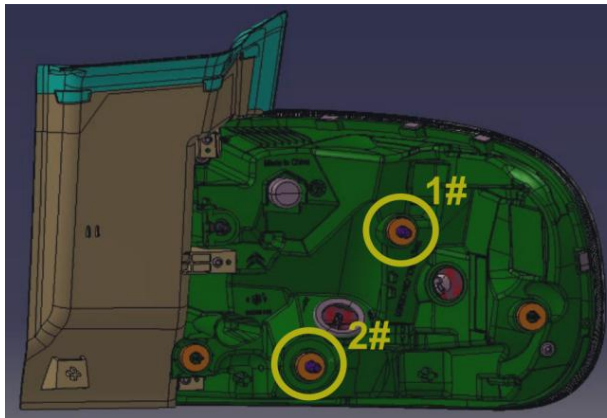
1. It is after the PSA Rennes firstly found this issue when they did the leakage test, then the supplier X began to analyse the problem.
2. After checking the defect lights, the bolt hole cracked and caused the leakage defect.
3. There are 2 bolt holes on the housing, and the cracking position for these defect lights are as below figure 28:

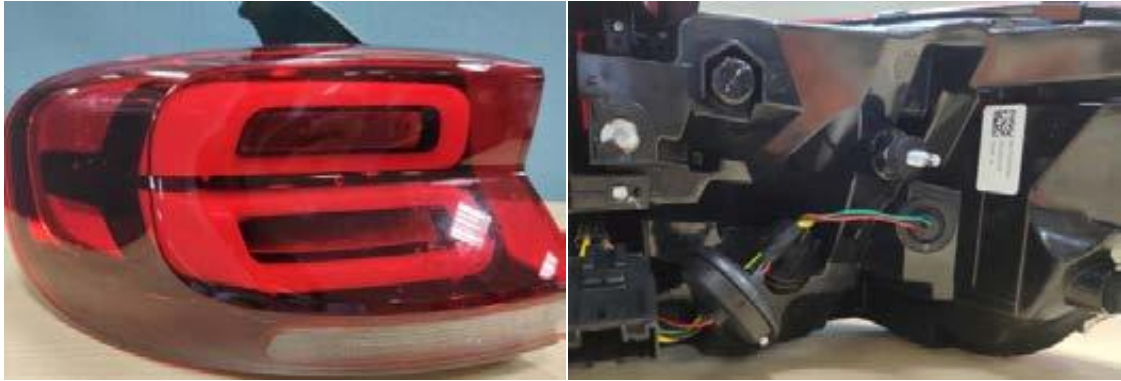
For this factor, we need to analyze it because during sea transportation, repackaging or installation, there may be external force impact resulting in the bolt hole cracking. It is easy to analysis because we only need to have a complete appearance inspection for judging. For the appearance front and back sides, check the figure 30, no scratch was found on all the lights returned.

Figure. 30. There is no scratch on the appearance of these four lights

No obvious bumps or scratches were found in the appearance of the problem light. Figure. 30.

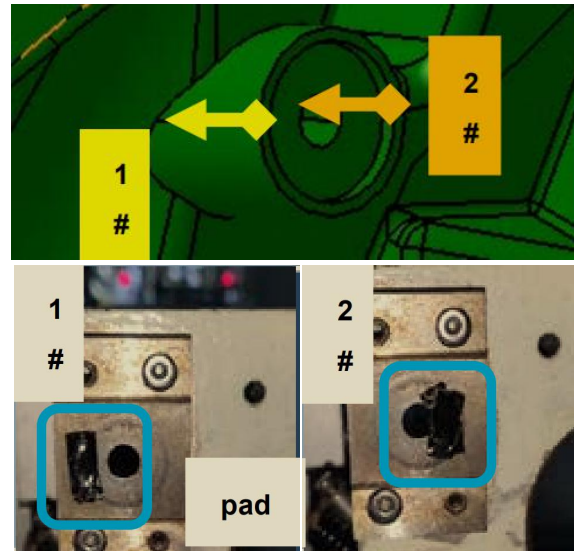
Test: Stick the pads on the cubing gauge to simulate the uneven stress in car body assembly, then use the torque force of 2Nm to lock. In the end they found no crack after 1h and 20h. figure. 33.

Figure. 33. Uneven force simulation test

**Conclusion:** Because in the bolt assembly process on housing and the process of assembly on the car body are all considered to avoid the badly assemblage, so after checking this can be eliminated from the possibility. **No abnormal force during assembly.**

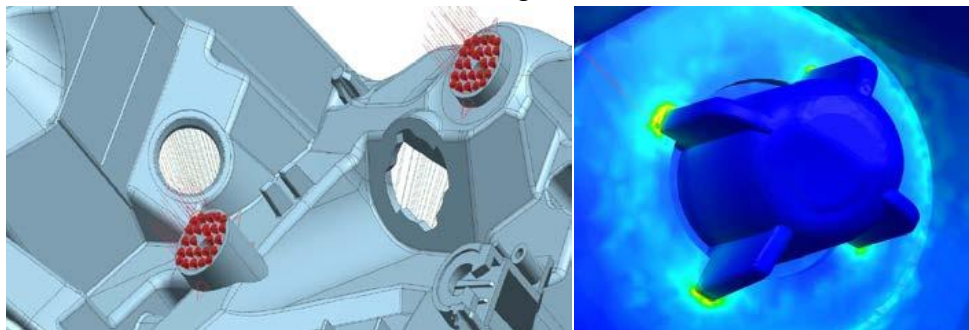
Simulate the constraint conditions of the whole light, and increase the load of 4N.m (double stress) at the bolt hole position. This is to verify if the structure is qualified under a certain torque. Under the figure 38 shows the result of the static structure analysis.

The stress is within the standard, the housing structure is OK.

Figure. 38.Simulation conditions

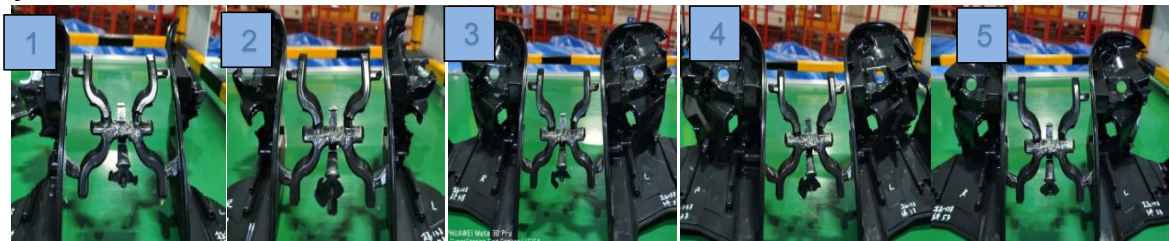
The figure 44 show the process that when inject the left and the right part together, and check if they will finish their injection the same time. Picture 1 to 5 shows the different period of injection. If the left and right parts are not formed in the same time(very near), then the first formed part will continue be heated and pressed under a high temperature and high pressure. Which will cause the material degrade or damaged. However if they form almost in the same time, it means that the velocity of injection on both sides are OK.

Through the verification of short injection parts, the velocity difference between left and right parts is within a qualified range.

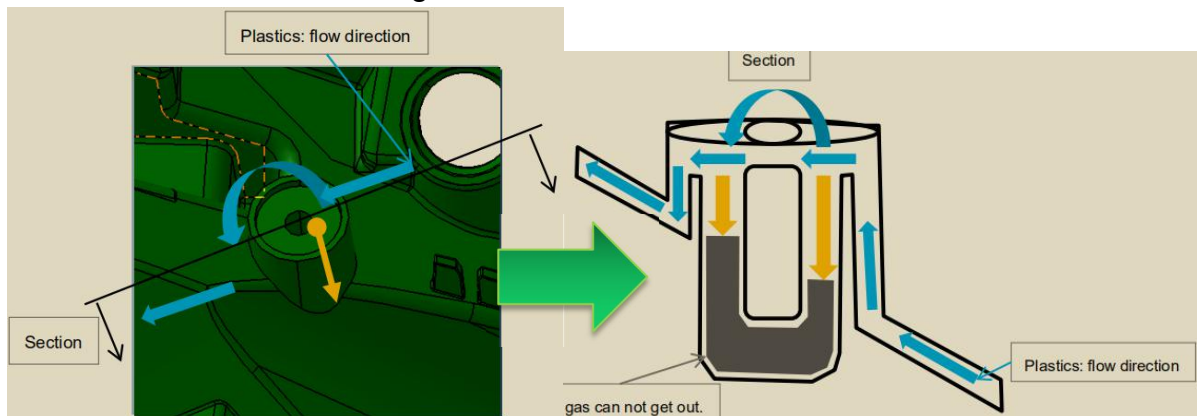
1) The arrows shows the molten material flow direction, The grey part is gas. Figure. 49.

2) When the molten material flows to the bolt hole, the gas will be compressed and the column can't be formed. Figure. 50.

3) Under the action of pressure, air is mixed in the molten plastic. Finally after high temperature damaged the plastic, resulting in insufficient strength.

In the beginning of injection, the temperature inside of tooling is not stable and cause material flow unsteadily , the trapped gas will affect PC/ABS material combining effect. Then reduce the strength of bolt hole.

Figure. 49. molten material flow direction

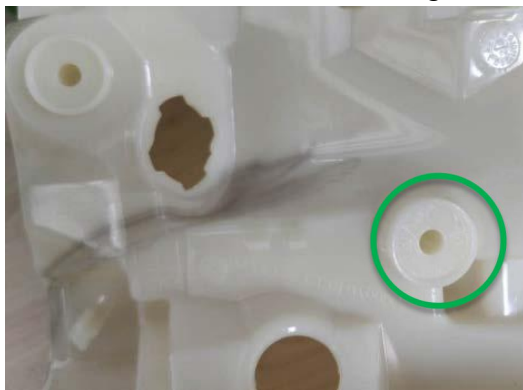
1) Use the same type of light colored material for the reproduction test, the samples were not scorched, and no cracking after locking for a week. Figure. 52.&Figure. 53.

Figure. 52. No scorching

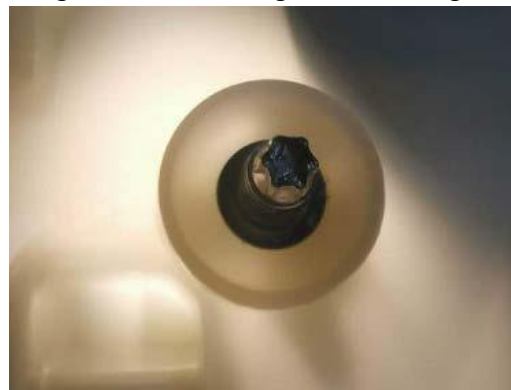
Figure. 53. No cracking
