Vehicle Damage Report

Peugeot 108

Generated 2025-06-26 14:46 UTC

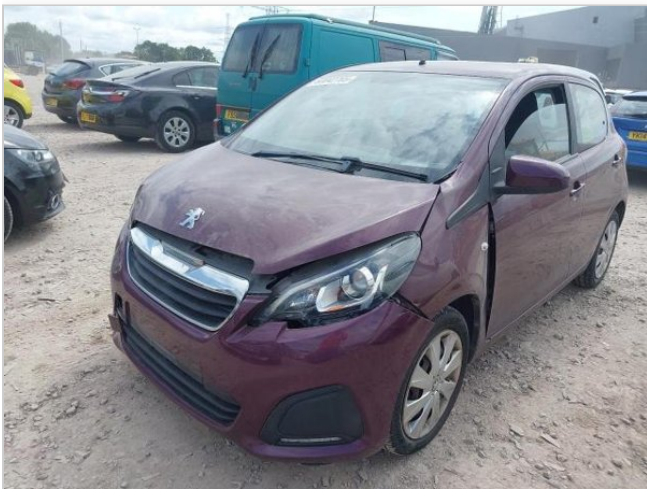
3

1. Front bumper cover (front)

Severity: moderate Repair: repair

The front bumper cover exhibits moderate deformation, likely from an impact. The damage is visible across a significant portion of the bumper, affecting its structural integrity.

2. Bonnet (front)

Severity: moderate **Repair:** repair

The bonnet has moderate deformation, suggesting a frontal impact. The damage affects the bonnet's ability to close properly and may impact aerodynamics.

Ensure alignment is checked post-repair.

Check for underlying structural damage.

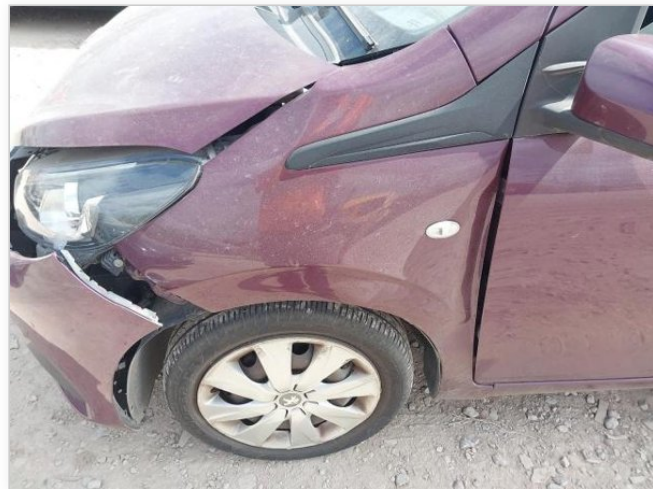
4

3. Left headlight (front LH)

Severity: moderate **Repair:** replace

The left headlight has a moderate crack, which may allow moisture ingress and affect light output. The integrity of the headlight is compromised.

Consider replacing the bulb if moisture is present.
