Richard H Lambie

104 Amanda Ln
Los Gatos CA 95032

Inspection Date
5/15/2024

Inspected By
Brett Reeder

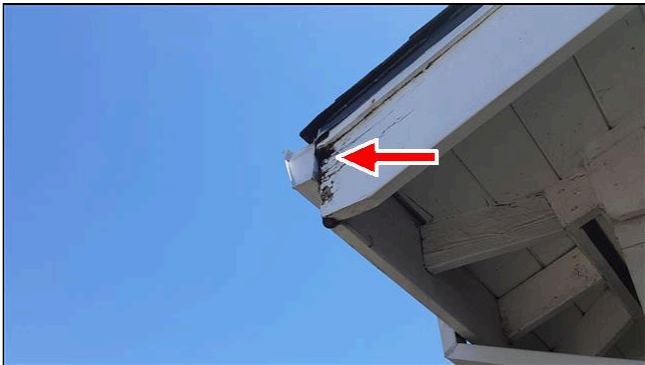
1.1 (Picture 2)

There was damage noted to rafter tails in various areas around the perimeter of the house (Pictures 1-5)

are examples). To prevent further damage this damage and the condition(s) causing this damage need to be corrected. I recommend contacting a qualified licensed structural pest control company at this time for further details to determine the extent of the damage and for appropriate corrections as needed.

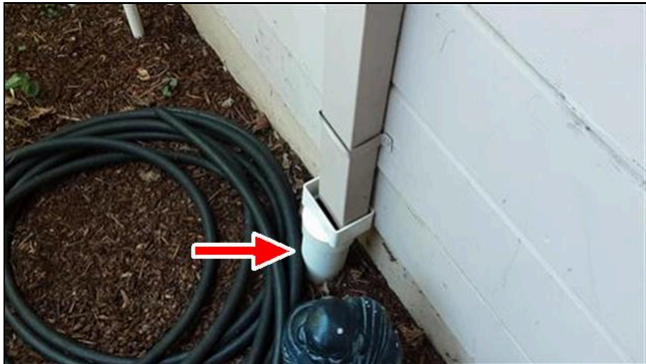
3.2 (Picture 1)

Please Note: Roof drainage systems need annual maintenance to remain functional. Controlling the roof water runoff is essential. Per our Standards of Practice, any installed underground drainage systems do not fall within the scope of this inspection and were not inspected (Pictures 1 & 2 are examples). If underground drainage systems exist, I recommend contacting a specialist in these systems for a complete evaluation to determine if they're fully functional and to make any needed repairs at this time.

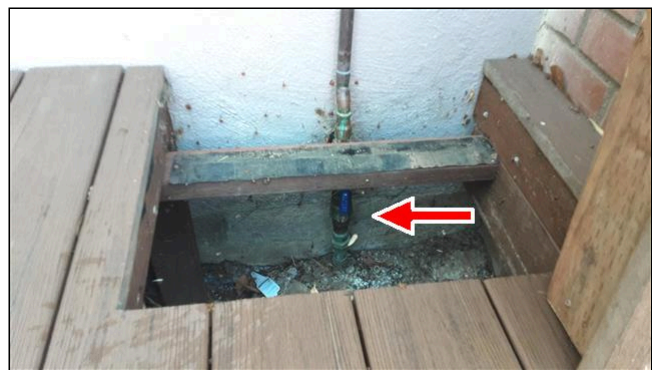
11.0 (Picture 1)

The main water shutoff valve was located at the left side of the house under the deck (Picture 1) was inspected for leaking and significant corrosion. However, per our standards of practice, these shutoff valves are not operated. The visible water flow from the fixtures in a given room were evaluated with multiple fixtures in use in the individual areas (bathroom and/or kitchen). The plumbing fixtures were not tested simultaneously in the bathrooms or kitchen, and testing for a drop in the water flow or temperature change throughout the house was not performed. No testing equipment was used to determine water pressure or quality. Any visible indications of needed further evaluation or needed repairs/corrections are noted in Summary Section 2.4

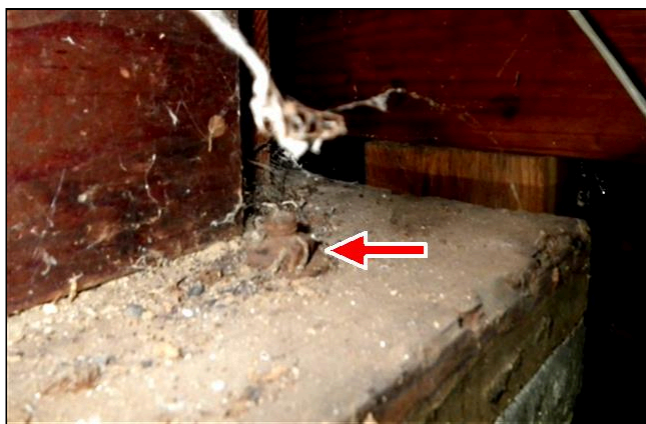
14.2 (Picture 1)

There were foundation bolts observed under the accessible areas of the home connecting the wood framing to the foundation (Picture 1 is an example). Any visible indications in need of further evaluation, monitoring or needed repairs/corrections are noted in Summary Section 2.10
