## Home Inspection Report

**16513 Bonnie Lane, Los Gatos**

Shawn Anderson  
May 3, 2024

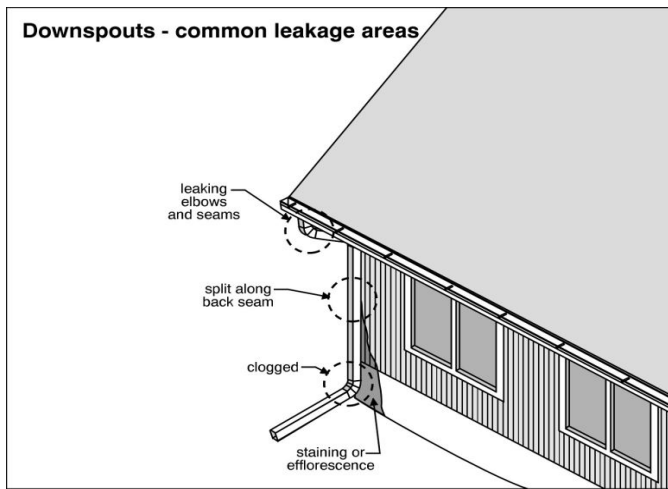
*Illustration 2D*

1. Leaks were noted in the downspouts and/or gutters at the front. During wet weather conditions these areas are more obvious and during dry weather conditions they are noted from the stains at the areas where the leaks have occurred. We recommend all leaks be repaired. (See Illustration 2D) (See Photo 7)

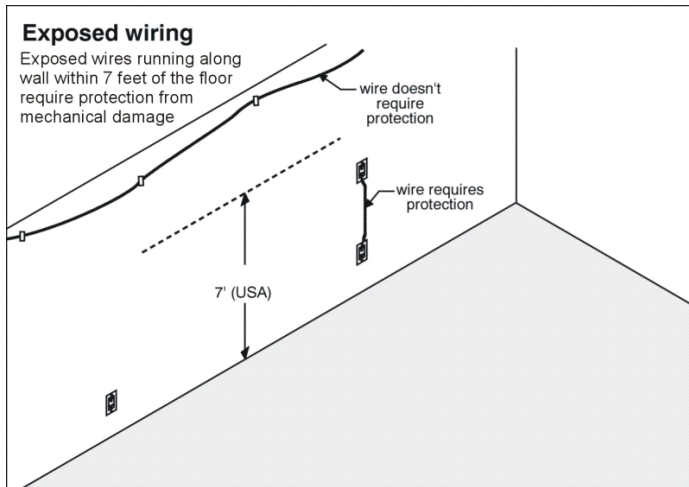
Illustration 4E

9. We found exposed wiring at the garage walls below 7' feet. Even if insulated, we recommend all wiring be encased in conduit or otherwise protected in accordance with present standards. (See Illustration 4E) (See Photo 9)

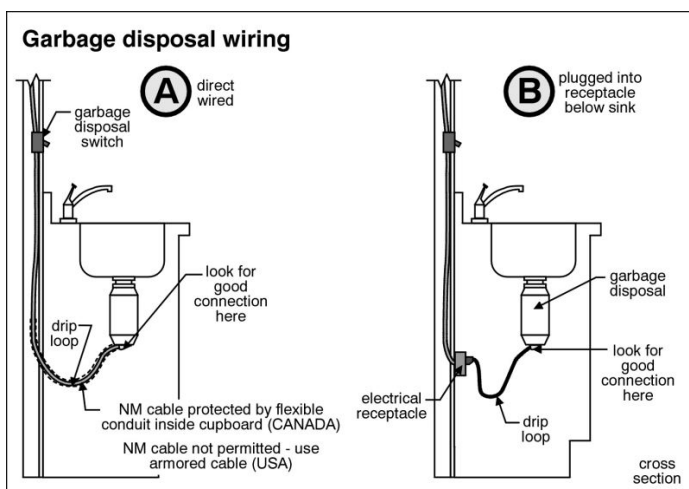
Illustration 9H

13. The power cord is not secured where it enters the bottom of the disposal and can be easily damaged. For maximum safety, we recommend the power cord be properly connected to the disposal. (See Illustration 9H) (See Photo 12)
