Body port : 3
Simulation : OFF
Vessel : Ranform ATLAS
Date : Tue May 30 16:14:02 2017
Author : ATLAS seismic crew
Version : beta 1.01
Test DB : ReportDB_Tue May 30 16:13:59 2017.sq3

Wings Condition monitoring

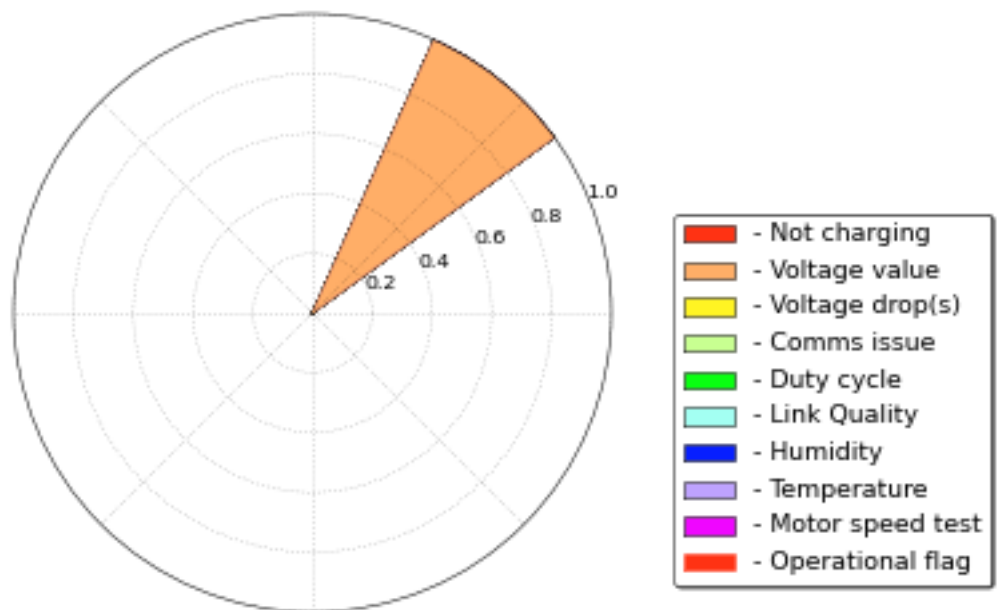
Prognostic graph & QR code

Element : - Voltage value Severity: 1 Notice

Recommendation: A test should always be followed by a wing cover inspection and a manual wing rotational test to detect loose mechanism.
