Body port : 1
Simulation : OFF
Vessel : Ranform ATLAS
Date : Tue May 30 15:32:24 2017
Author : ATLAS seismic crew
Version : beta 1.01
Test DB : ReportDB_Tue May 30 15:32:20 2017.sq3

Wings Condition monitoring

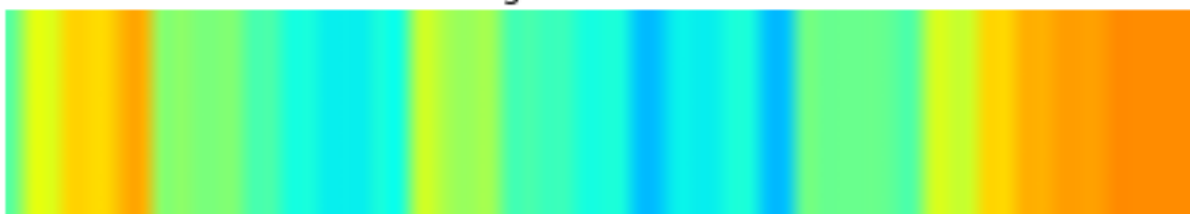
Average current matrice

Maximum current: 52.0 mA		Wing has been charging
Minimum current: -36.0 mA		
Average current: 4.37 mA		
Current variation: 88.0 mA		
Charging capacity: 60.51 mA/H		Wing charging.

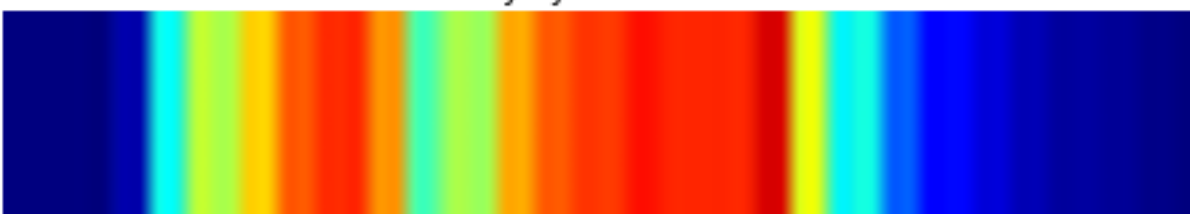
Duty cycle matrice

Maximum duty cycle: 92 %	
Minimum duty cycle: 0 %	
Average duty cycle: 45.15 %

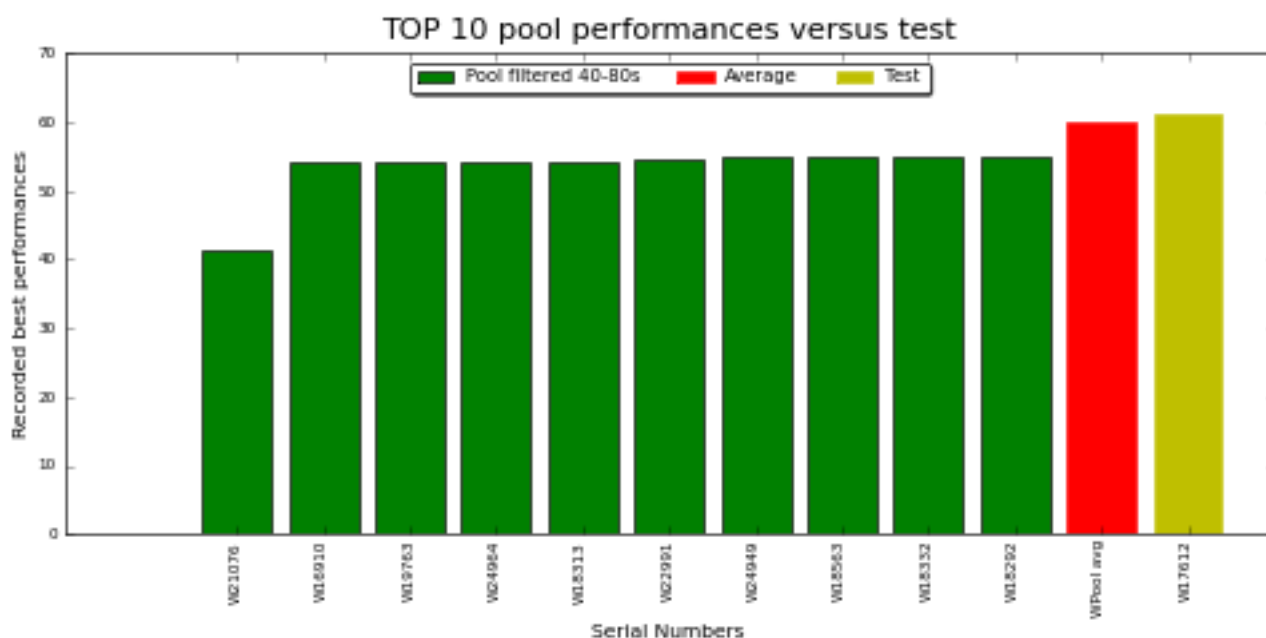
Speed (this test) : 61.053 seconds

Warning! motor speed is lower than average

Pool classement : 113/150

Recommendation: A test should always be followed by a wing cover inspection and a manual wing rotational test to detect loose mechanism.
