Simulation : False  
Vessel : Ranform Atlas  
Date : Wed May 3 23:36:39 2017  
Author : Berenguer Yoann  
Version : beta 1.01

## Body Condition monitoring

## Body QC checks

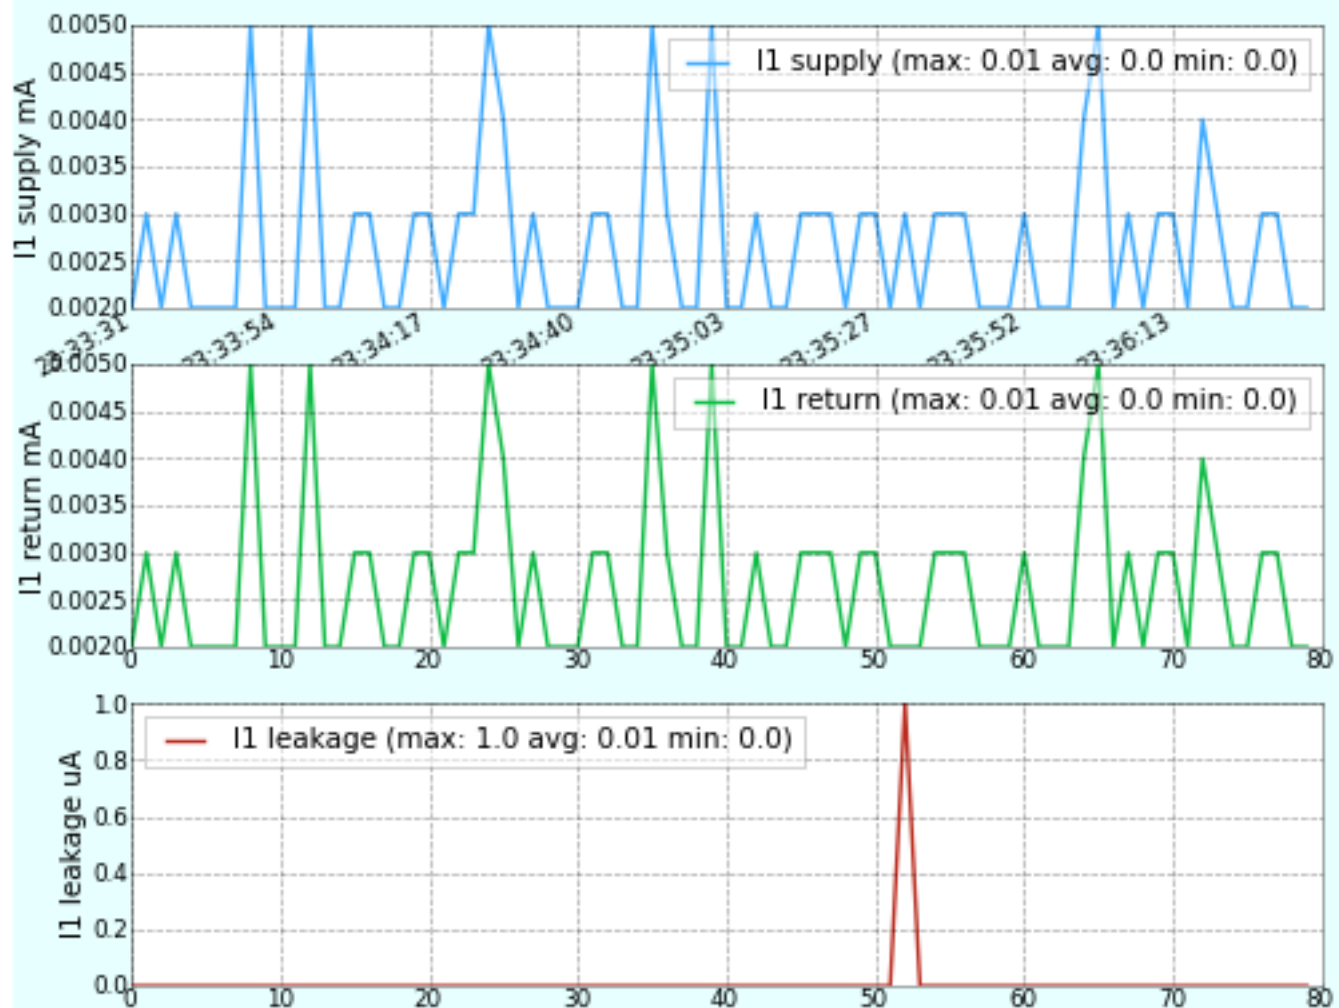
### L1 current plots

## Leakage detection

Leakage detected: no

Leakage recurrence: None

Leakage maximum: 1.0

Leakage average: 0.01

Leakage minimum: 0.0

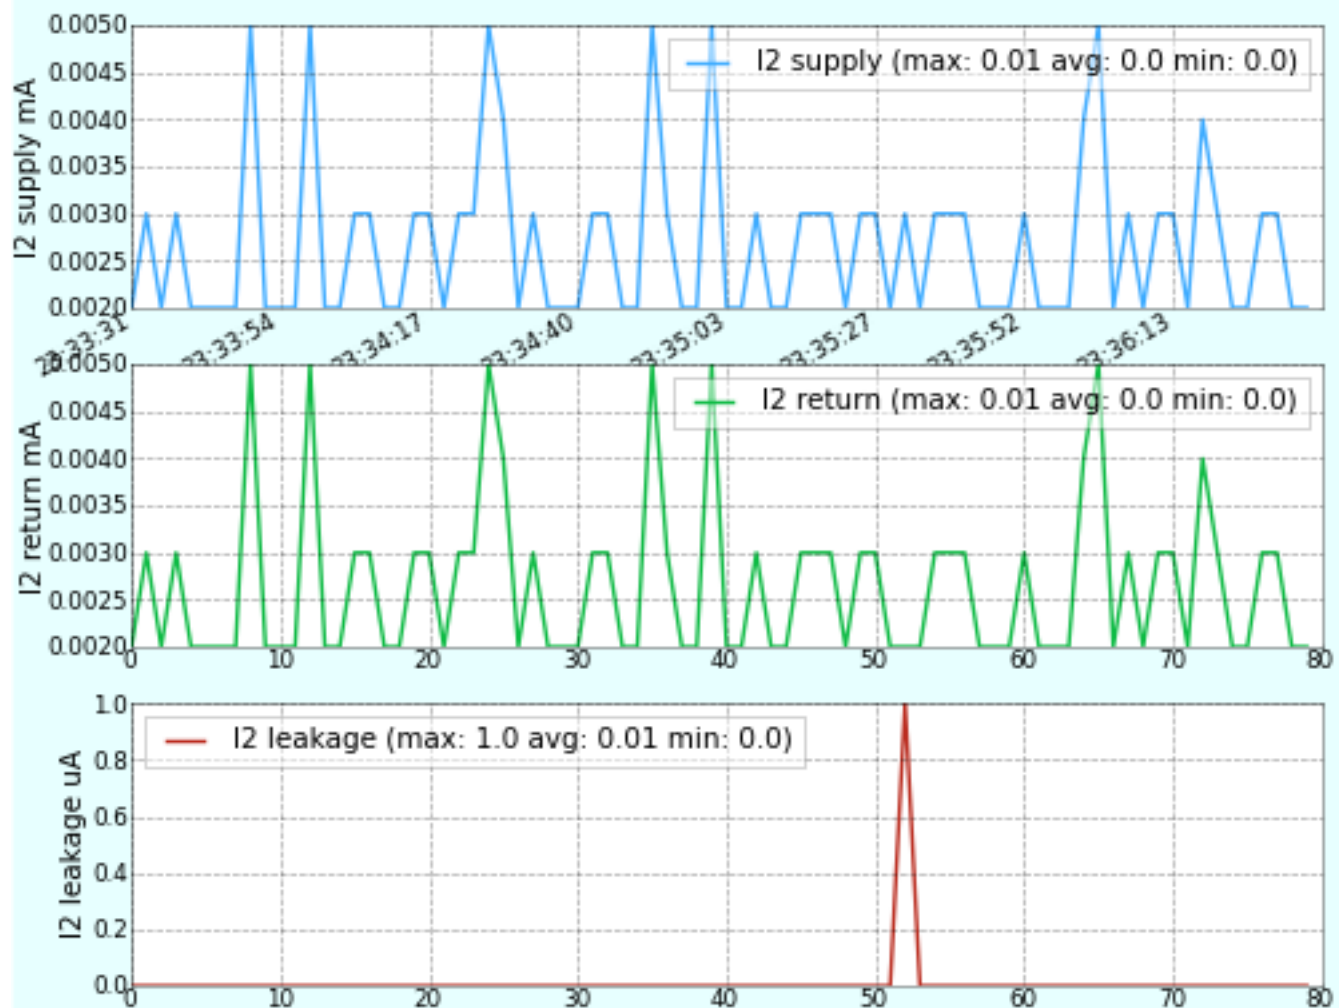
### L2 current plots

Element : - Firmware outdated	Severity: 0	Pass
Element : - Rotation count	Severity: 0	Pass
Element : - Humidity	Severity: 2	Warning
Element : - DT recalibration	Severity: 4	Fail
Element : - Temperature	Severity: 0	Pass
Element : - DT test @0m	Severity: 0	Pass
Element : - DT test @10m	Severity: 0	Pass
Element : - DT test @20m	Severity: 0	Pass
Element : - Leakage L1	Severity: 0	Pass
Element : - Leakage L2	Severity: 0	Pass
