# Tech Tip 19: Firmware Loading Tool Best Practices and Troubleshooting

**Product Class: Firmware Loading Tool**

### **Firmware Loading Tool - Best Practices**

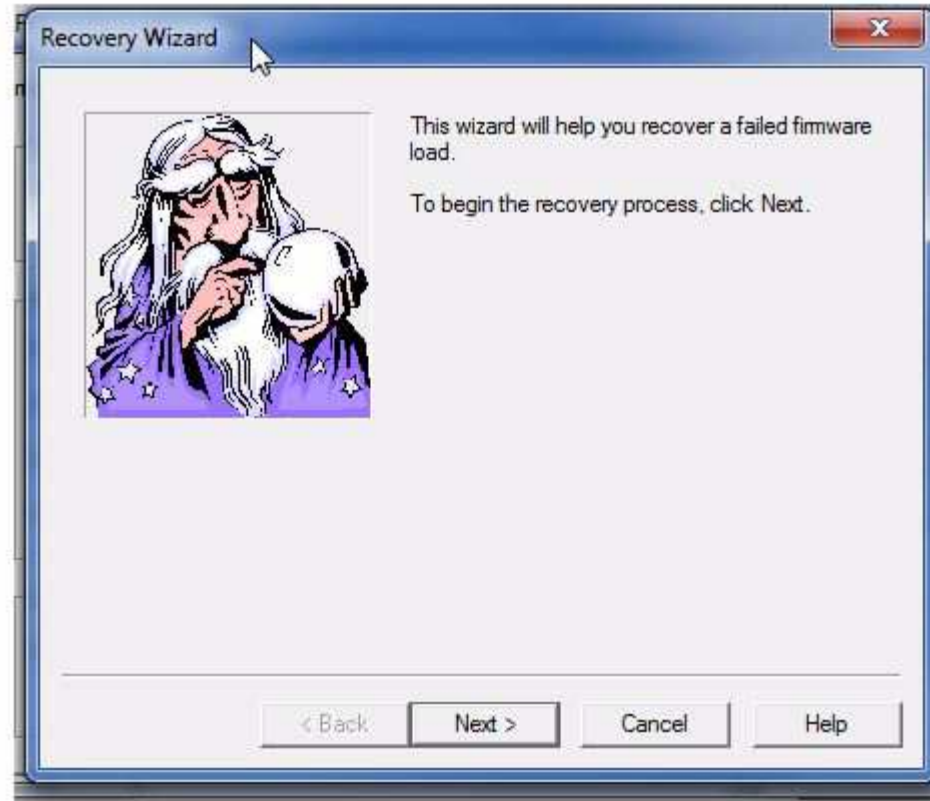
3. From the System menu, click Recover Failed Firmware Load. The Recovery Wizard displays.

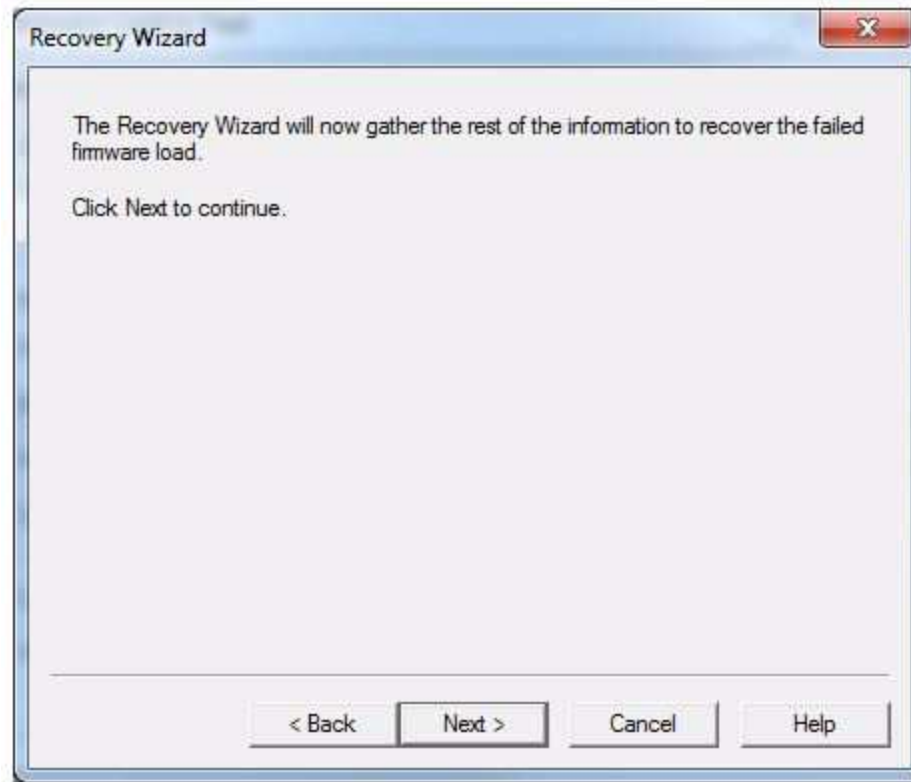
8. The Recovery Wizard now displays a message indicating that it is recovering a failed firmware or language load.

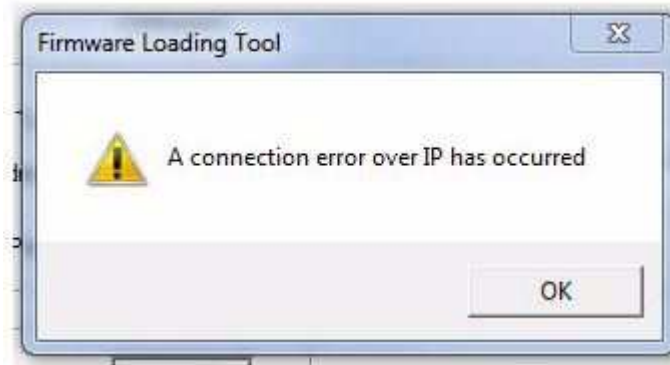
When attempting to identify a panel after configuring the IP setting the following error may occur:

This error will occur if one of the two scenarios is true

1. Telnet is not enabled on the panel
2. Telnet is being blocked on the customer network
