A vaccine cold chain temperature monitoring study in the United Mexican States

Verónica Carrión Falcón^a, Yara Verónica Villalobos Porras^b, César Misael Gómez Altamirano^c, Umit Kartoglu^{d,*}

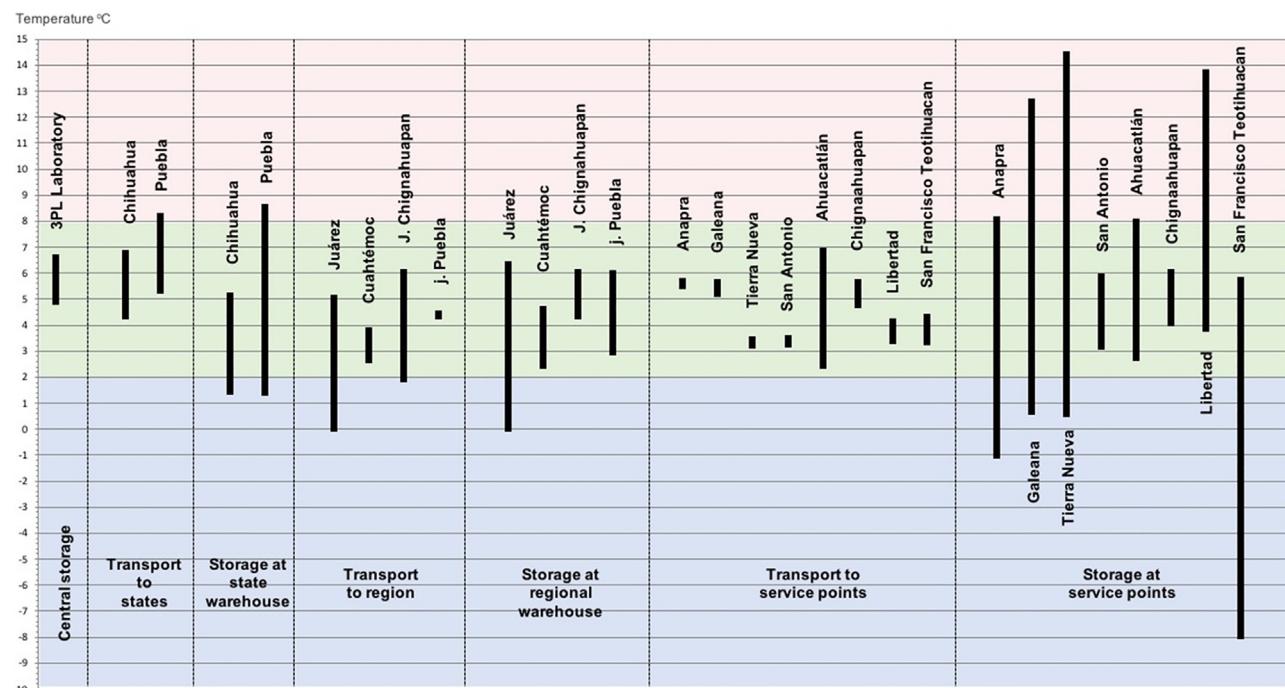
Fig. 3. Minimum and maximum temperature recordings along the vaccine cold chain throughout the study (July–December 2018).

Fig. 3 shows the minimum and maximum temperature recordings inside the study packages along the vaccine cold chain throughout the study.

Ninety two percent of the time, temperatures were kept between recommended temperature range of 2–8 °C. Temperature variation got wider when products moved from 3PL Laboratory to service points. The wider variation is found at the service points. The biggest range was found in Tierra Nueva (13.82 °C) followed by San Francisco Teotihuacan (13.67 °C). However, it should be noted that the negative temperatures in Tierra Nueva were recorded between 26 October 2018 at 02:07 am and 09:27 am for 7 h and 20 min. Same day manual recording of the temperature indicated as 2.5 °C.

Despite this, it should be noted that temperatures below 0 °C and above 8 °C are found to be short exposures by time (less than one hour). In Chihuahua state store, half of the time, temperatures were below 2 °C but did not exceed 0 °C. Vaccines were kept at temperatures between 1.99 °C and 0.0 °C 91% of their storage time. In Anapra service point, a similar pattern was observed, but much shorter (16% of the storage time). Regarding the temperatures above the 8 °C, the longest exposure was observed in Galeana (5% of the storage time).

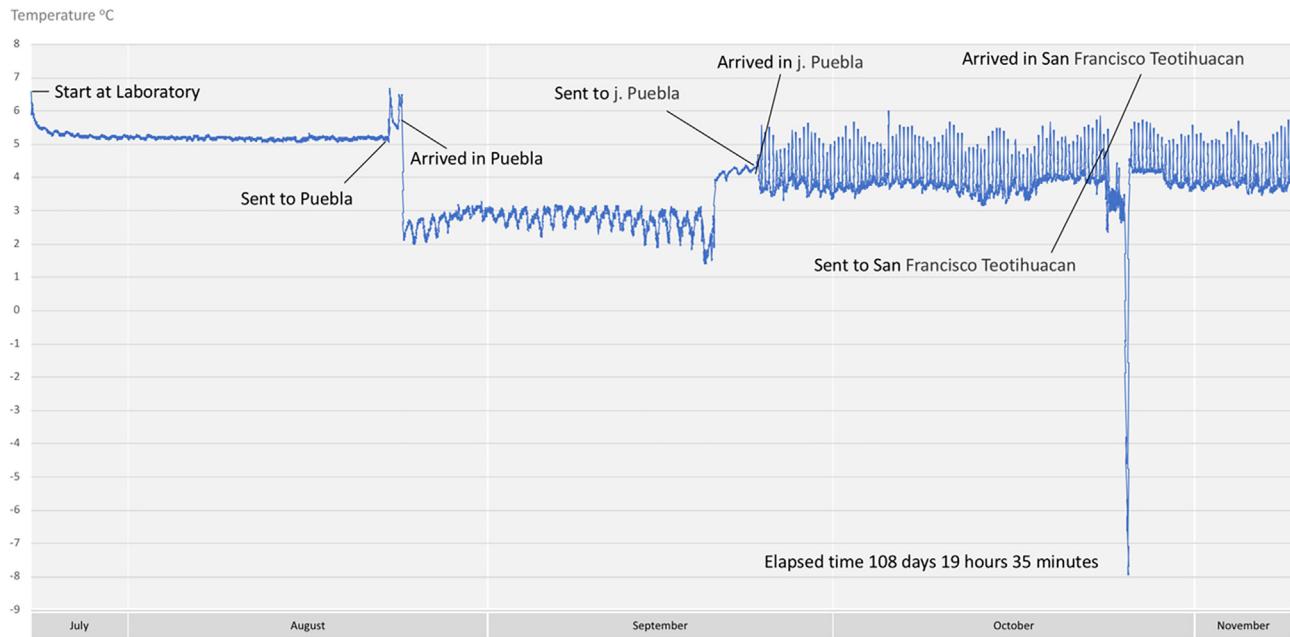
Fig. 4. Temperature profile throughout the study, destination San Francisco Teotihuacan.

Fig. 4 gives full details of temperature recordings by a selected destination (San Francisco Teotihuacan).

The negative temperature excursion in San Francisco Teotihuacan was due to malfunction of the refrigerator over the night which was noticed in the morning.

The most serious negative temperature exposure was observed at San Francisco Teotihuacan service point refrigerator. The lowest temperature recorded during the storage was –7.94 °C. This negative temperature exposure started after midnight and was in total 7 h and 20 min (see Fig. 5).

This exposure resulted in FREEZEmarker® L to trigger. Despite 7 h and 20 min exposure to temperatures below 0 °C, no physical difference was observed in HepB vaccines in the morning. The shake test resulted in a pass result, meaning that vaccines were not affected by freezing. Although scientific freezing point for HepB is at -0.5 °C, freezing is a very complex process and requires more than negative temperature exposure below the particular freezing point of the product. In the validation of the shake test study, freeze sensitive vaccines, including HepB were exposed to -2°C for 24 h and none of the vaccines were found to be affected at this exposure [15]. Besides average temperature being set close to 2 °C, there is no other explanation what could have triggered this one-time event on that particular night.

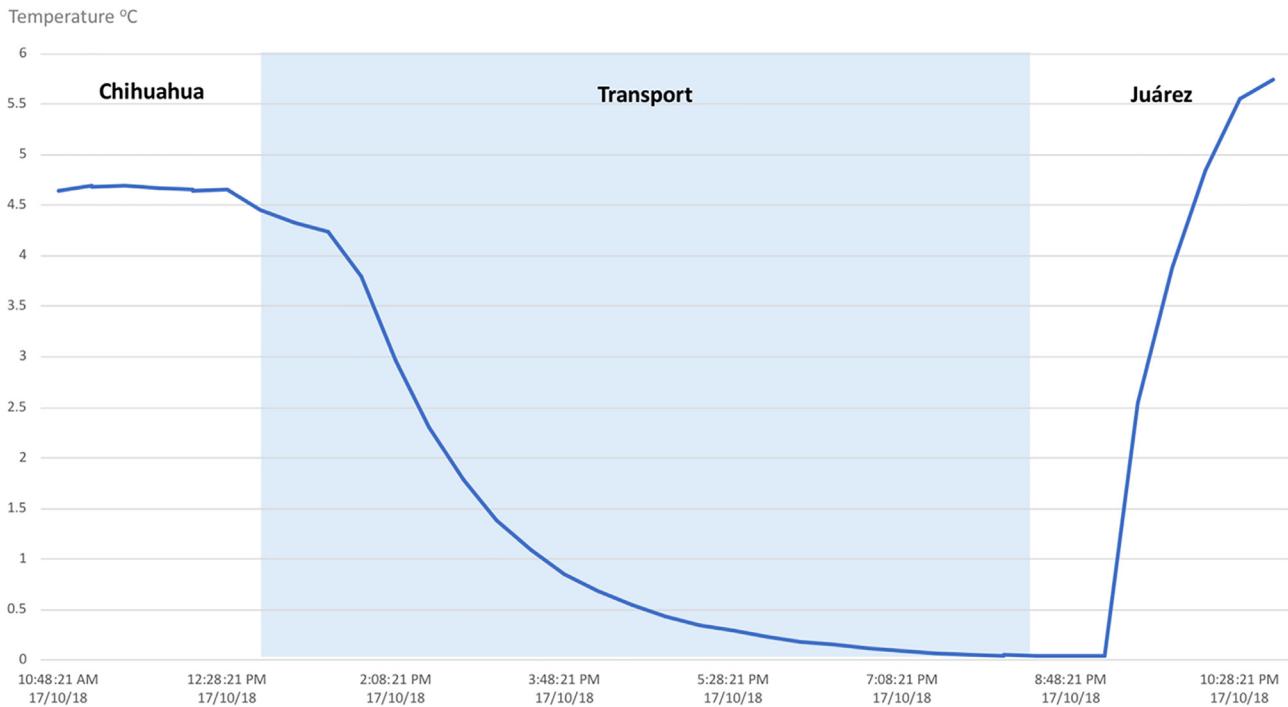
Fig. 6. Temperature details of dispatch, transport and arrival of study package between Chihuahua and Juárez.

The lowest temperature recorded in Juárez comes right after receiving the shipment of study package from Chihuahua. Once the study package is moved in to Juárez storage facility, in 45 min the temperature of the package reached 2.5 °C, and continued to 5 °C. Fig. 6 shows the details of this dispatch, transport and arrival period.

A temperature-controlled truck is used for transport. Common practice is to use conditioned icepacks inside the expanded polystyrene (EPS) insulated boxes where the products are loaded. In theory, the additional 0 °C conditioned icepacks create quite a strong cold thermal mass inside the container forcing heat to be removed from the vaccines, and potentially risking vaccines to be exposed to freezing temperatures especially in the case of inadequate conditioning. In theory, when a temperature-controlled truck is used, additional thermal mass is not required in packages.

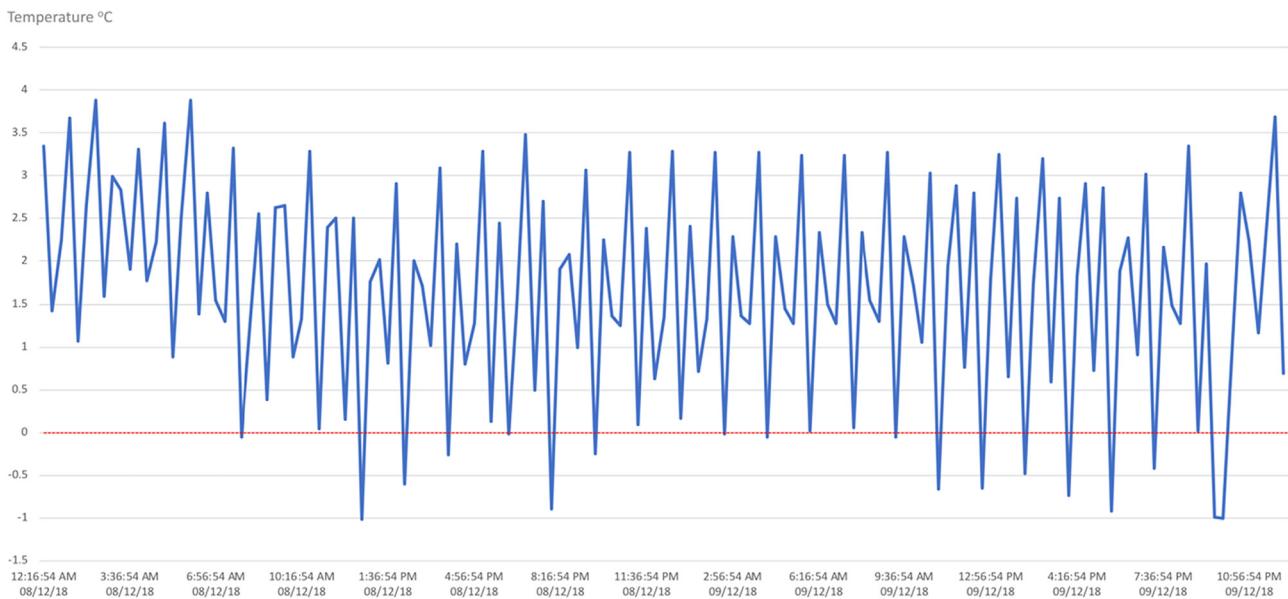
Fig. 7. Cyclic details of temperature in Anapra service point refrigerator.

Another detail analysis of the negative temperature exposure during the storage at Anapra service point indicates that the aver-

age temperature in the refrigerator is set too low (around 2 °C), and as a result, the cycling temperatures always go to 0 °C and sometimes below. Fig. 7 shows a two-day period from this service point to illustrate the problem.

Because of having the average temperature close to 2 °C almost in all cold chain equipment, it is critical that the cold rooms and service point refrigerators be temperature mapped and the set-points calibrated and raised to 5 °C.

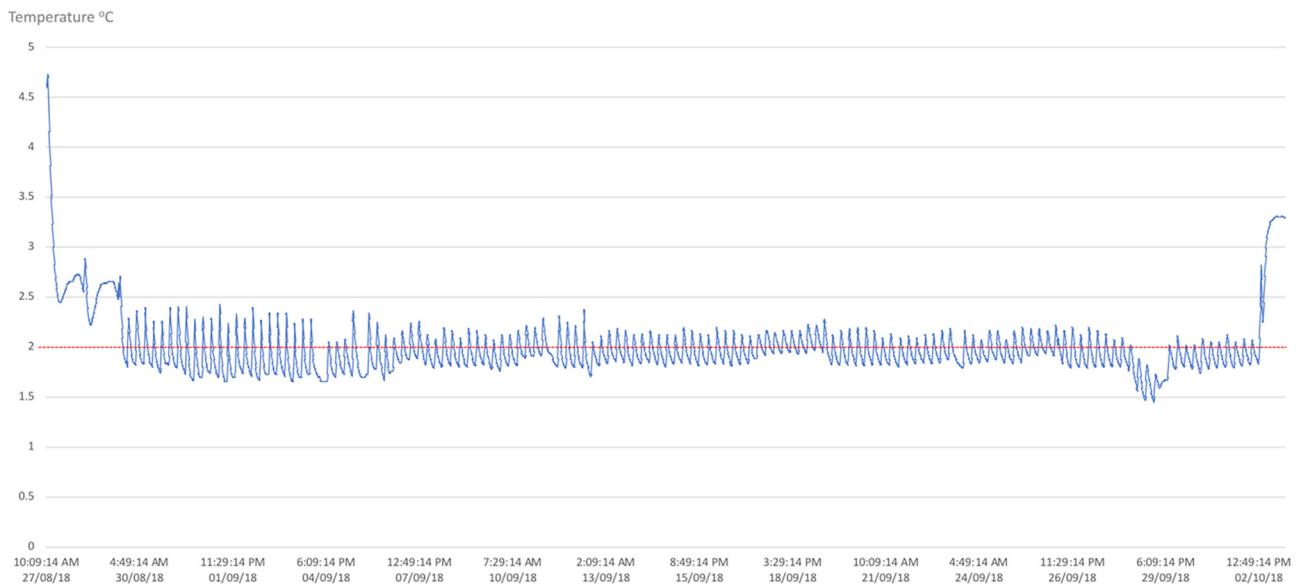
Fig. 8. Chihuahua state cold room temperatures during the storage of study packs.

A similar phenomenon is found in Chihuahua state cold room. 91% of their storage time vaccines were exposed to temperatures below 2.0 °C. However, the temperatures never reached 0.0 °C. Full storage time and temperatures in Chihuahua state cold room are displayed in Fig. 8.
