### Silicon identification

This errata sheet applies to the revisions 'A', 'Z' and '1' of STMicroelectronics STM32F405xx/STM32F407xx and STM32F415xx/STM32F417xx microcontroller families. In this document, they will be referred to as STM32F40x and STM32F41x, respectively, unless otherwise specified.

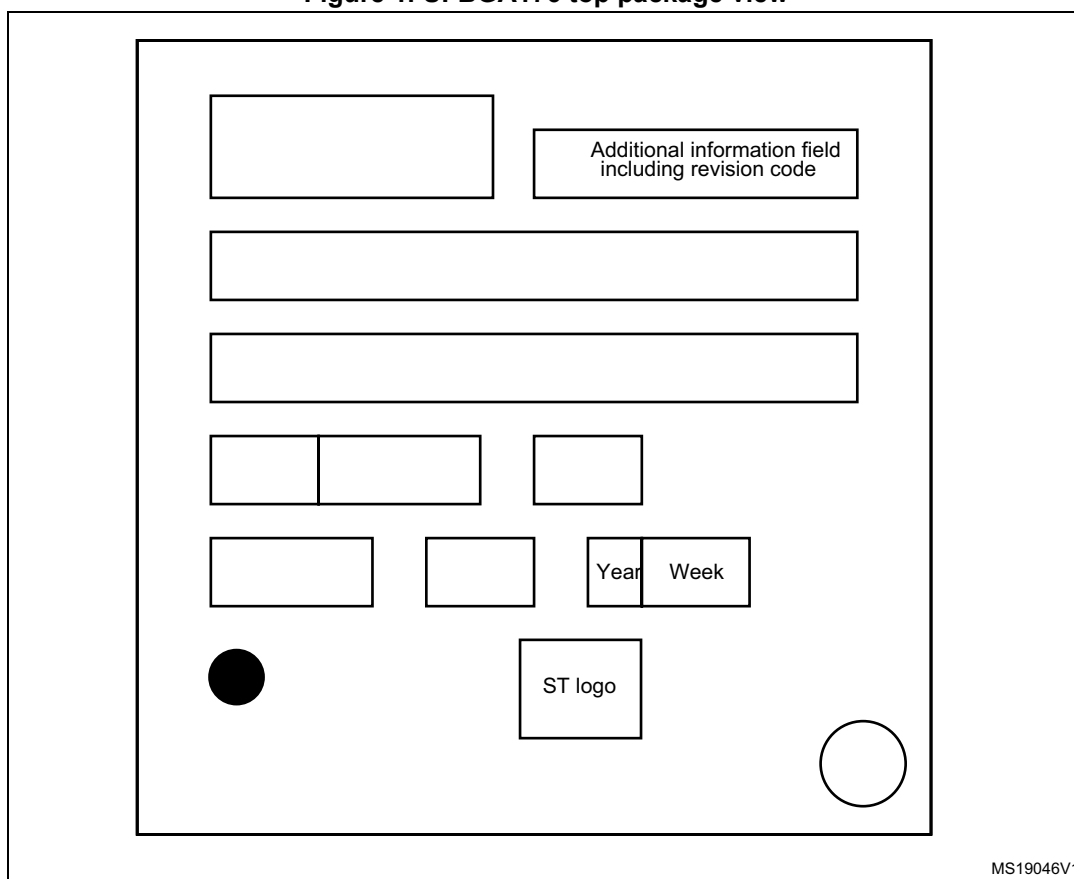
**Figure 1. UFBGA176 top package view**

[Figure 1](#), [Figure 2](#), [Figure 3](#), [Figure 4](#), [Figure 5](#) and [Figure 6](#) show the marking compositions for the UFBGA176, LQFP176, LQFP144, LQFP100, LQFP64 and WLCSP90 packages, respectively. The only fields shown are the Additional field containing the revision code and the Year and Week fields making up the date code.
