Identifying Persistent X States in Serving RAM's Read Path

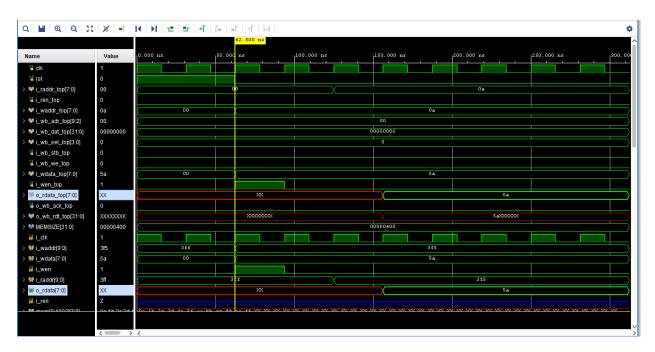
Figure: 01 – Faulty Read Behavior – Baseline Waveform for Debugging

This waveform captures faulty behavior in the SRAM's read path. Specifically:

- → o_rdata_top[7:0] and o_rdata[7:0] stay X for an extended duration, even after valid address and enable signals are applied.
- → A read request is made (i_ren_top = 1, i_raddr_top = 0x00) while the system is out of reset, yet the read data output is not valid for multiple clock cycles.
- → o_rdata is not driven immediately and stays undefined. This suggests either the internal memory was not initialized or the logic to drive o_rdata was gated behind handshake signals.
- → Meanwhile i_wdata_top, i_waddr_top, etc. show correct behavior, confirming the write path works fine.

Figure 01 represents a **functional issue** — not just a transient glitch. The prolonged undefined state of o_rdata makes it unreliable during the first few read cycles. The root cause lies in the lack of:

- → Proper memory initialization,
- → Default assignments to output signals,
- → Immediate data forwarding logic upon valid reads.

This behavior must be corrected to ensure timing-accurate and deterministic reads from the memory module.

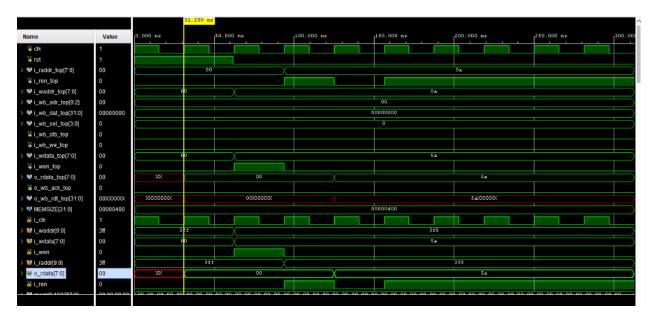
Figure: 03 – Response after memory initialization

Initially, o_rdata is undefined (X) because it hasn't been assigned a value before the first clock edge. After the rising edge of i_clk and deassertion of i_rst, a write occurs (i_wen=1, writing 0x5a to address 0x3f). On the subsequent read (i_wen=0), o_rdata correctly outputs 0x5a, confirming successful memory write and readback.
