History of BLHeli-Suite Revisions

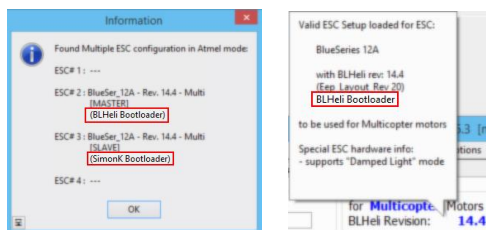
- Removed support for 4way-interfaces with protocol rev <6/106.
- Fixed minor bug in BLHeli_S LED Control hint.
- Added status messages for the ESC connection mode
