HP Color LaserJet Enterprise M552, M553

HP Color LaserJet Enterprise MFP M577

Control Panel Message Document (CPMD)

HP Color LaserJet Enterprise, Managed M552, M553, M554, M555, E55040, MFP M577, M578, MFP E57540 - Control Panel Message Document (CPMD)

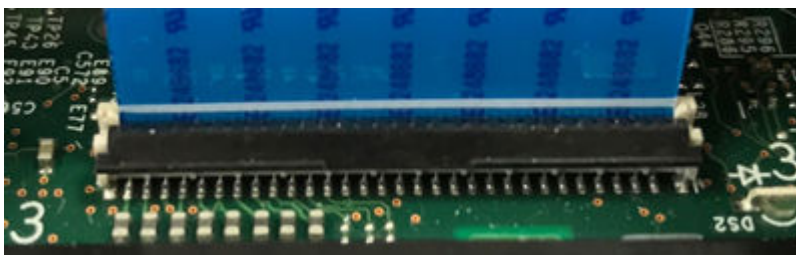
Figure 6-50 Improper insertion

ZIF connectors have gates that need to be opened and closed for proper removal/reinsertion. These connectors are significantly different than the Light Insertion Force (LIF) connectors found on some other LaserJet printer families.

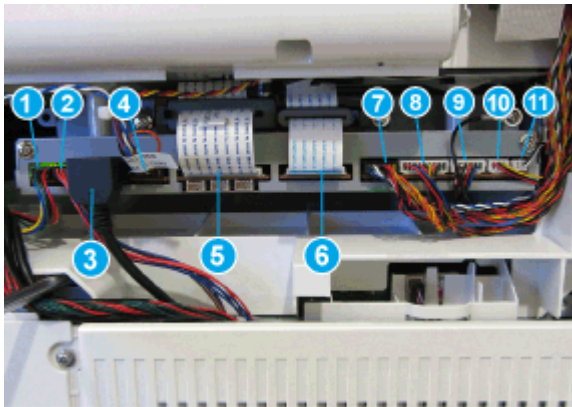
Figure 6-53 Scanner control board (SCB) connections

Backside illumination calibration failure.

3. Verify the cables between the image scanner and the SCB are correctly connected.

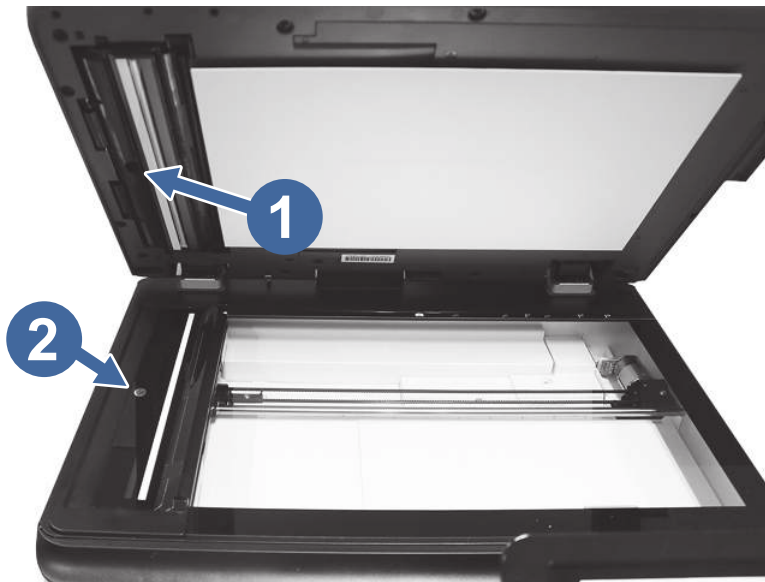
- b. Check for any paper remnants blocking the sensor as well as wiping any paper dust off the glass in the region shown below. If significant debris has accumulated over the circular mirror (used for paper edge sensing) this can cause a paper jam error.

Callout 1: Check for paper blocking this area.

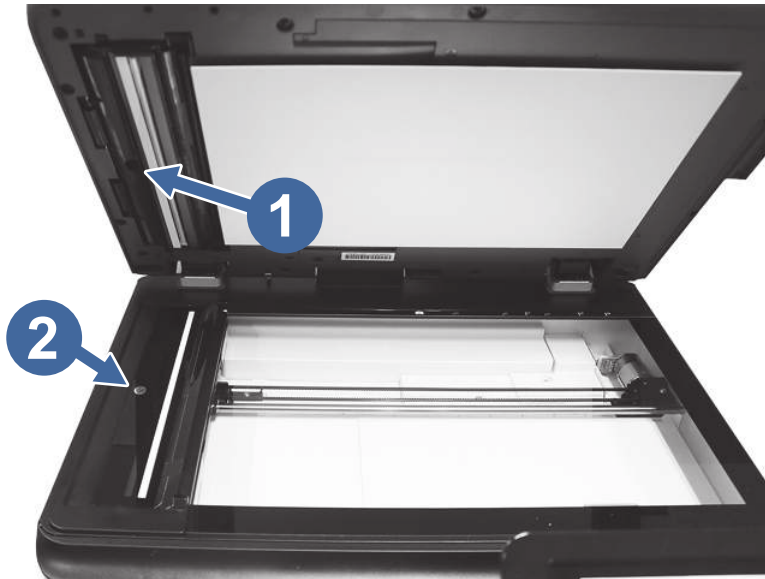
- b. Check for any paper remnants blocking the sensor as well as wiping any paper dust off the glass in the region shown below. If significant debris has accumulated over the circular mirror (used for paper edge sensing) this can cause a paper jam error.

Callout 1: Check for paper blocking this area.

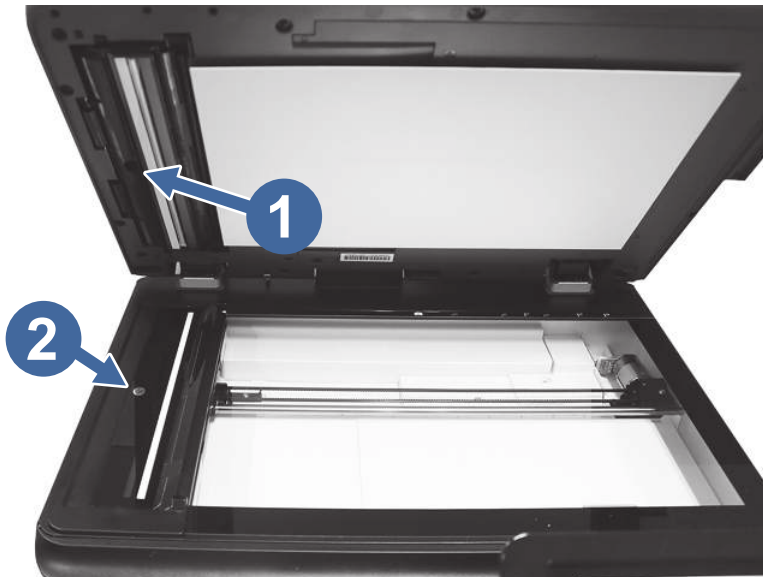
10. Check the REDI sensor reflector on flatbed. If there is any dust or fiber remnants, clean it by using a can of compressed air to blow out and clean. (related issue, ADF jam without paper inside)

Callout 1: Check for paper blocking this area.

Callout 2: Clean this area with a damp lint free cloth.

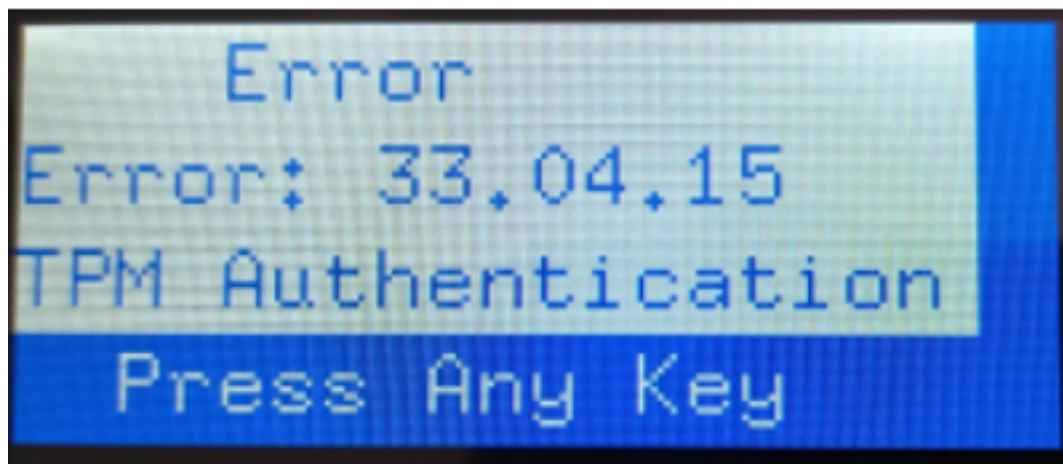
Follow these troubleshooting steps in the order presented.

An error message "**Error: 33.04.15 TPM Authentication**" displays on the printer control panel when the formatter with the part number "B5L46-60008" is installed on an HP LaserJet Managed MFP E57540.

This change implied that the formatter manufacturing part number "B5L46-60008" for MFP M578 was installed for MFP E57540. As this formatter was incompatible with a Trusted Platform Module (TPM) accessory, it caused an error message to display on the control panel when installed on a MFP E57540 with a TPM accessory.

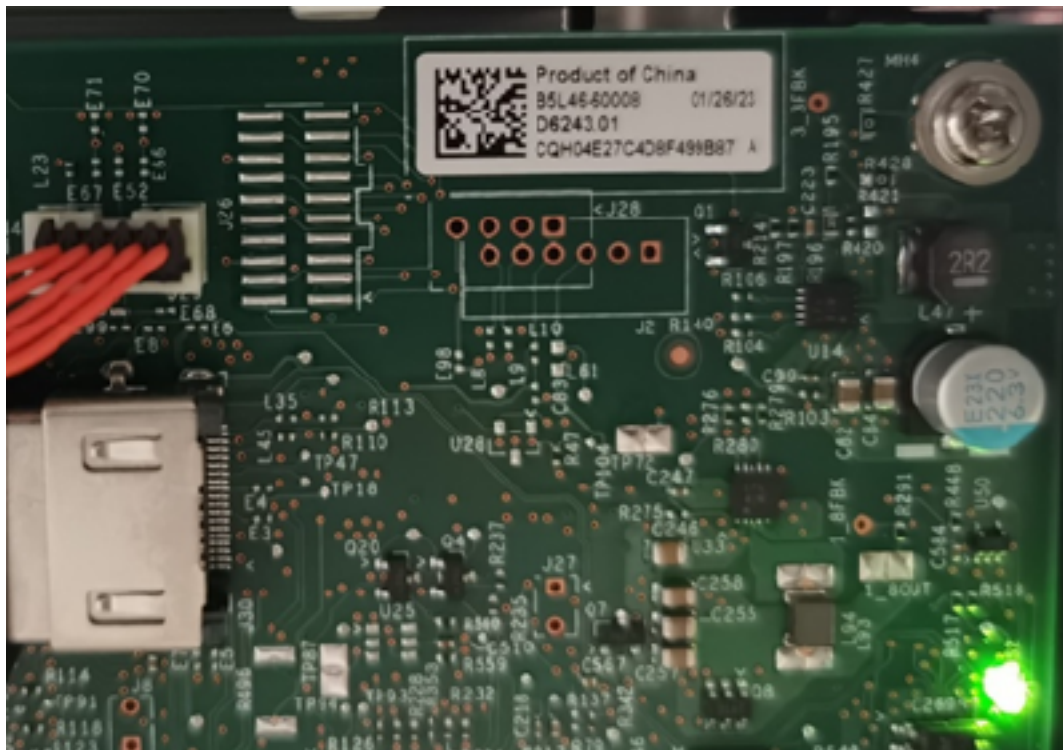
Figure 6-71 Formatter B5L46-60008 with the TPM accessory

NOTE: If a service to replace the formatter on MFP M577 or E57540 is required and the customer has the TPM accessory, this issue will occur if the replacement formatter has the manufacturing number "B5L46-60008" on the label.

1. Remove the TPM Module.
 - a. Use the power button to turn off the printer and disconnect the power cable.
 - b. Remove the formatter cover, and then remove the hard disk drive (HDD).

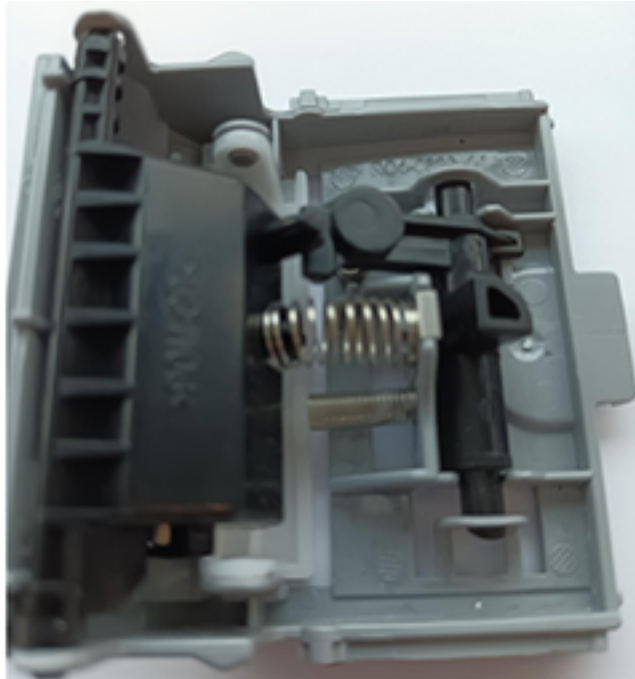
Figure 6-76 Location of springs in the separation pad assembly for Tray 2

If the separation pad does not spring back up, the springs might be missing.

NOTE: The separation pad assembly is mounted to a spring and should move up and down freely when installed correctly

- d. Replace the tray 2 roller assembly.

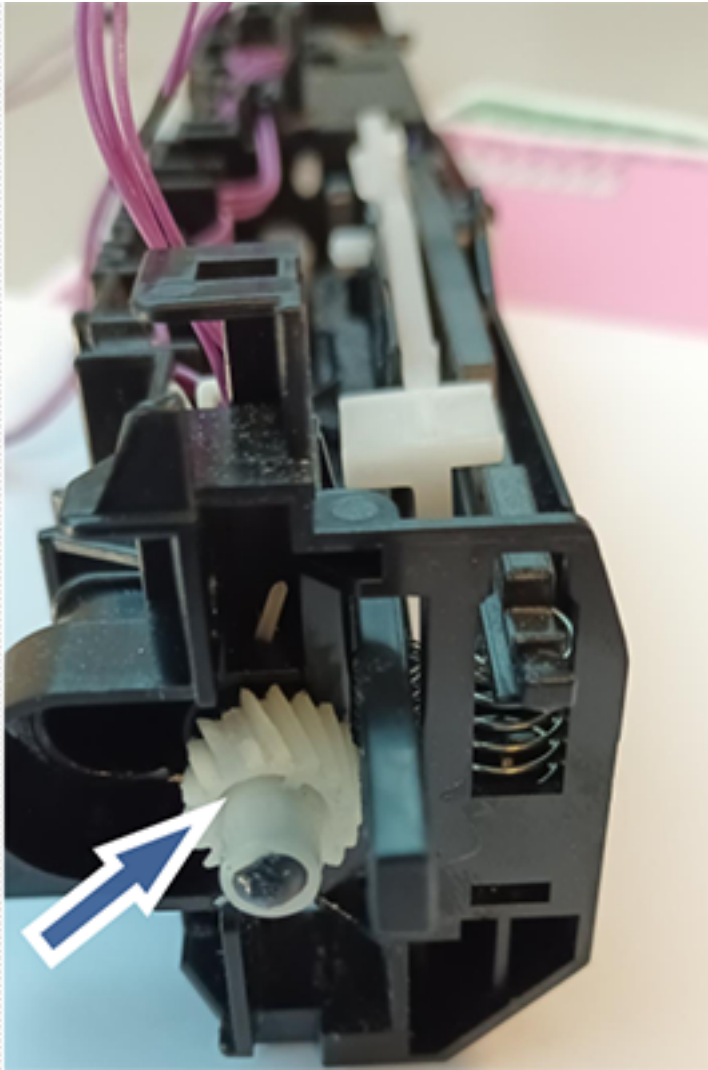
Figure 6-77 Broken gear teeth on pick up gear

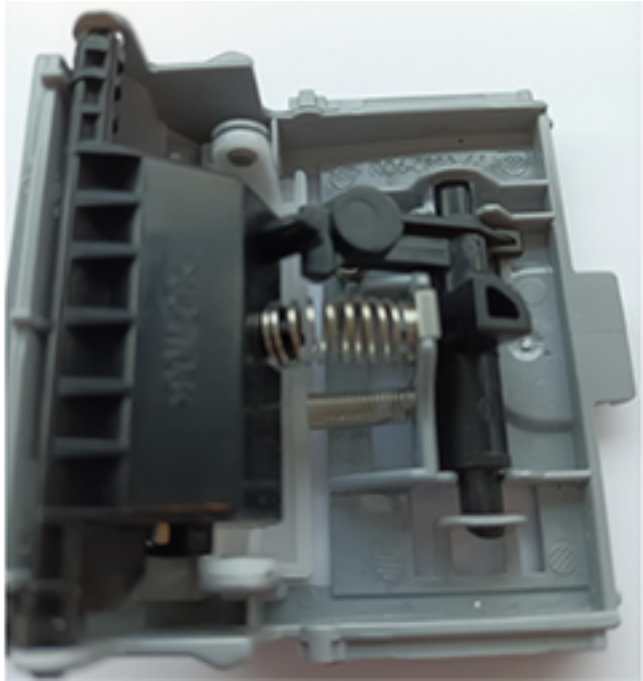
Figure 6-78 Location of springs in the separation pad assembly for Tray 2

3. Verify tray 2 pick-up, feed, and separation rollers are not dirty.
- Use compressed air or a clean, lint-free cloth moistened with warm water to clean the rollers.
4. Ensure the tray 2 pick-up, feed, and separation rollers are not worn, or damaged.
5. Check if the tray 2 separation pad is installed correctly or if the springs are missing.
- a. Pull tray 2 out. Lift the front of the tray, and then pull it out of the printer to remove it.
 - b. Locate the separation pad.
 - c. Push down on the separation pad, and then release it to check if the springs are missing.
- If the separation pad does not spring back up, the springs might be missing.

NOTE: The separation pad assembly is mounted to a spring that should move when pushed down. When installed correctly, the separation pad should move up and down on the spring.

- d. Replace the tray 2 roller assembly.

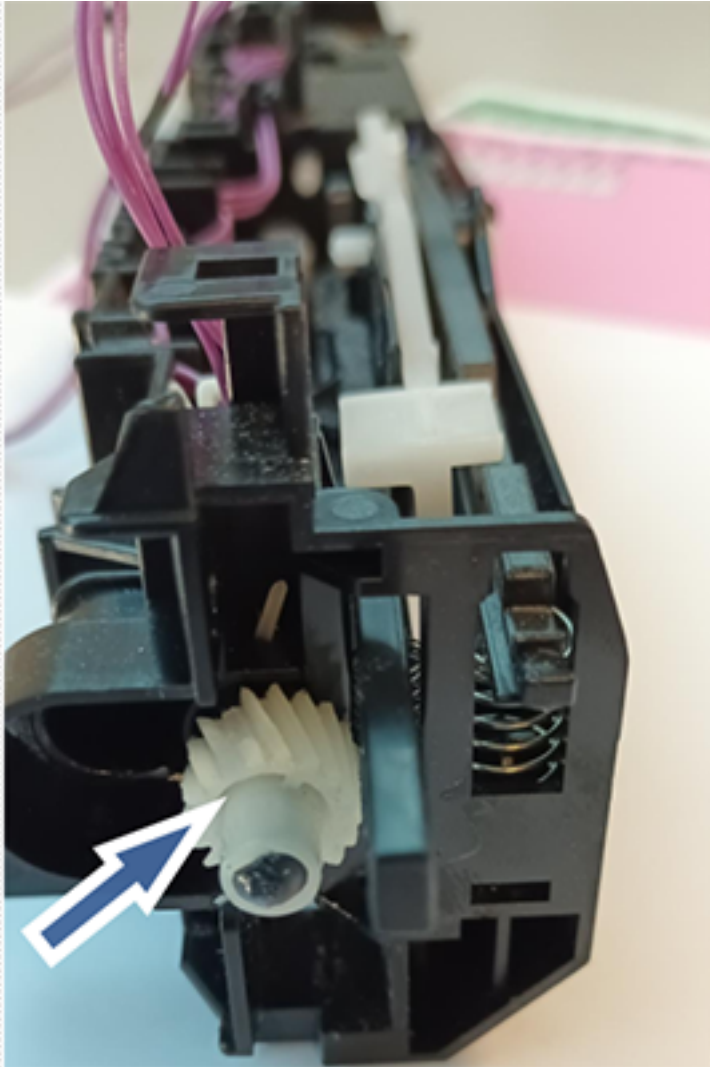
Figure 6-79 Broken gear teeth on pick up gear

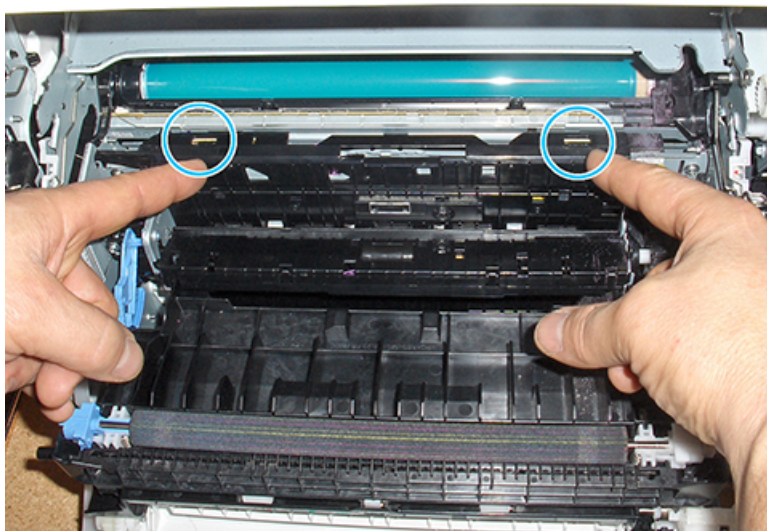
Figure 6-80 Front and rear density sensors

NOTE: To clean the density sensors open right and front doors and remove both the fuser and ITB.

Close the front door to expose the density sensors for cleaning as shown in the following image.

3. Reconnect the connector (J120) on the DC controller PCA.
4. If the error persists, replace the registration density sensor assembly.

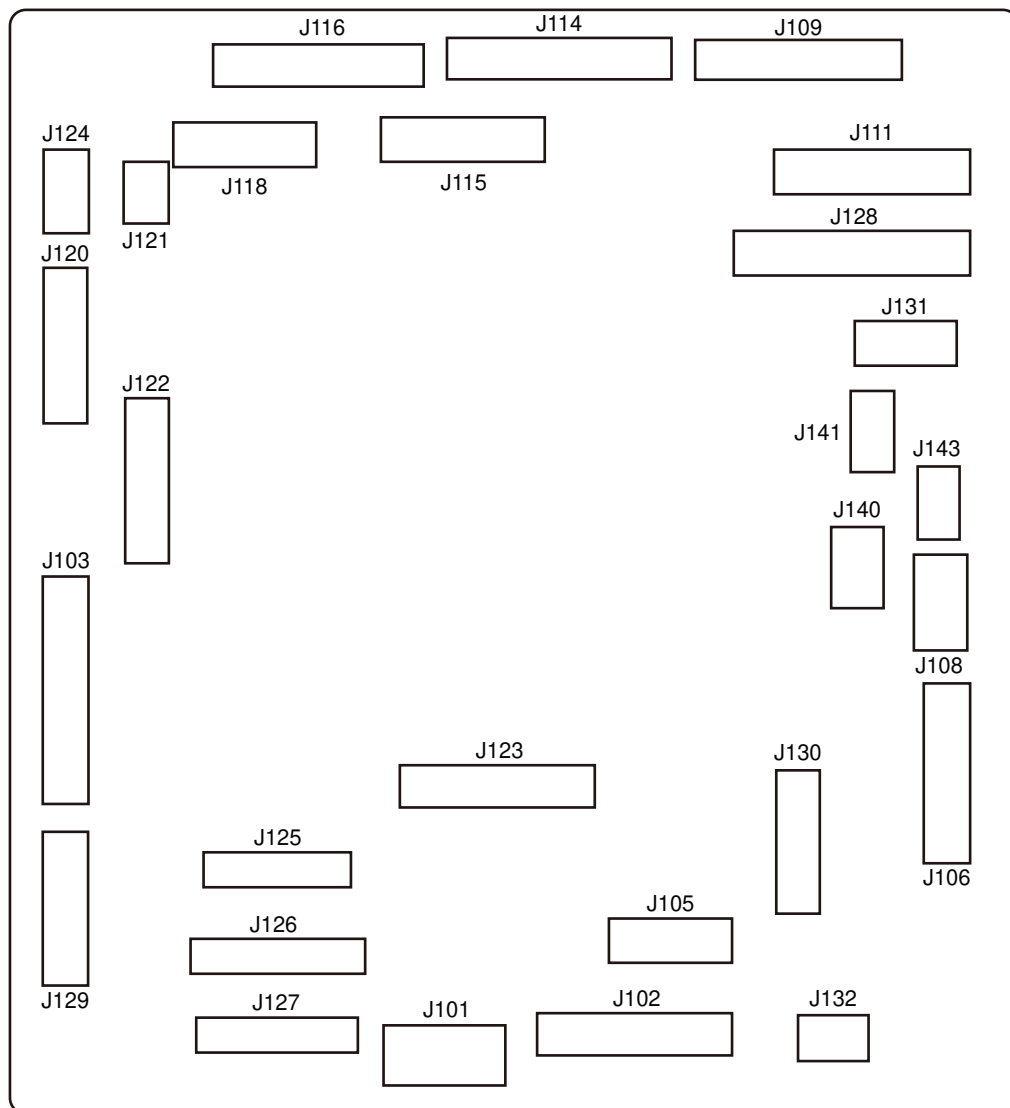
Figure 6-91 DC controller PCA connections

1. Turn the printer off, then on.
2. Check the exhaust fan (FM3).
 - Disconnect and reconnect the connector (J2505) on the high-voltage power supply
 - Disconnect and reconnect connector (J109) on the DC controller PCA.

3. If the error persists, replace the exhaust fan (FM3).

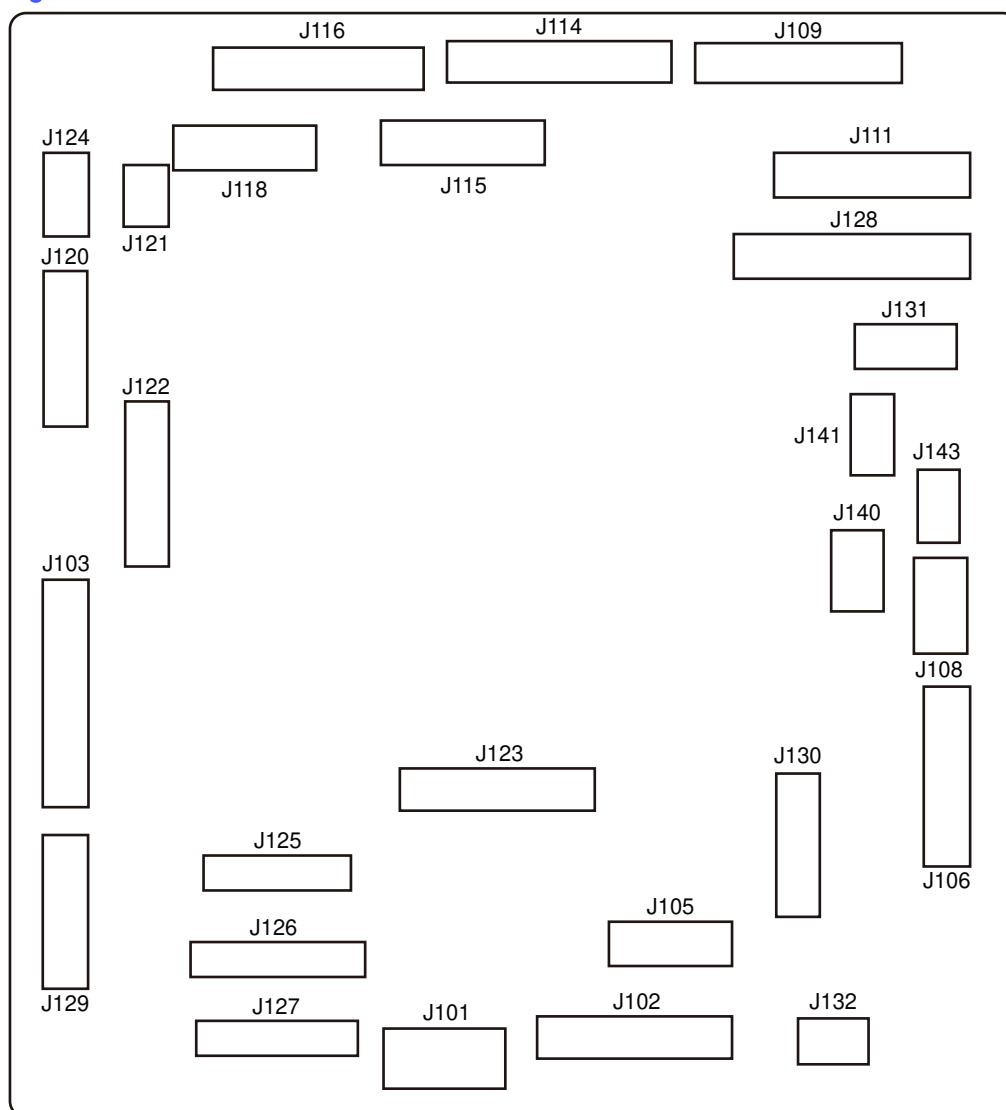
Figure 6-92 DC controller PCA connections

1. Turn the printer power off, and then on.
2. Check the cartridge fan, FM2.
 - Disconnect and reconnect the connectors (J6003 and J606) on the fuser power supply assembly.
 - Disconnect and reconnect connector (J128) on the DC controller PCA.

3. If the error persists replace the cartridge fan FM2.

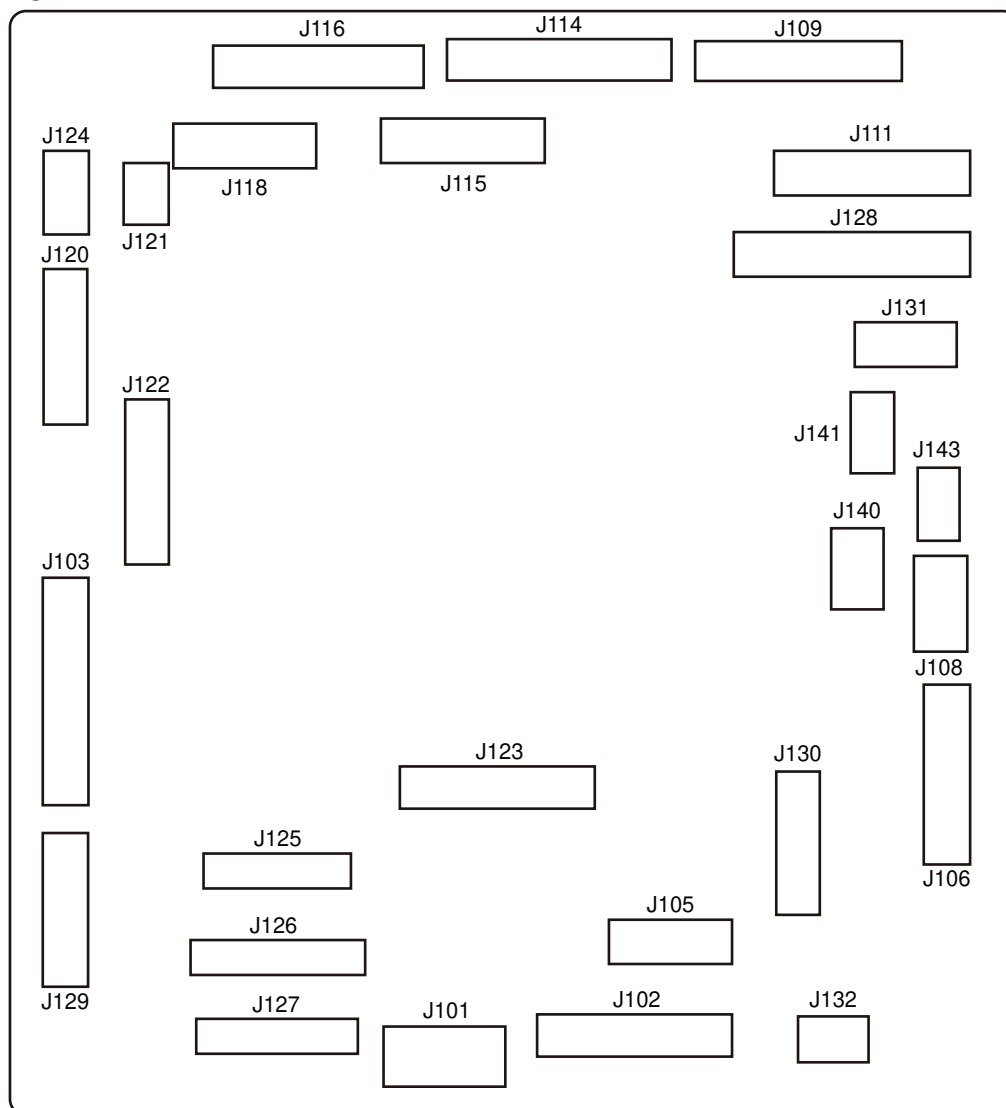
Figure 6-93 DC controller PCA connections

1. Turn the printer power off, and then on.
2. Check the power supply fan, FM1.
 - Disconnect and reconnect the connectors (J602 and J603) on the low-voltage power supply assembly.
 - Disconnect and reconnect connector (J105) on the DC controller PCA.

3. If the error persists, replace the power supply fan FM1.

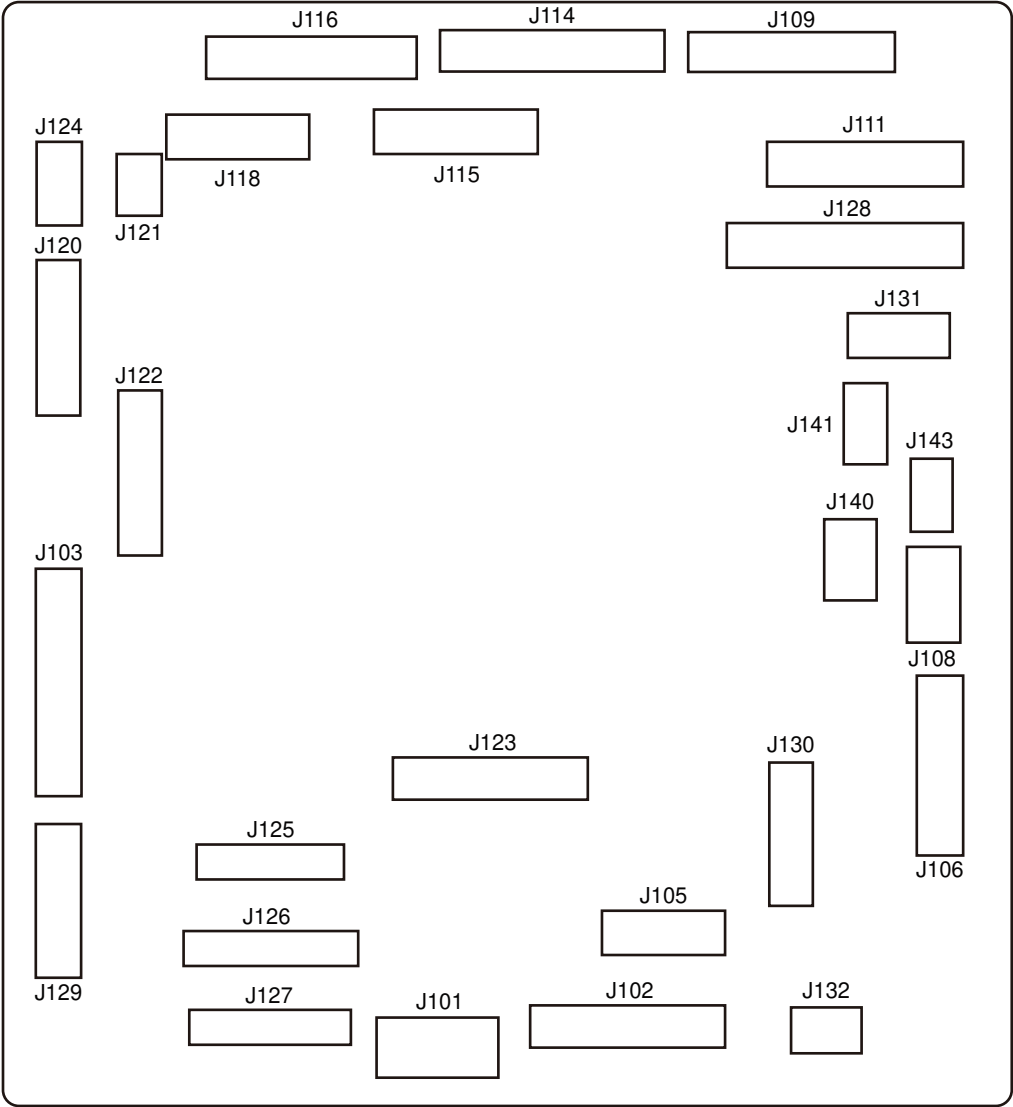
Figure 6-94 DC controller PCA connections

1. Turn the printer off, then on.
2. Check the fuser fan (FM4).
 - Disconnect and reconnect the connector (J54) of the fuser fan, intermediate connector (J1801).
 - Disconnect and reconnect the intermediate connector (J1801).
 - Disconnect and reconnect the intermediate connector (J2506) on the high-voltage power supply -T PCA
 - Disconnect and reconnect the intermediate connector (J109) on the DC controller PCA.

**NOTE:** Technicians can measure the voltage between the connectors (J109-2 and J109-3) on the DC controller PCA immediately after the printer is turned on. If the voltage changes from 0V to approximately 24V, replace the fuser fan FM4. If the voltage is not present, check the voltages for other fans and replace the DC Controller as needed.

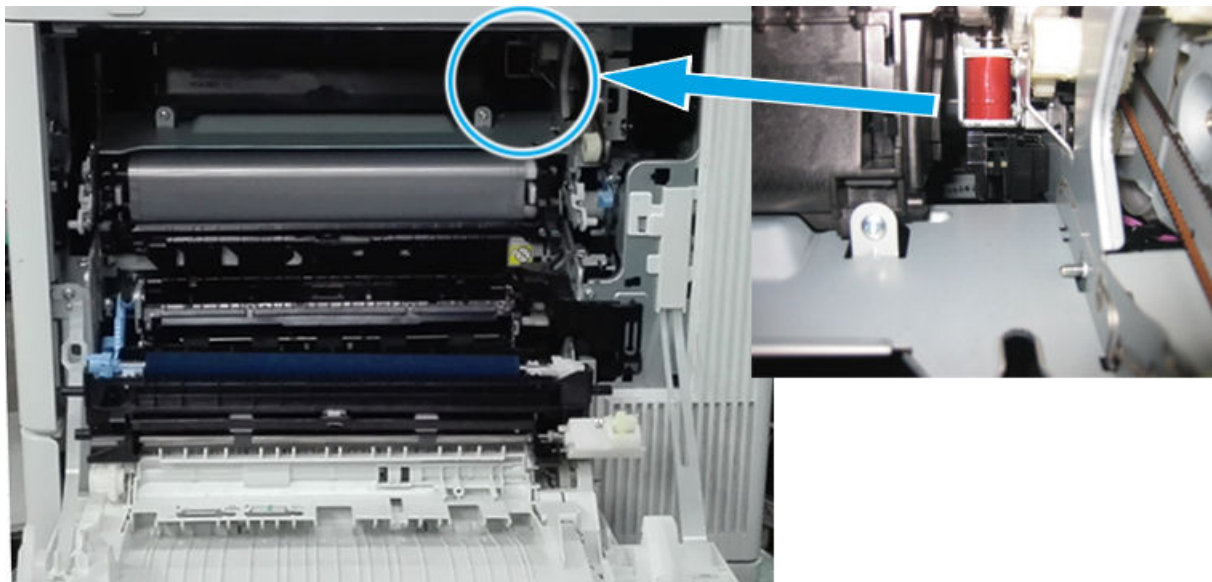
Figure 6-103 ITB Detect PCA housing

7. Use the following steps and images for reference. Check the PCA sensor and the black plastic housing that detects the ITB to ensure they are installed correctly.
 - a. Locate the sensor for the ITB on the right side of the printer (remove the fuser and it is directly behind it on the right side).

- b. Close up image of the right showing the small PCA that the sensor is mounted to. This PCA must be parallel with the bottom of the solenoid. If it is skewed or tilted in any angle and not parallel, this part needs to be removed and the PCA re-seated in the plastic housing correctly.

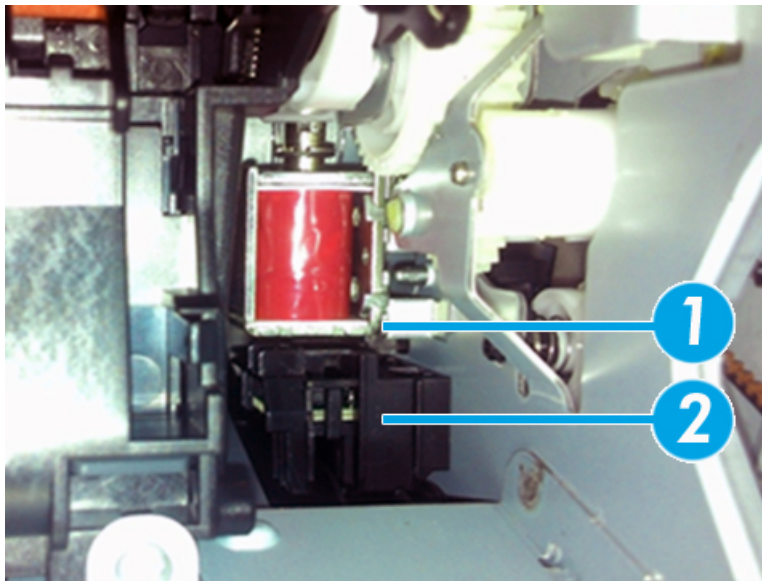
Figure 6-104 PCA housing correctly mounted

Callout 1 Solenoid base

Callout 2 PCA with sensor

The PCA must be parallel with the solenoid base as shown in the image

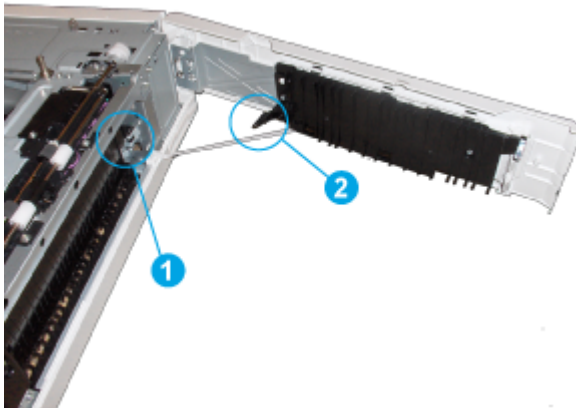
Figure 7-1 500 Sheet paper tray door

See **callout 2** in the following image for flag location.

4. Check connector J2022 on the paper feeder right door switch and connector J1902 on the paper feeder controller PCA.

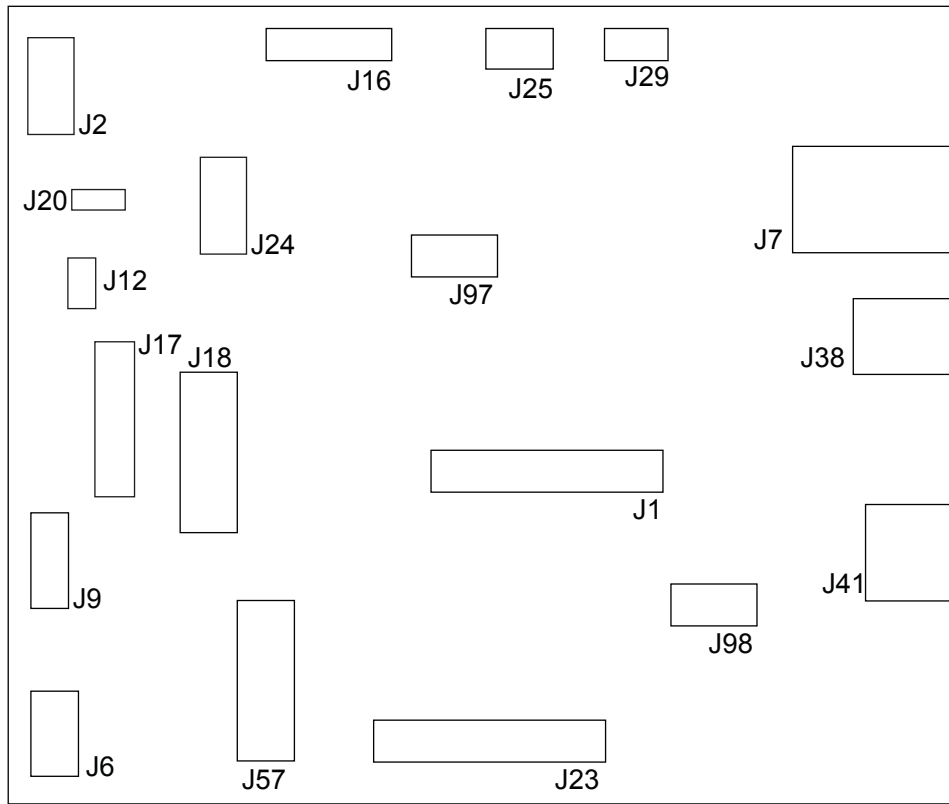
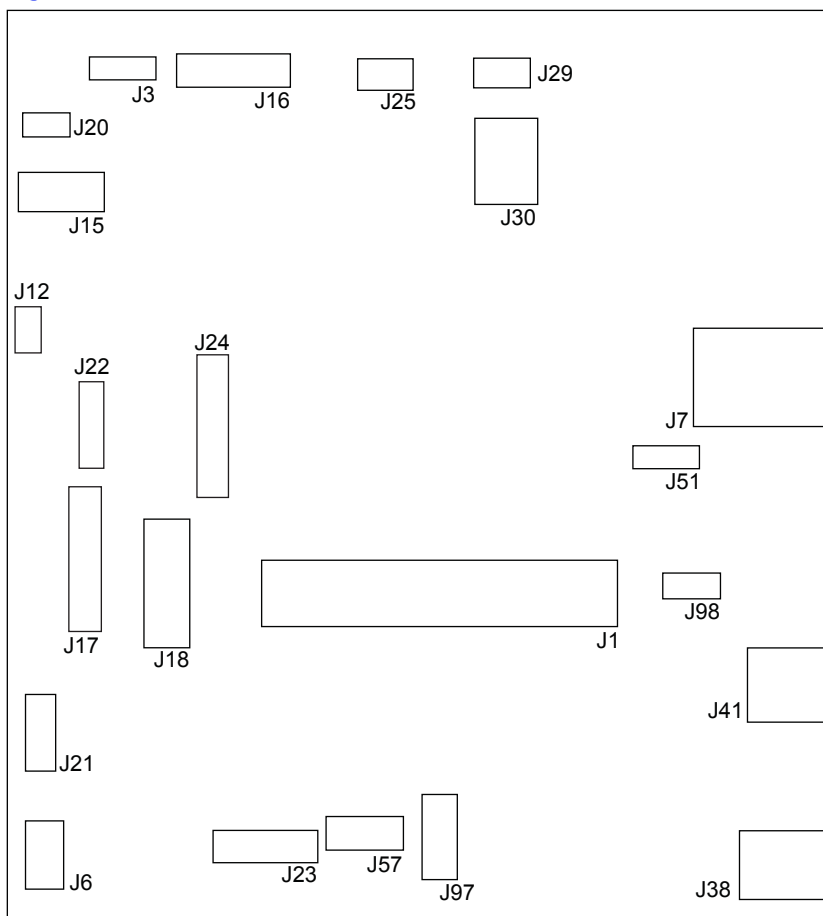
Locate J20 in upper right hand side of the formatter PCA.

7. If the error persists from the walk up easy-access USB port and with USB flash drive directly connected to the formatter USB port, replace the formatter.
