高通8996功耗温升优化技术期刊- 20160315

Qualcomm Technologies, Inc.

Checklist

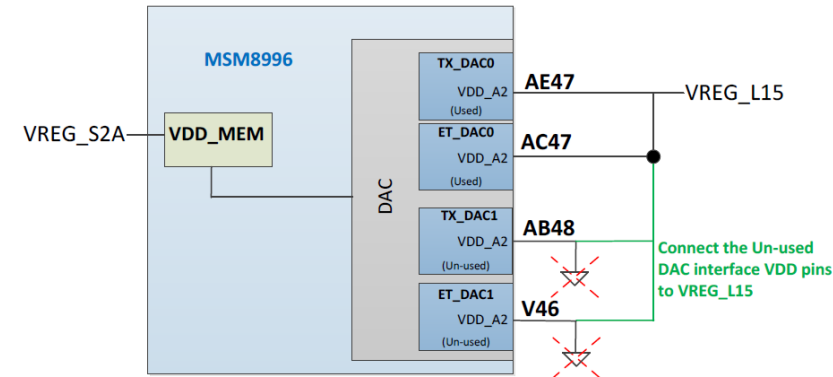
- Check HW design to make sure the following block is correct
The original design may lead 3-10mA leakage on RBSC
Refer to 80-NT204-41 **MSM8996 Baseband** Reference Schematic and 80-NT204-5B
If HW can't be changed as above, you may implement SW workaround like this.
