Preventive maintenance IDEV

February, 10 2021, Annual visit

Equipment data		Customer Ref. :	
Equipment concerned	: IDEV	Install/Startup date	: September, 10 2020
Serial number	: SCE 153578	Capacity	: 52.5 kW
Configuration	: Group configuration		
Unit number within group system: 1 / 2

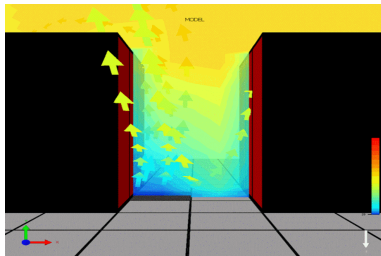
Perforated tiles in hot aisle

To optimize a raised-floor cooling system, cooling air tiles must be located in the cold aisle and hot air return vents should be located above the hot aisle.

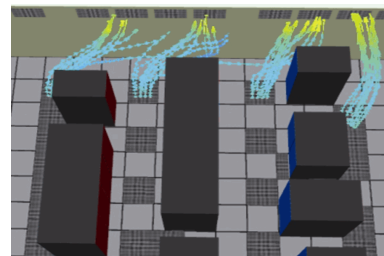
Perforated tiles placement

In order to optimize cooling units performance and decrease dehumidification needs, the location of distribution vents sources should ensure to not end up returning air to the CRAC unit at lower temperatures.
