Technical Service Bulletin

**CENTER DISPLAY OPERATES BY ITSELF (GHOST TOUCH,
SURFACE PEELING, WHITE DOTS)**

Bulletin No.: 09-036/22

Last Issued : 09/09/2022

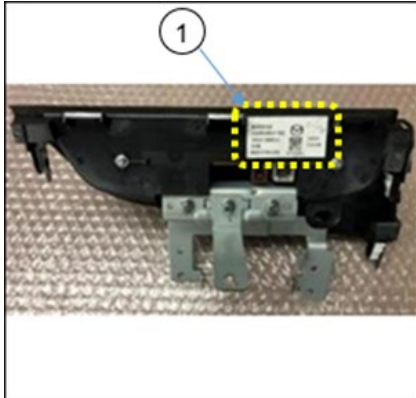
- Center display touchscreen operates by itself (Ghost Touch).
- The film of the center display may be peeled off.
- White dots may appear on the center display

• Ghost Touch	(Touch screen operates by itself)
Peeling of the film surface of the center display
