# Preventive maintenance IDEV

February, 12 2021, Annual visit

Customer		Customer Ref. :	
Customer Company	:		
Site contact name	:	Geir Vistung	Site contact Tel :
Site contact email	:		
Site company	:	Digiplex Norway AS - Holtskogen	
Site address	:	Holtskogen 31, 1825 Tomter	
Site country	:	Norway	Customer account :
Room name	:	Digiplex - Holtskogen POD E

Equipment data		Customer Ref. :	
Equipment concerned	: IDEV	Install/Startup date	: September, 01 2020
Serial number	: SCE153580	Capacity	: 52.5 kW
Configuration	: Group configuration		
Unit number within group system: 2 / 2

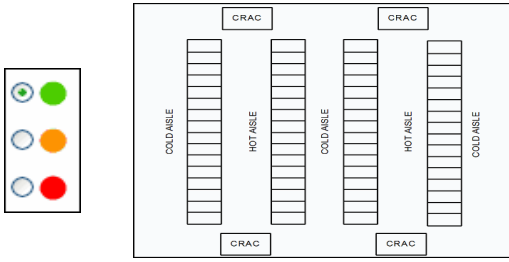
### Cooling unit alignments

To optimize a raised-floor cooling system, cooling units must be aligned with hot aisles.

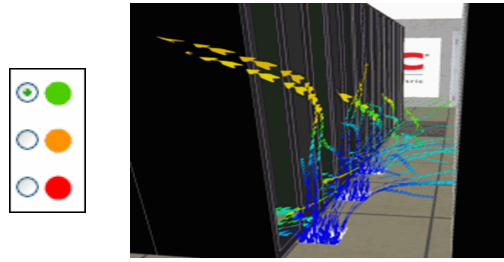
### Raised floor leakage

Cable cutouts in a raised floor environment should be sealed to avoid bypass airflow.

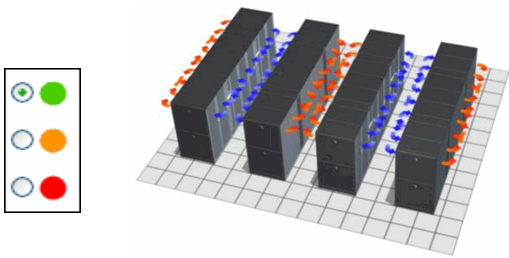
### Hot/Cold aisle configuration

Configure rows in alternating 'hot' and 'cold' aisles to avoid mixing between 'hot' and 'cold' air.

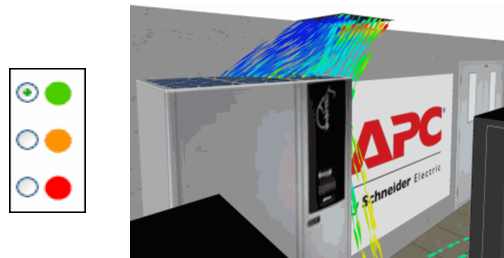
### Diffuser location

Roof or wall mounted distribution vents need to be properly positioned to better facilitate hot air removal.

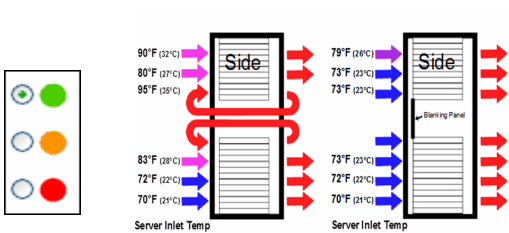
### Gaps in the racks

Prevent hot exhaust from re-entering the equipment's intake by installing blanking panels in all of the empty front panel U-spaces in the rack.

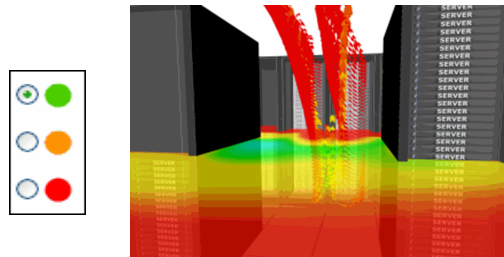
### Gaps in the rows

Prevent hot exhaust from recirculating back to the equipment's intake side by removing any openings (gaps) in the rows.

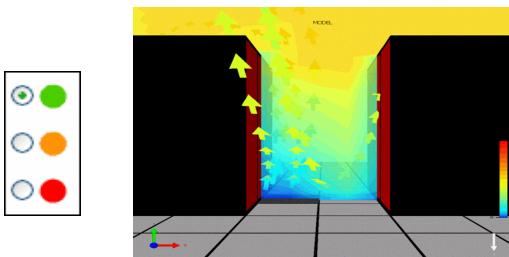
### Perforated tiles in hot aisle

To optimize a raised-floor cooling system, cooling air tiles must be located in the cold aisle and hot air return vents should be located above the hot aisle.

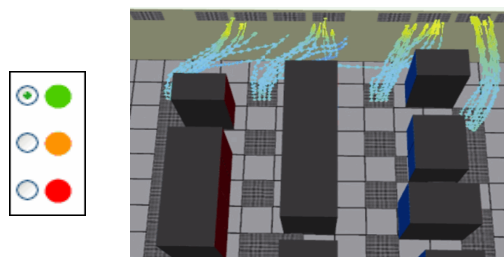
### Perforated tiles placement

In order to optimize cooling units performance and decrease dehumidification needs, the location of distribution vents sources should ensure to not end up returning air to the CRAC unit at lower temperatures.
