What Is the RCC_CSR Register in STM32 Microcontrollers?

Christopher Kalitin Blog (<https://ckalitin.github.io/posts/stm32-rcc-register/>)

Background

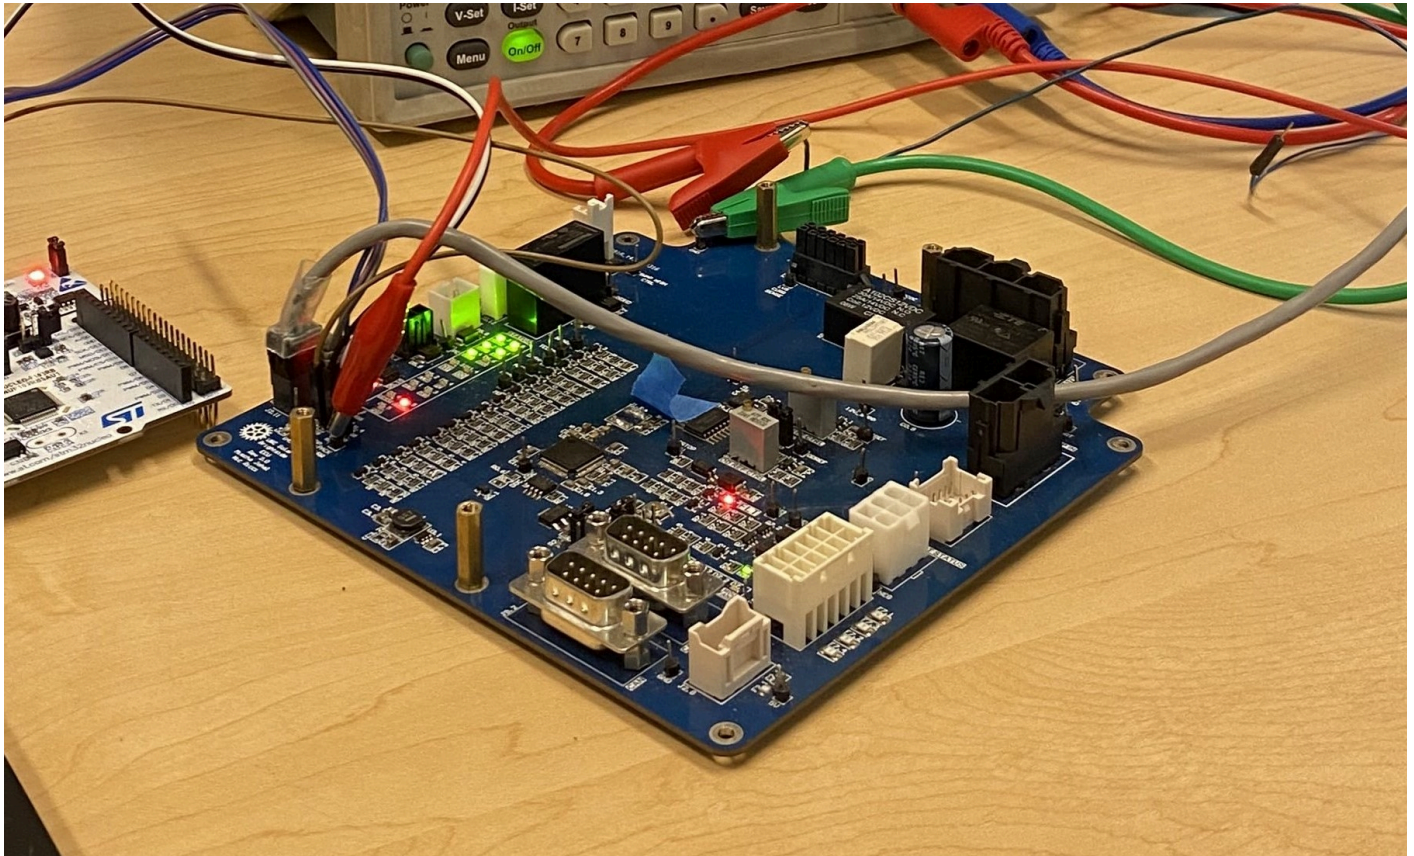
This is the board that controls UBC Solar's Battery, the Elithion Control Unit (ECU). Absolute Beauty.

During test a couple weeks ago, I shorted 3V3 and GND on the board that controls the battery, the Elithion Control Unit (ECU). (If you have suggestions for better acronyms that literally "ECU" pls dm me).

As described in [this project update](https://docs.google.com/document/d/1xOfLdrTIRzjXy1PGJlzUYaPMIBG1Atdfq_sDKa-XnOE/edit?usp=sharing) (https://docs.google.com/document/d/1xOfLdrTIRzjXy1PGJlzUYaPMIBG1Atdfq_sDKa-XnOE/edit?usp=sharing), this was completely my stupid mistake. To fix the issue, I came in almost every day after classes to work on the ECU. With help of a few other UBC Solar members (Michelle and Krish!), we soldered on a new microcontroller.

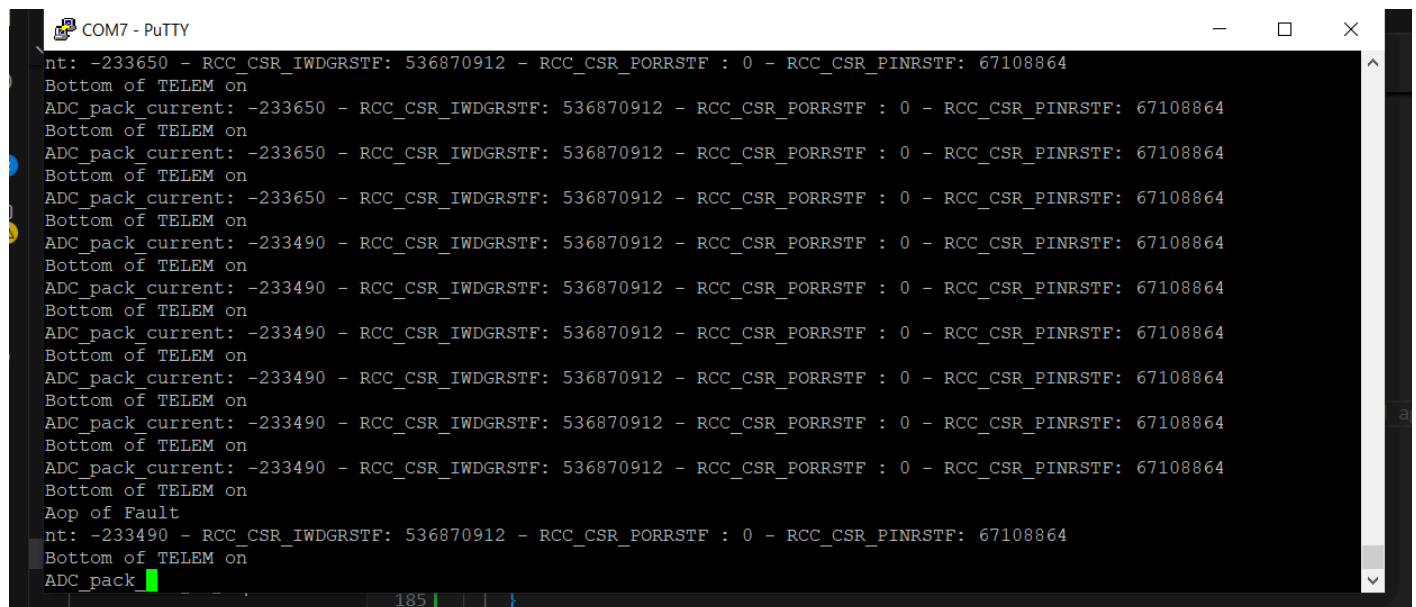
I did a HAL_delay of 1000ms every time the ADC_pack_current was greater than zero. This delay triggered the IWDG.

With a jumper cable hooked up to a test pin on the current sensor line (Batt_curr_sense), I connected it to 3V3 so that the voltage reading from the current sensor would be 3.3V, which corresponds to a current reading of ~233A. Whenever the current reading was greater than 0 amps, I paused the code for 1000ms, which triggered the IWDG to power cycle the STM32 chip.

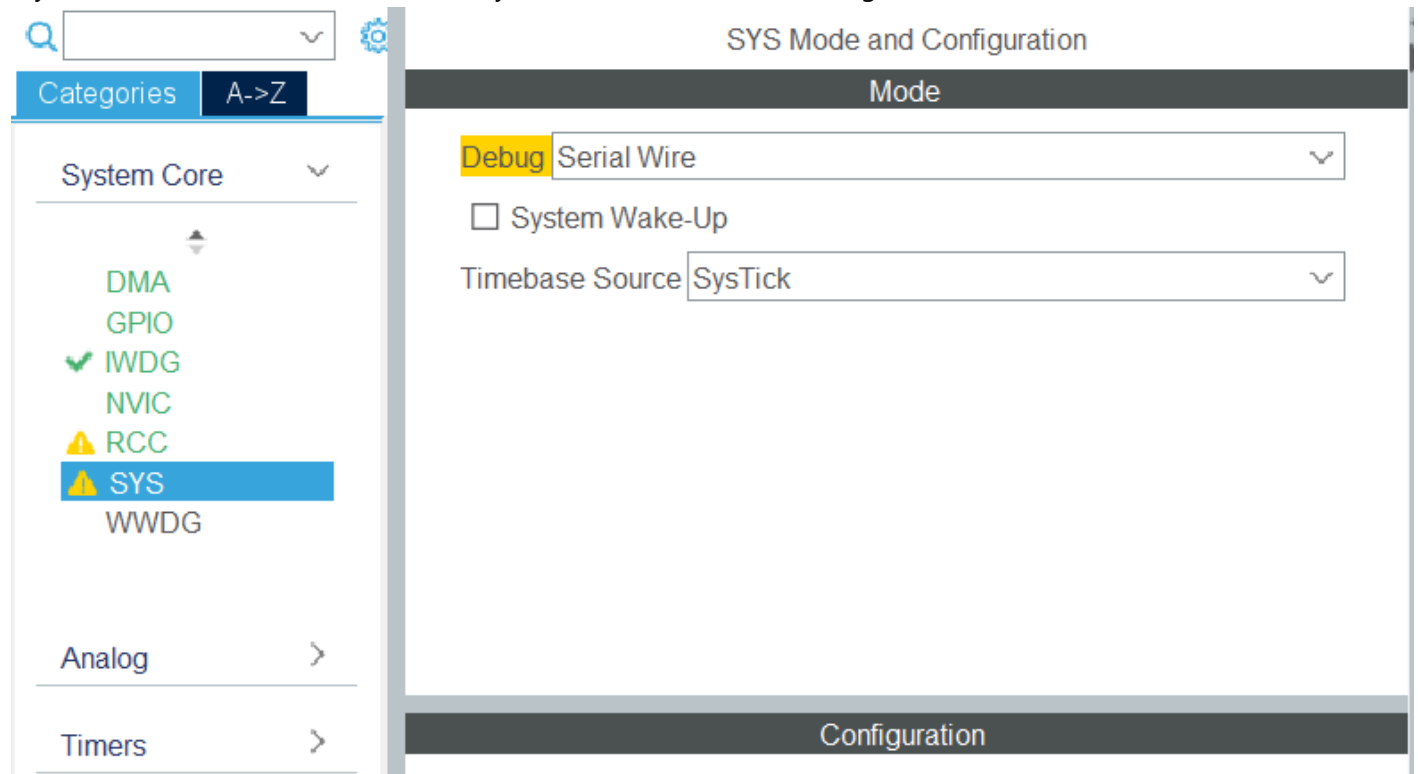
We've had the issue many times that after flashing a new STM32 project once, we weren't able to flash code ever again, getting an error in both STM32 CubeIDE and PlatformIO saying something along the lines of "Target device not found."

We would flash once, the code would work, then we couldn't flash again.

If you ever have this issue, first check if you enabled Serial Wire Debug Mode:

Setting Serial Wire Debug mode should allow you to flash code once again. However, for me this didn't solve the issue.

Instead, what I had to do was short boot0 to 3V3. Power cycle the board. Then return the boot0 pin to GND. Then, reflash. This process resets some configuration in the STM32 microcontroller that ends up allowing us to flash again.
