What Is the RCC_CSR Register in STM32 Microcontrollers?

Christopher Kalitin Blog (<https://ckalitin.github.io/posts/stm32-rcc-register/>)

This is the board that controls UBC Solar's Battery, the Elithion Control Unit (ECU). Absolute Beauty.

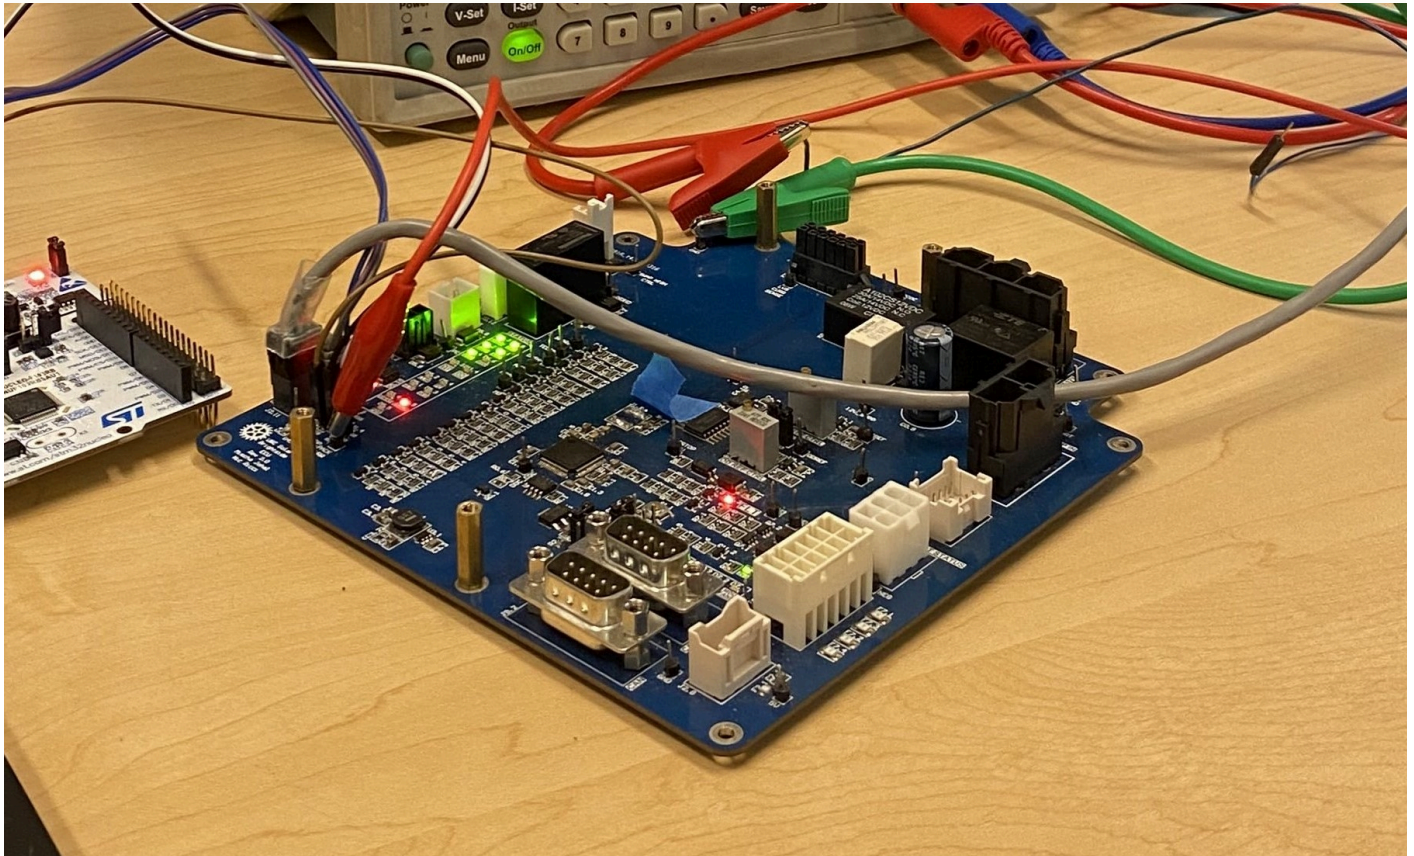
During test a couple weeks ago, I shorted 3V3 and GND on the board that controls the battery, the Elithion Control Unit (ECU). (If you have suggestions for better acronyms that literally "ECU" pls dm me).

As described in [this project update](https://docs.google.com/document/d/1xOfLdrTIRzjXy1PGJlzUYaPMIBG1Atdfq_sDKa-XnOE/edit?usp=sharing) (https://docs.google.com/document/d/1xOfLdrTIRzjXy1PGJlzUYaPMIBG1Atdfq_sDKa-XnOE/edit?usp=sharing), this was completely my stupid mistake. To fix the issue, I came in almost every day after classes to work on the ECU. With help of a few other UBC Solar members (Michelle and Krish!), we soldered on a new microcontroller.

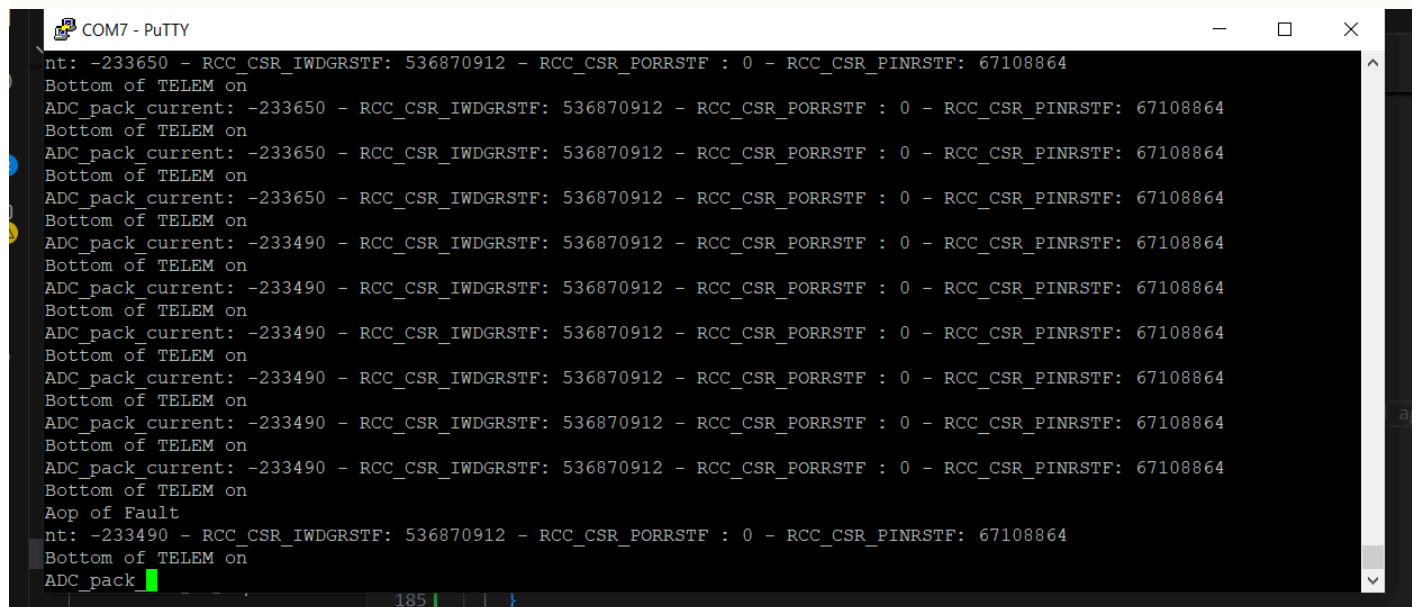
I did a HAL_delay of 1000ms every time the ADC_pack_current was greater than zero. This delay triggered the IWDG.

With a jumper cable hooked up to a test pin on the current sensor line (Batt_curr_sense), I connected it to 3V3 so that the voltage reading from the current sensor would be 3.3V, which corresponds to a current reading of ~233A. Whenever the current reading was greater than 0 amps, I paused the code for 1000ms, which triggered the IWDG to power cycle the STM32 chip.
