# Preventive maintenance IDEV

February, 12 2021, Annual visit

| Room name | : | Digiplex - Holtskogen POD E | | | |

| Equipment data | | Customer Ref. : | |
|--|---|---|---|
| Equipment concerned | : IDEV | Install/Startup date | : August, 27 2020 |

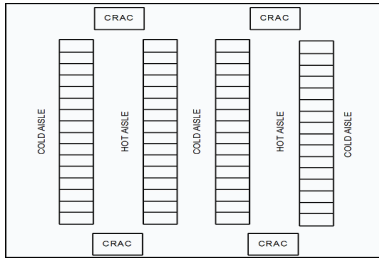
### Cooling unit alignments

To optimize a raised-floor cooling system, cooling units must be aligned with hot aisles.

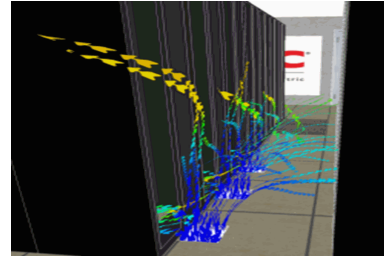
### Raised floor leakage

Cable cutouts in a raised floor environment should be sealed to avoid bypass airflow.

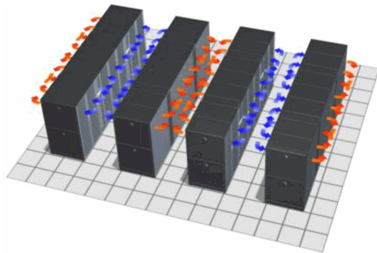
### Hot/Cold aisle configuration

Configure rows in alternating 'hot' and 'cold' aisles to avoid mixing between 'hot' and 'cold' air.

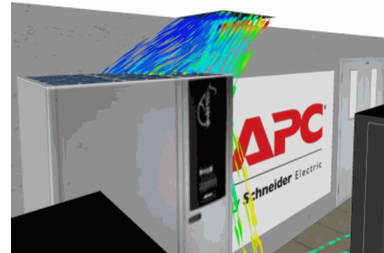
### Diffuser location

Roof or wall mounted distribution vents need to be properly positioned to better facilitate hot air removal.

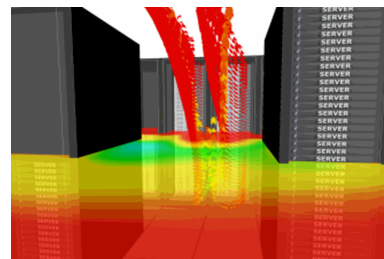
### Gaps in the rows

Prevent hot exhaust from recirculating back to the equipment's intake side by removing any openings (gaps) in the rows.

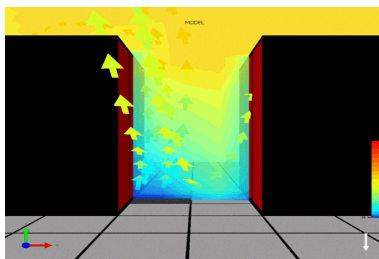
### Perforated tiles in hot aisle

To optimize a raised-floor cooling system, cooling air tiles must be located in the cold aisle and hot air return vents should be located above the hot aisle.

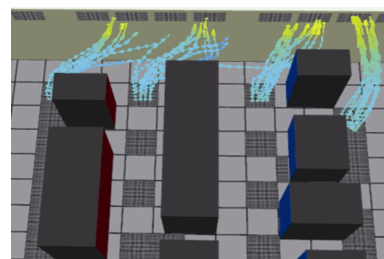
### Perforated tiles placement

In order to optimize cooling units performance and decrease dehumidification needs, the location of distribution vents sources should ensure to not end up returning air to the CRAC unit at lower temperatures.
