## ABNORMAL SOUND DURING DOOR GLASS OPENING/CLOSING [POWER WINDOW SYSTEM]

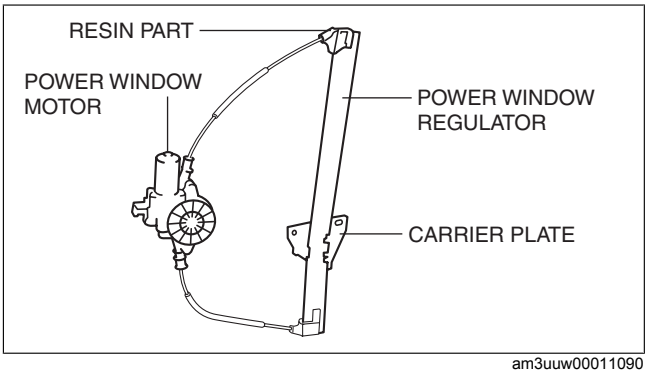
am3uuw00011090

| Description | Abnormal sound during door glass opening/closing |
|---|---|
| **Possible Causes** | • Installation screw is loose between the door glass and carrier plate.<br>• Deformity in the power window regulator plastic part due to use.<br>— Scratching, wear marks to the power window regulator resin part due to twisting of the cable.<br>— Gear deformity in the power window motor.<br><br>**Note**<br>• Identify the location of the noise using a stethoscope or similar device. |

| Noise type | Time of occurrence | Possible cause | Location of noise | Action |
|---|---|---|---|---|
| Clanking noise | Door glass begins to move | Insufficiently tightened installation screw between the door glass and carrier plate. | Between door glass lower edge and carrier plate. | Securely tighten the installation screw. |
| Groaning noise (Sound increases due to use) | While door glass is operating | Vibration caused by wear on the resin part from cable twisting due to use of the power window regulator.<br><br>**Note**<br>• Noise does not occur if a roller is equipped to power window regulator resin part. | Power window regulator | Replace the power window regulator (See FRONT POWER WINDOW REGULATOR REMOVAL/ INSTALLATION.) (See REAR POWER WINDOW REGULATOR REMOVAL/ INSTALLATION.) |
| Whining noise | | Gear inside power window motor is deformed due to use. | Gear in power window motor | Replace the power window motor (See FRONT POWER WINDOW MOTOR REMOVAL/ INSTALLATION.) (See REAR POWER WINDOW MOTOR REMOVAL/ INSTALLATION.) |
